HGF11 HAGG101
Durham University
Conservation Services
Conservation Record

SF No : 1Δ	Context : 003	X-radiograph No : 6338
Object : Frags	Material : CuA	Photography : Digital pix bc&ac

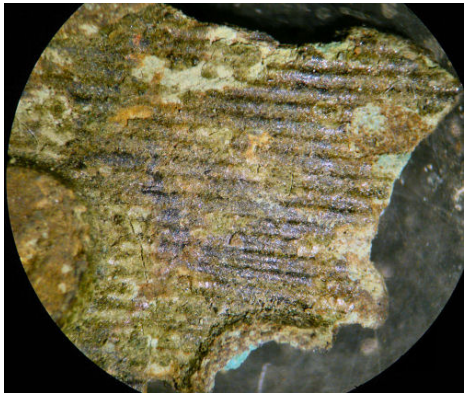
Very fine ribbing (4 lines per mm) on surface of decorated fragments X10

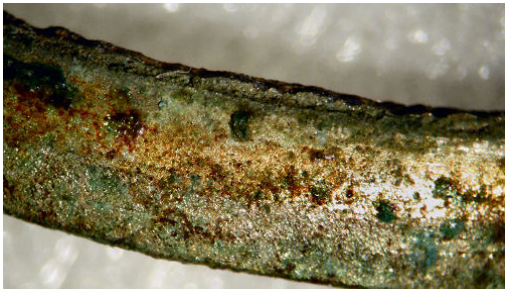
White metal plating on outside of edging strip X10
