**SWALEDALE AND ARKENGARHTHDALE  
ARCHAEOLOGY GROUP**

**REPORT OF AN ARCHAEOLOGICAL WATCHING BRIEF  
CARRIED OUT AT**

**RALPH BANK HOUSE  
LOW ROW, SWALEDALE**

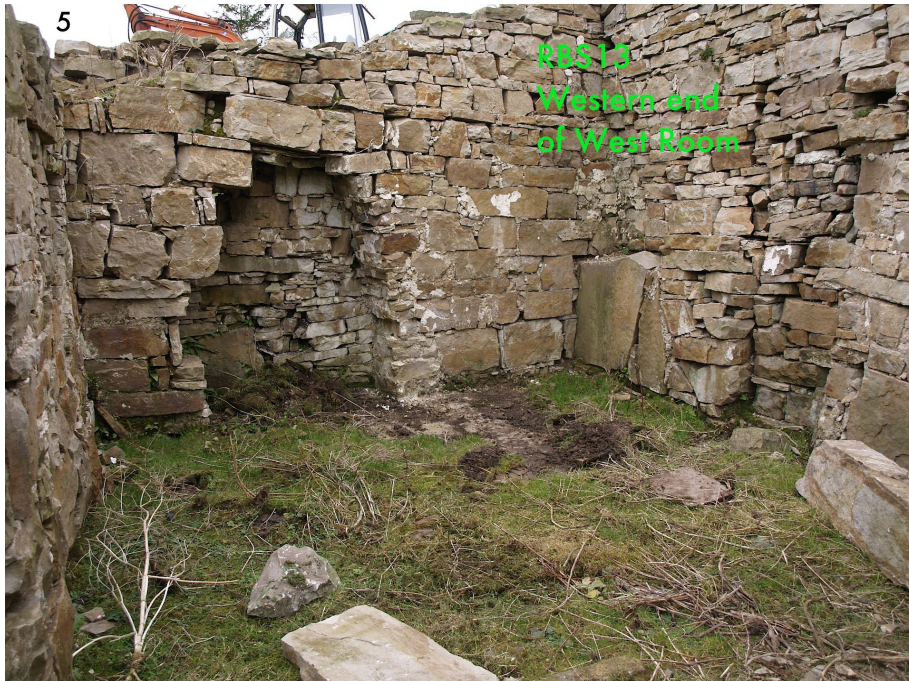
Figure 1: West Room before excavation

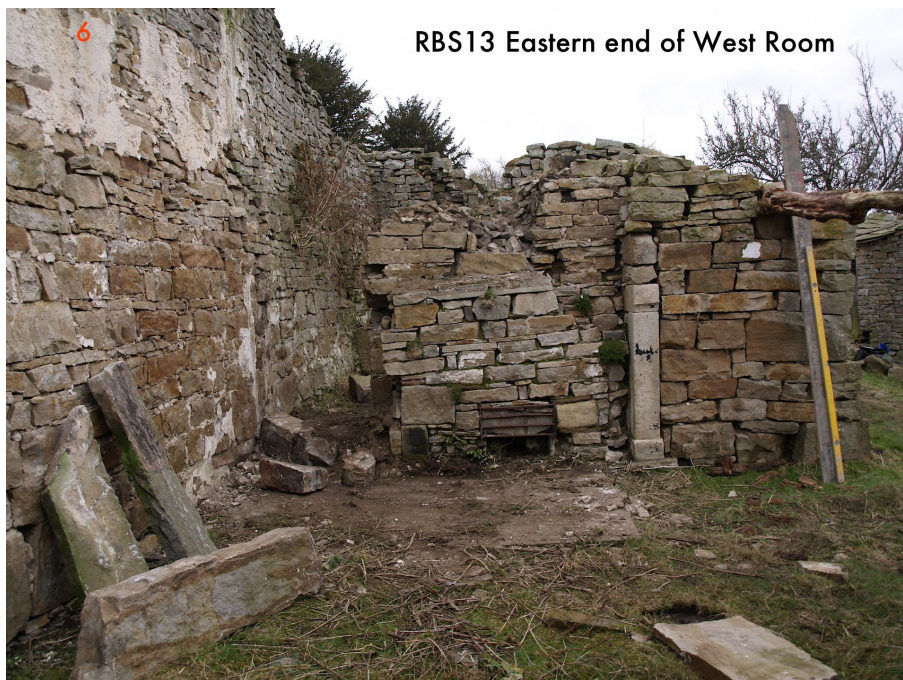
Fig 2: West Room before excavation

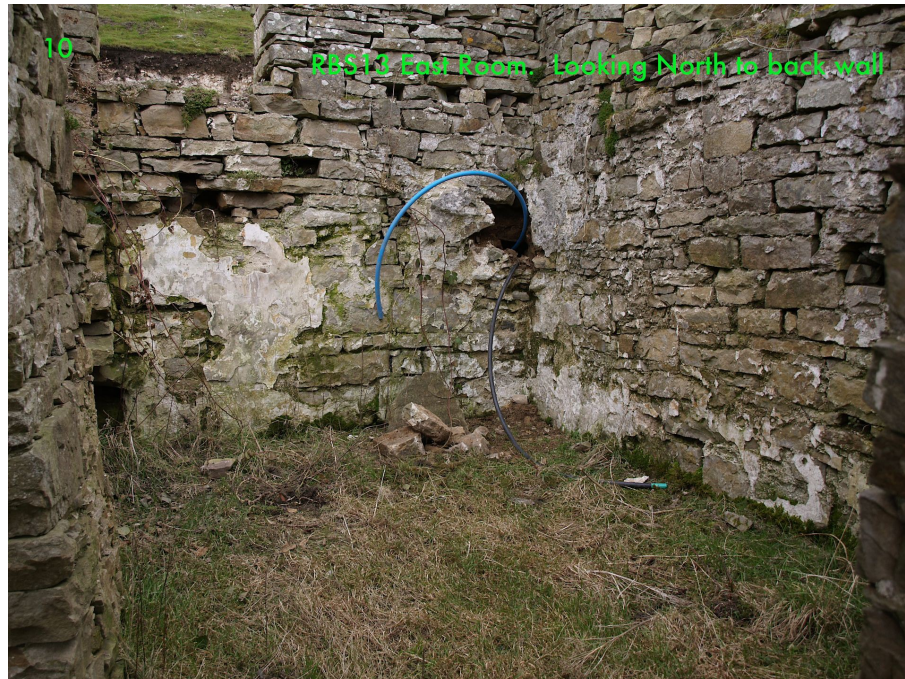
Figure 3: East Room before excavation

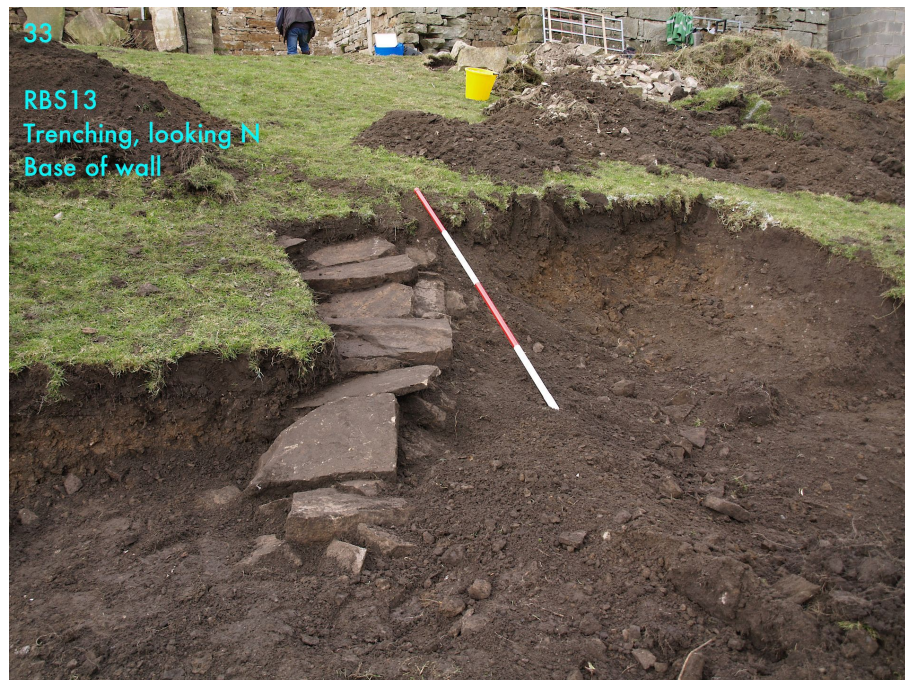
At 11.5m from the eastern end of the trench, the probable remains of the base of a field boundary wall [204] running roughly north to south were uncovered. This extended into the area to the north of the main trench and which is intended to house the septic tank. The remaining stone from the wall appeared to have been robbed out.

Figure 4: Base of field wall in trench

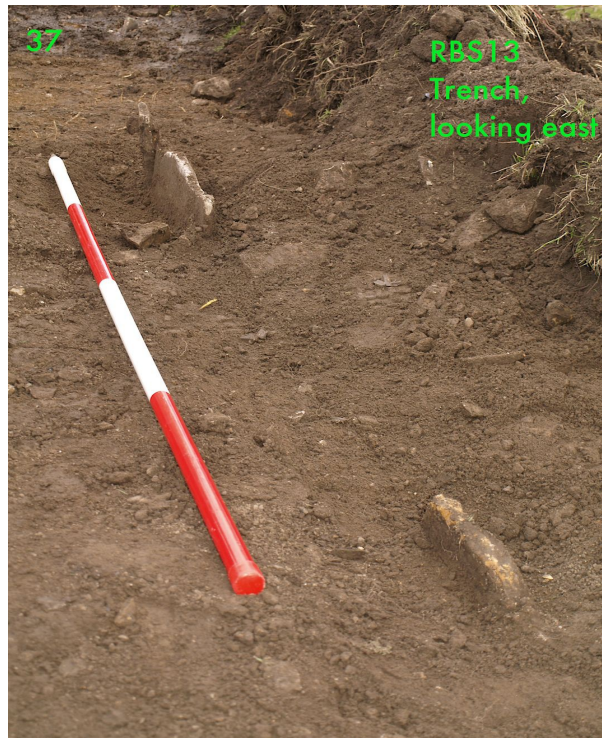
At 5m and 7m from the eastern end of the trench two stones measuring 60cm x 30cm x 3cm [202] and 25cm x 30cm x 3cm [203] respectively, had been placed vertically.

Figure 5: Trench showing the vertical slabs

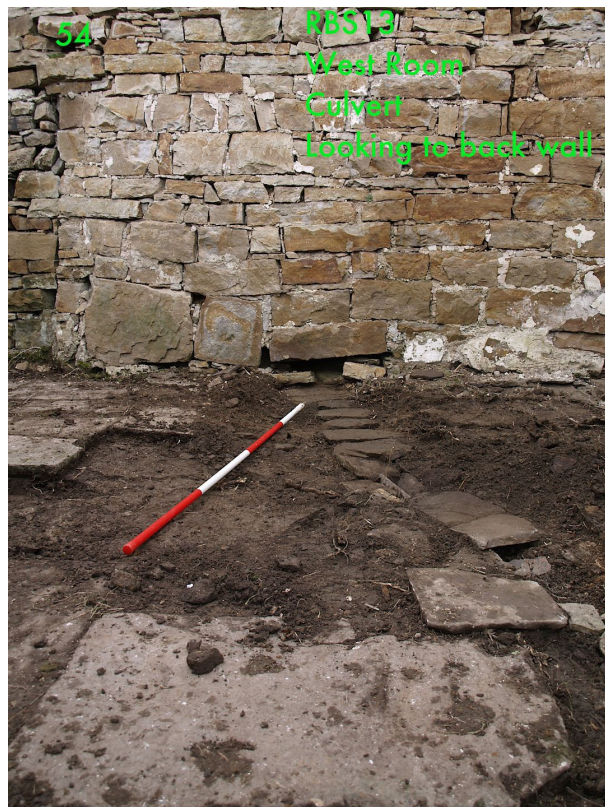
Cleaning of the bedrock at the western end of the room exposed a clay/silt layer which ran between the laminated layers of the bedrock. The layer sloped gently east under the wall of the culvert [103] running approximately north/south and capped, but not sealed, with small pieces of stone [104]. The culvert measured 15-20cm in width and 15cm deep.

Figure 6: West Room showing culvert

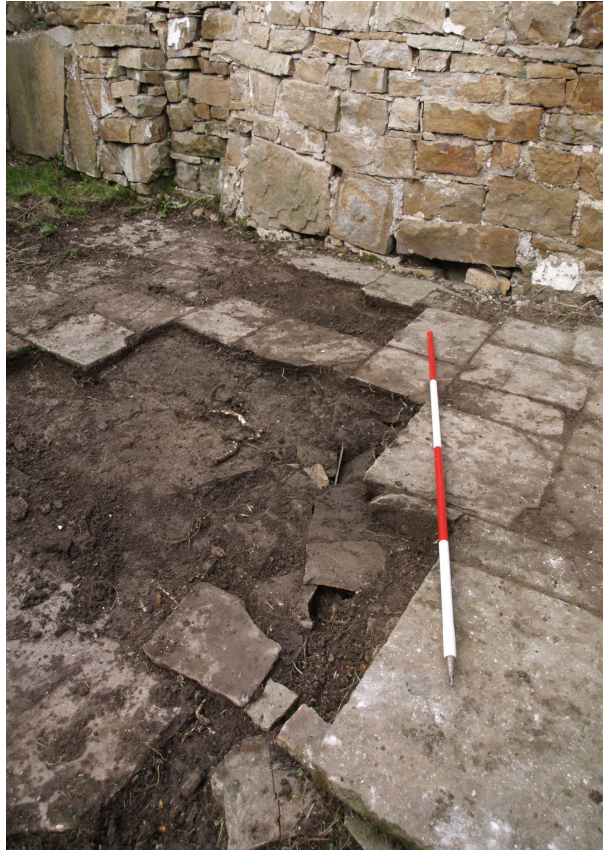
Floor flags covered the majority of the room and would seem to have been laid on a mix of sand and soil [101] probably to level an older floor surface; the flags stopped short of the southern wall by 1m creating a noticeable lip where they overlapped a lower layer of floor flags [106]. The older floor surface appeared to be a mix of limestone bedrock [102] at the northern and western end of the room with flags on the southern side and the culvert [103] at the eastern end.

Figure 7: West Room, top layer of flags cleaned back

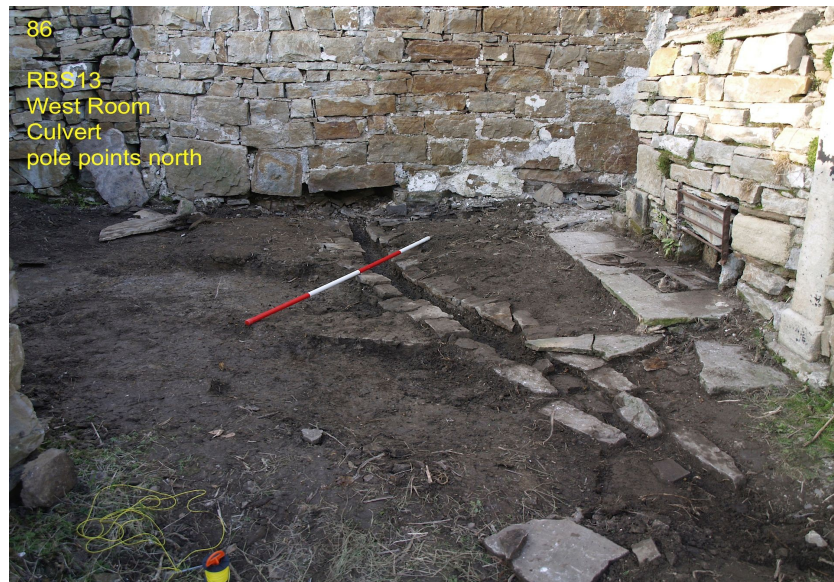
Further cleaning of the floor at the north end of the room revealed two further culverts running east/west and joining the north/south culvert [103] at its northern end nearest the house wall.

Figure 8: West Room, showing culvert

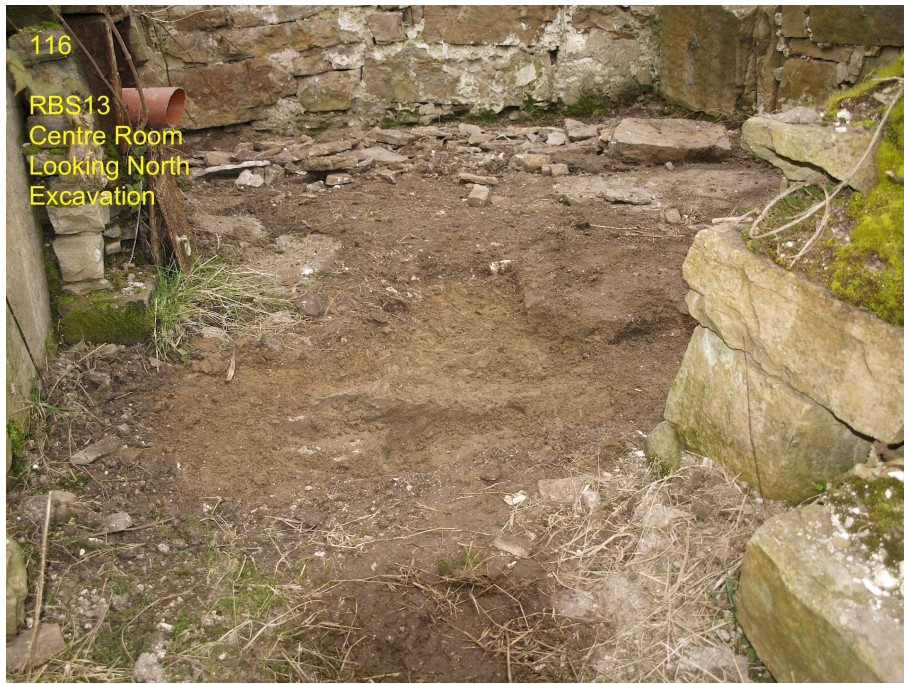
To help assess the build-up of the floor on the southern side of the room, a T-shaped trench was opened up just inside the doorway. The east/west top of the T was parallel to the front, south wall, 1.2m in length and 35cm wide. The leg of the T ran north/south central to the top, 45cm long and 35cm wide. The trench was excavated to depths between 7.5cm and 20cm.

A dark compacted layer [109] varying in depth up to 20cm and possibly introduced to level the floor contained numerous stones between 25mm and 150mm across and 25mm to 75mm thick and a number of lumps of hard white material, about 25mm across. This last material was probably mortar from the walls of the room.

Figure 9: Excavation of Centre Room

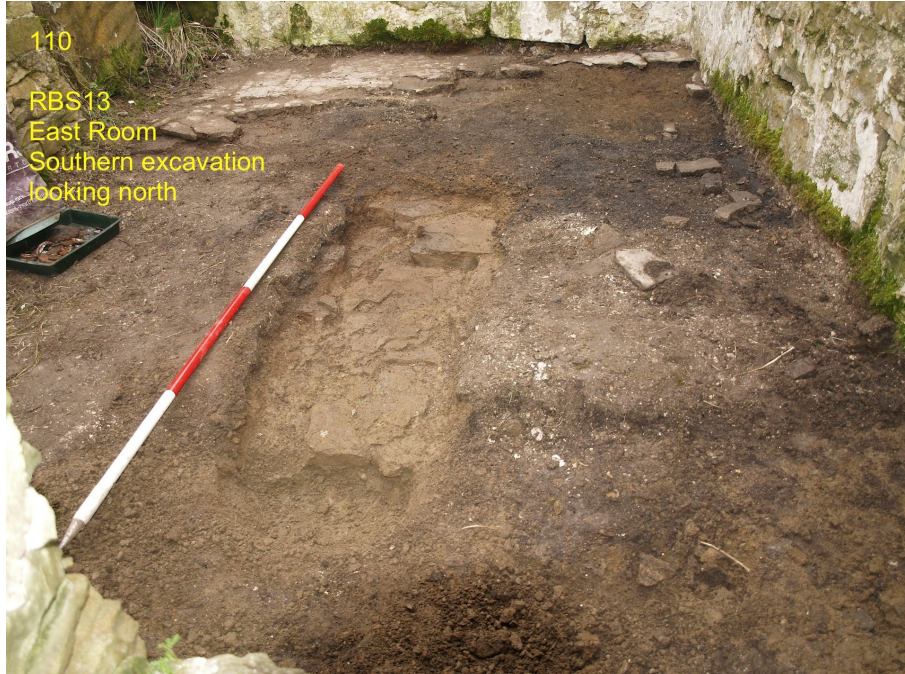
To determine whether the bedrock underlay the whole of the room, a trench running east/west and 1m wide was opened in the front (south) quarter of the room adjacent to the south wall.

The trench revealed three layers: soil, orange/brown soil, and grey clay [111], [112], [102] respectively. The grey clay was probably undisturbed ground. The trench was excavated down to 60cm with no sign of bedrock.

Figure 10: Excavation of East Room

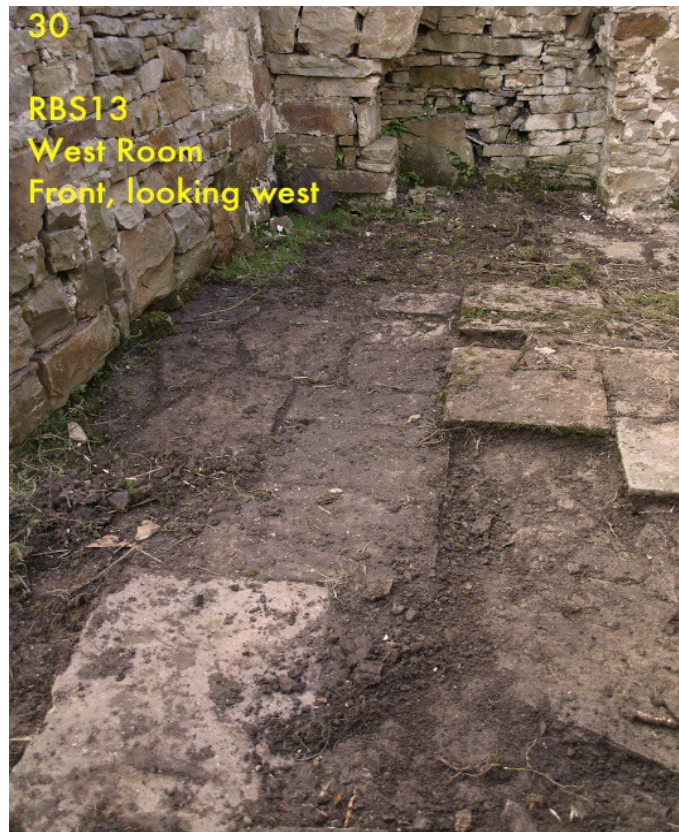
Figure 11: West room. Door on left, lip between old and new flags

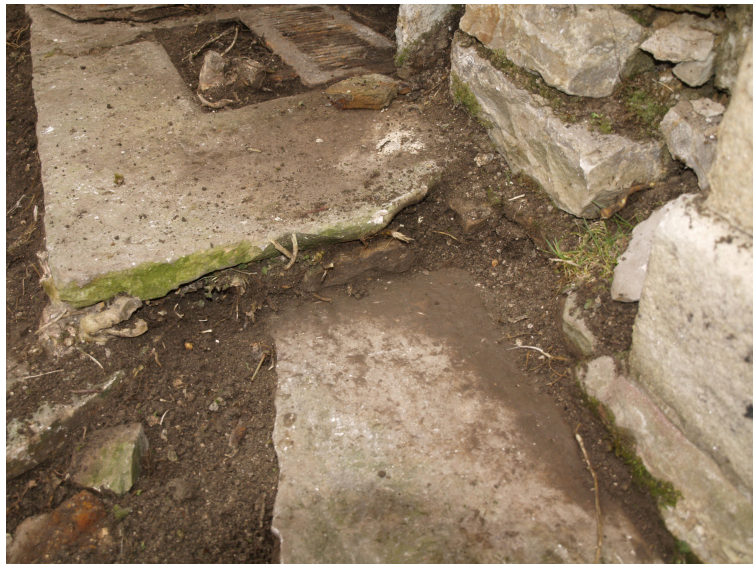
The room contained a fireplace on the eastern wall adjoining the centre room and which is probably an infill of a much earlier and larger C18th fireplace. Examination of the surround and base suggests that the base of the original fireplace sat lower than the flags [100].

- **Phase 2** covers the period in the late C18th/early C19th when the large stone fireplace was installed at the east end of the room. The hearth flag and side pillar were both seated on the original flag layer and abutted the bedrock to the north of the fireplace (see photograph, Figure 12 in Appendix 1).

Figure 12: West room. Shows different contexts around fireplace.

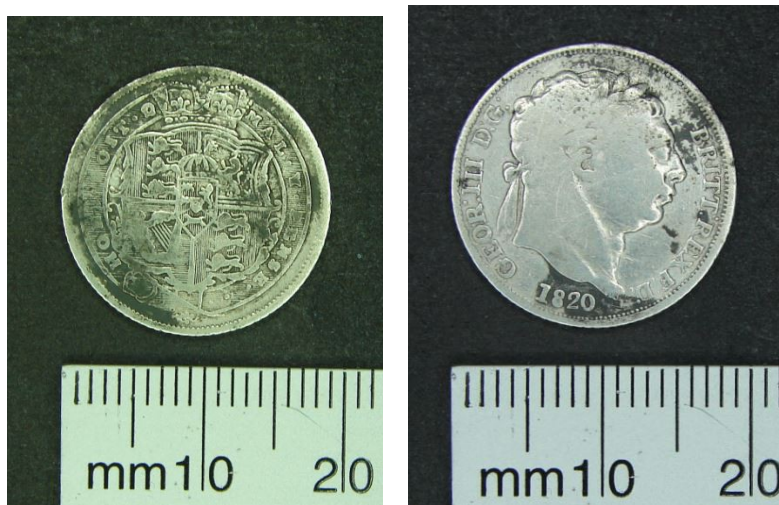
Figure 13: George III silver sixpence [105] <1>

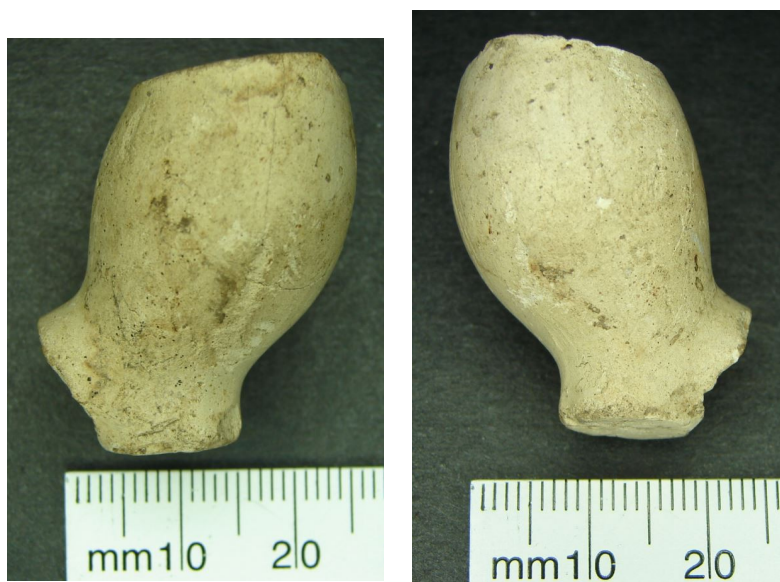
The clay tobacco pipe bowl was assessed against the Oswald Typology, (reference 7) and dated as mid/late 17<sup>th</sup> century. In a private communication, Dr Susie White, Curator of the National Clay Tobacco Pipe Archive and author of reference 8, after inspection of the photographs of the pipe bowl confirmed a date of 1650 – 1670.

Figure 14: Clay tobacco pipe bowl [105] <2>
