Thorns through Time

The story of an abandoned settlement

Stories in Stone: Project H3

David S. Johnson

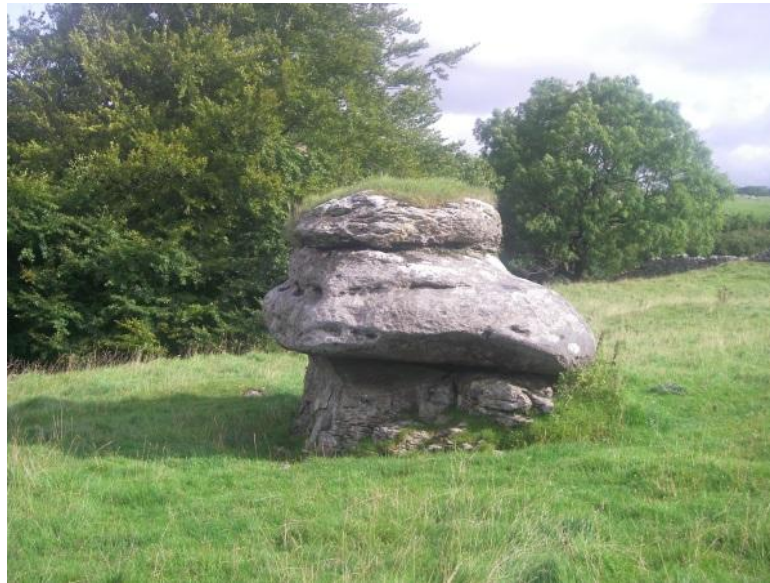
Fig. 2.2 A limestone pedestal near Thorns Gill (David Johnson)

There are also individual outcrops of pedestal-like limestone broadly parallel to the gorge extending from just below the bridge to the settlement (Fig. 2.2).

There is some doubt about the origin of these pedestals, though the two most tenable theories put forward both involve natural geomorphological processes. One suggests that they are glacial erratics, or more pedantically glacially-moved boulders,¹ carried along under ice flows and deposited at random as the ice lost momentum and therefore the energy to transport heavy material. Some of the isolated pedestals could indeed be erratics as their angle of repose is not horizontal so they are not part of the bedrock. The alternative suggestion is that they are tor-like features, a term normally applied to masses of granite rock common on the moors of south-west England, exposed by normal weathering processes. In such cases the pedestal would have rocks lying horizontally, as clearly seen in Figure 2.2. It is, however, not acceptable to see the lower layer of any given pedestal representing the amount of rock weathered away since de-glaciation.

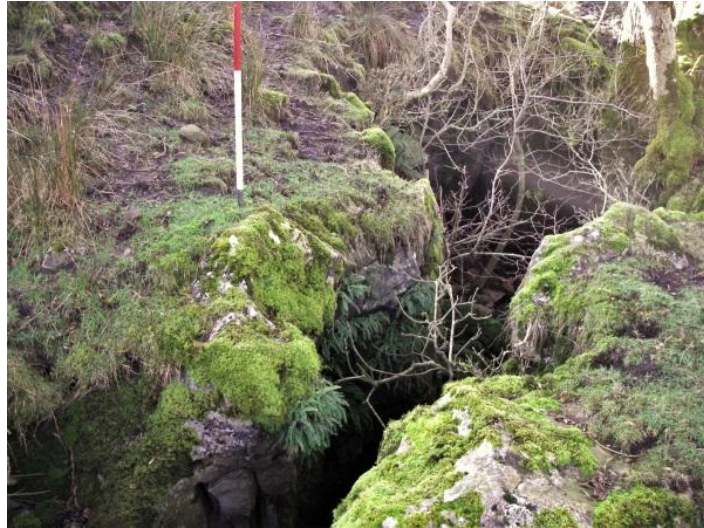
Fig. 2.6 Cove Hole (David Johnson)

a. Cove Sike flows as a small stream across Thorns Close and sinks immediately east of the settlement of Thorns at Cove Hole, at SD7824 7942 (Fig. 2.6), to flow underground for a surveyed distance of about 400m. It runs directly below the bank barn across the meadow towards the lime kiln and it is possible that the obvious 1m-high bluff seen on the surface within the meadow represents the edge of a palaeochannel from when this stream flowed on the surface (Fig. 2.7). It rises and joins Gayle Beck at the outflow of Thorns Dub Cave.

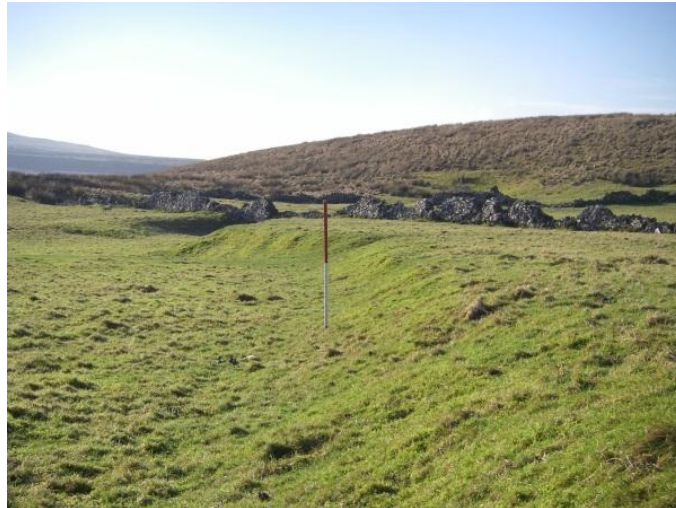
Fig. 2.7 Palaeochannel edge west of Thorns settlement (David Johnson)

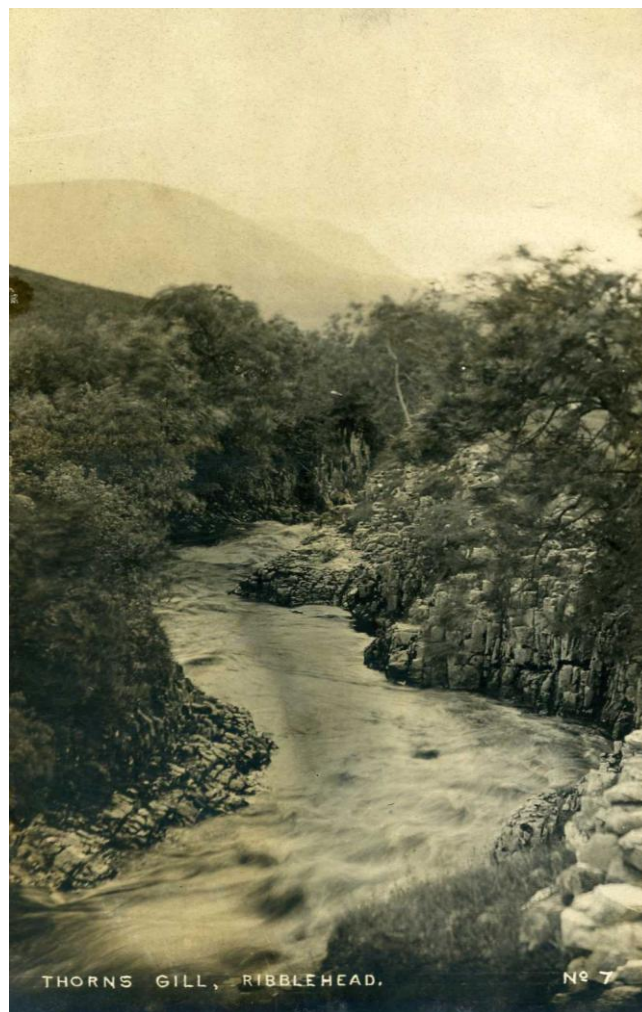
Fig. 2.8 Thorns Gill photographed by Alfred Shaw between 1900 and 1910, with Park Fell and Ingleborough in the background (David Johnson Collection)²

Towards the end of the most recent glacial period, some 10-12,000 years ago, vast quantities of water flowed out from melting glaciers and ice sheets, finding its way wherever a pre-glacial river valley provided it with an easy passage. Meltwater from Great Knoutberry Hill, Gayle Moor, Cam Fell and Blea Moor, all of which had been ice growth centres, poured south-westwards towards Ribbleshead. Meltwater flows had the energy and power to greatly deepen and widen existing river courses so what would have been pre-glacial Gayle Beck's normal open and gentle-sided valley was transformed into the narrow rocky gorge now called Thorns Gill (Figs. 2.8 and 2.9) between Gearstones and Holme.

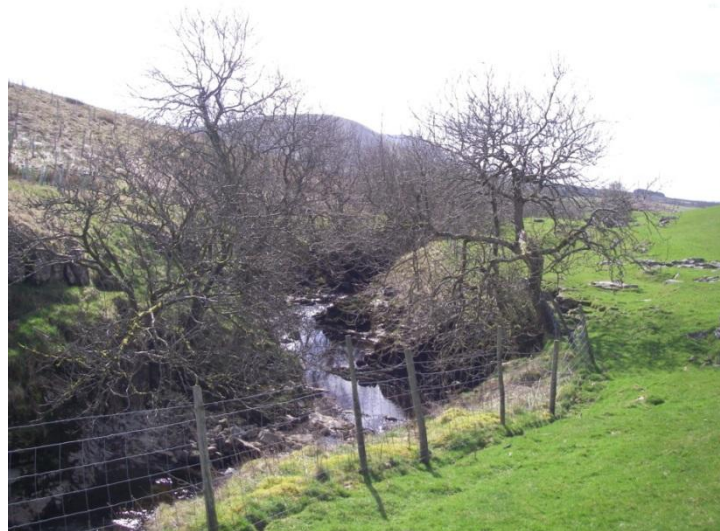
Fig. 2.9 Thorns Gill, more or less from Shaw's viewpoint, photographed in April 2017 (David Johnson)

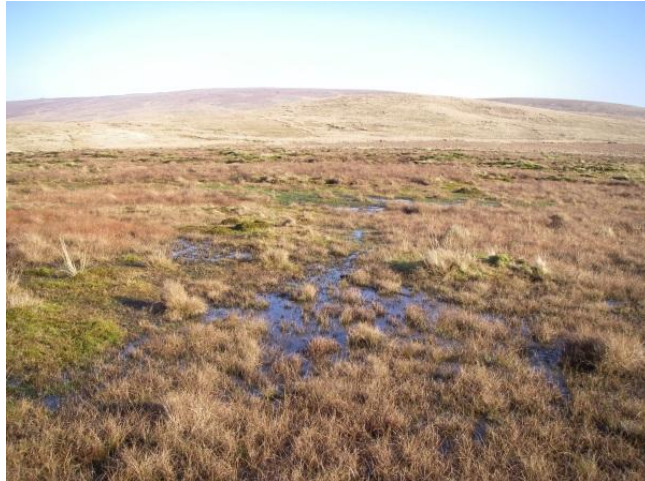
Fig. 2.14 Blanket bog in Thorns Close (David Johnson)

Down the eastern side of the project area, in Thorns Close and on Cam End, lies 'Soilscape 25, blanket bog peat soils' which are very acidic with a pH value little more than 4 (Fig. 2.14). Consequently, they have very low nutrient levels and minimal populations of organic recyclers, and consist largely of (here at least) relict heather moorland and active bogs, especially along Cove Sike and around Broad Reyn Hill. The water table is always very high, peat is highly resistant to successful agricultural improvement, and such ground is only suitable in farming terms for very extensive low-density grazing.

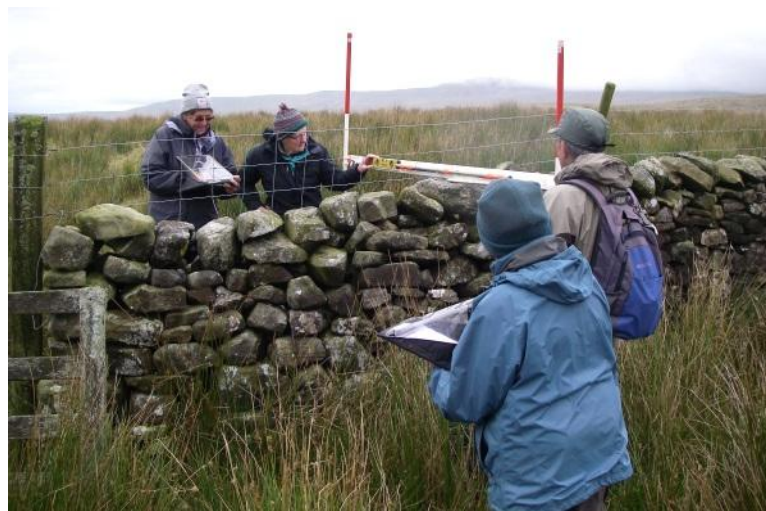
Fig. 4.2 Volunteers using the wall profile measuring frame (David Johnson)

A 'snapshot' of each length of wall was recorded utilising more than just observation and written notes: how many snapshots were taken depended on how often a given wall changed its characteristics. For some, a single snapshot sufficed; for others it was felt necessary by the joint team leaders to take several. This was achieved using a measuring frame (Fig. 4.2) devised by team leaders Pat and Phil Carroll for wall surveys elsewhere in the Dales. It was possible by using the frame to record accurate cross-profiles for each surveyed wall.

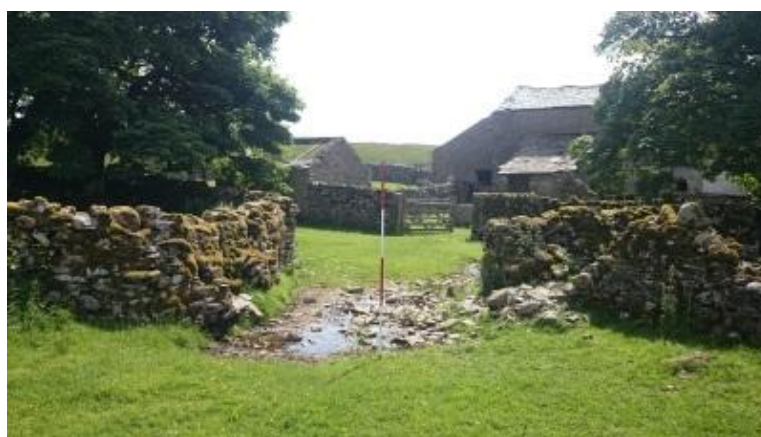
Fig. 7.2 Trackway no. 1 at its east end (Sarah Hunter)

At SD7813 7939 the wall on the north-west side turns northwards and the trackway remains open on its north side, past the remains of a building and to the end of the trackway where it enters the settlement (Fig. 7.2).

At SD7815 7939 a solid surface, probably bedrock, was found about 300mm below the grassy surface and this extends for 13m to the end of the trackway where it meets Trackway nos. 2 and 6. At this point the track is 2.5m wide.

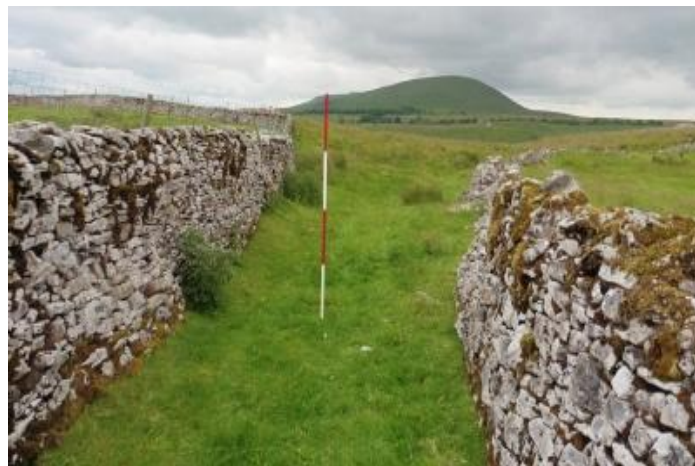
Fig. 7.3 Trackway no. 2 opens out into Pry (Gayle Wray)

There is a field gate on the east side, giving access to the field called Jammy, beyond which the lane is blocked by a ruinous cross-wall, possibly erected in relatively recent times to help with stock management. Width here is 2.8m and the paved surface continues. At SD7812 7928 the lane opens out into a field called Pry where the east wall ends and beyond which no more solid surfaces were found (Fig. 7.3).

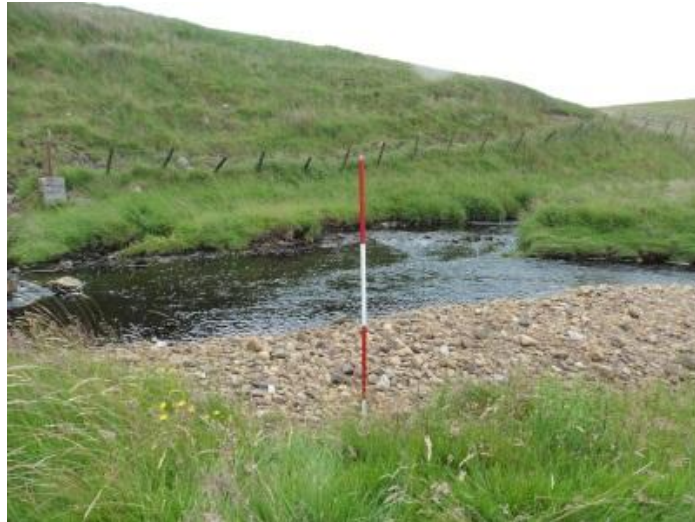
Fig. 7.4 Trackway no. 2 at the ford across the Ribble (Gayle Wray)

The trackway crosses the wall at a field gate (SD7797 7886), and the trackway is shown on OS First Edition mapping (surveyed here in 1846-48) heading for a ford (SD7789 7881) across the River Ribble (Fig. 7.4), thence round the northern flanks of Ashes Eller Bank, whereas Second Edition mapping (surveyed in 1893) shows it crossing a footbridge (SD7882 7882) further downstream. The present remains of an iron bridge were a modern replacement for the original bridge which was long since swept away by flood water.

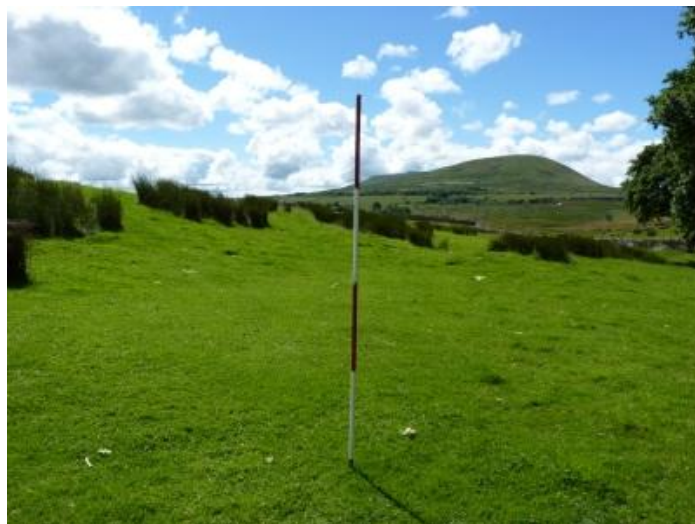
Fig. 7.5 Trackway no. 3 leading away from the bank barn (Carol Ogden)

This trackway commences at the west end of the bank barn (Thorns 10) at SD7818 7936, and heads south and is initially indistinct (Fig. 7.5), apart from a grassy section between rushes where it is sinuous but with no apparent hard surface beneath.

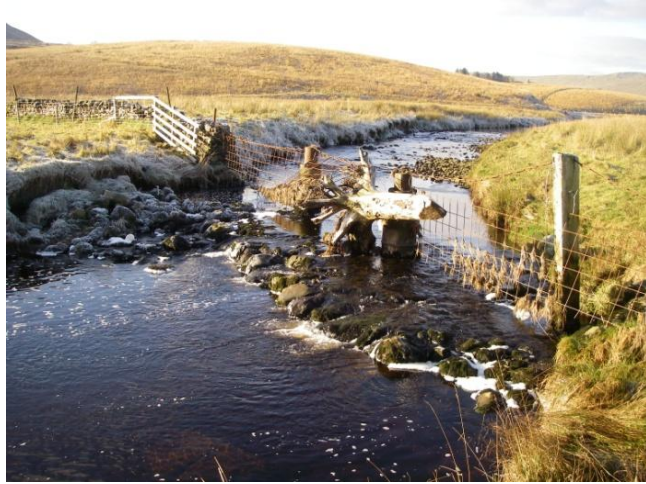
*Fig. 7.6 The stepping stones by Hipping House, looking upstream
(David Johnson)*

The word 'hipping' denotes 'stepping stones' which suggests that the route carried on across the river just beyond the house, probably joining up with Trackway no. 2, but no trace of such a track or path is to be seen on the ground beyond the Ribble. The actual hippings (Figs. 7.6 and 7.7) are still visible at low water (SD78188 78793) though time has not treated them kindly and to cross them now would be hazardous. Lying more or less on the line of the stepping stones is a modern metal-mesh flood gate (see Figure 7.6) which is anchored on the east bank to four vertically-set slabs of flagstone in a single line (Table 7.1). It is possible that their original purpose was to anchor an earlier flood gate – the heavy-duty chains that link the slabs together are certainly not modern – though they could have provided a safety line for negotiating the stepping stones (see Figure 7.7).

Slab no. counting away from the river	Height (m)	Base width (m)	Detail
1	1.7m	550mm	Three small holes drilled through; set 3.5m from no. 2
2	1.2m	400mm	One large hole drilled through; set 4.3m from no. 3
3	1.2m	550mm	As no. 2; set 4.3m from no. 4
4	1.3m	550mm	
Chain links			The western half has 5 inch forged links; the rest 2 inch forged links

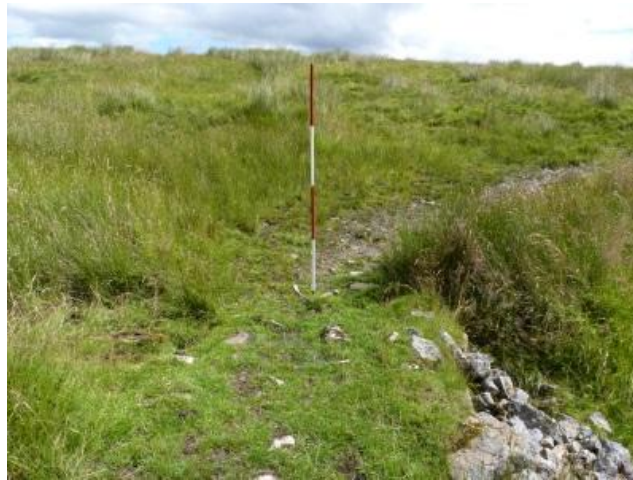
*Fig. 7.8 Trackway no. 4 crossing a small stream on a stone bridge
(Carol Ogden)*

indicating an older bridge, 1.5m wide (Fig. 7.8). The trackway has a solid surface beneath, either side of the bridge, and it continues all the way to a ruinous lime kiln.

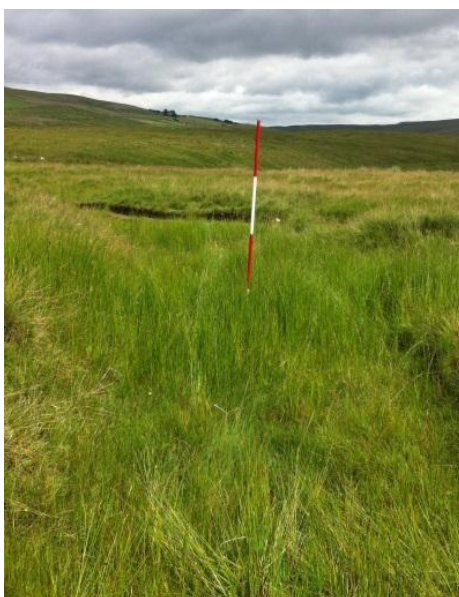
Fig. 7.9 Trackway no. 5 showing as a line of rushes in a holloway (Gayle Wray)

It is intermittently seen as a sinuous holloway heading north-north-east through a rushy area (Fig. 7.9).

At SD7827 7951 stones are visible on the track surface and it is braided here. They are the remains of an earlier – possibly original – laid surface, necessary as the ground is so wet.

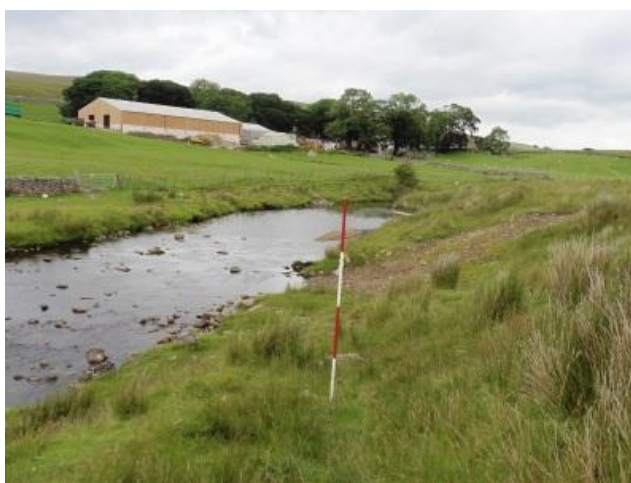
Fig. 7.10 Trackway no. 5 at the ford across Gayle Beck (Gayle Wray)

At SD7822 7982 the trackway reaches the beck and the original fording point (Fig. 7.10). Beyond the beck the trackway is shown on early mapping heading south-west and then north-west to meet up with the major east-west route way which is now Blea Moor Road.

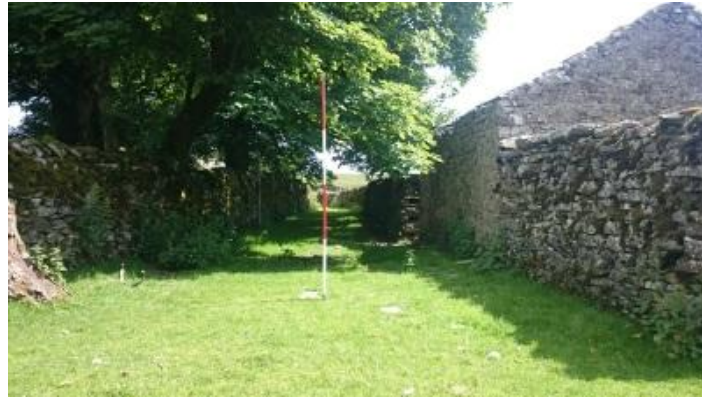
Fig. 7.11 Trackway no. 6 within the settlement (Sarah Hunter)

This commences at SD7818 7939 at the junction with Track no. 4 and runs in a north-north-east direction through the centre of the settlement (Fig. 7.11), confined between stone walls. Width averages 3.3m and the track is grassy overlaying a man-made cobbled surface. At SD7820 7940 the edge of the paved surface is revealed.

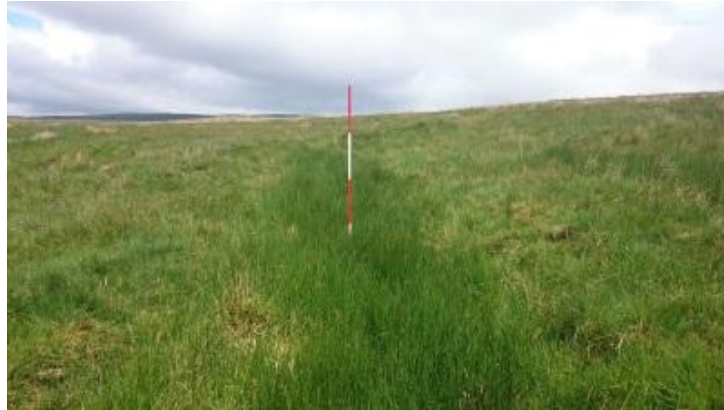
Fig. 7.12 Trackway no. 8 showing as a sunken rush-filled holloway (Sarah Hunter)

This newly-found trackway which starts at SD7825 7943 is not shown on First Edition six-inch mapping. It commences just beyond the end of Trackway no. 6 and is sinuous throughout. A holloway is visible amongst the rushes (Fig. 7.12), with a width of 3m and depth of 500mm. No hard surface was found along its length.

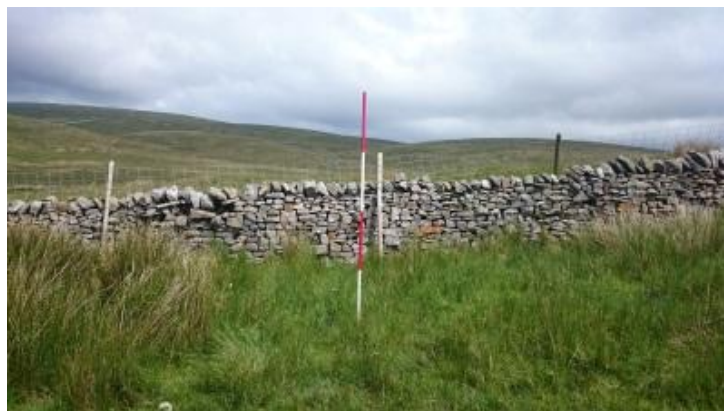
Fig. 7.13 Trackway no. 8 at the Thorns-Cam End boundary wall (Sarah Hunter)

SD7883 7962 marks the end of this trackway within the survey area at the Thorns-Cam End boundary wall, where trackway width is 2m and depth 300mm (Fig. 7.13). There is no evidence of a blocked-in gateway in the wall here, indicating that the trackway had gone out of use before the wall was built.

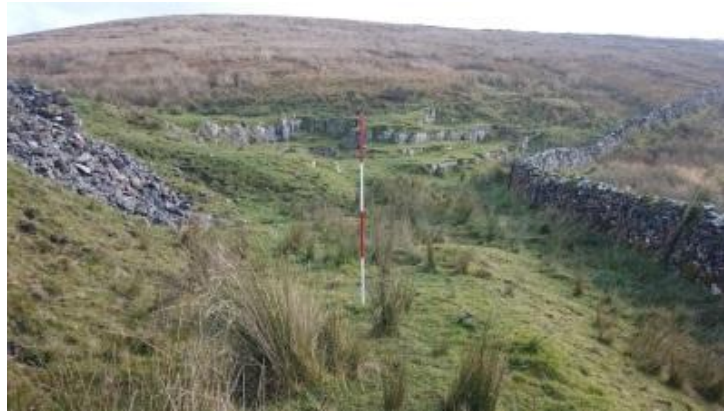
Fig. 7.14 Trackway no. 9 by the now-ruined lime kiln (on the left) (Sarah Hunter)

At SD7860 7890 the trackway finishes at the kiln draw arch (Fig. 7.14). Width is still 2.3m.

This trackway must either have been engineered to help transport burnt lime away from the kiln to Thorns or was maintained after the original line of Track no. 4 was moved above the kiln.

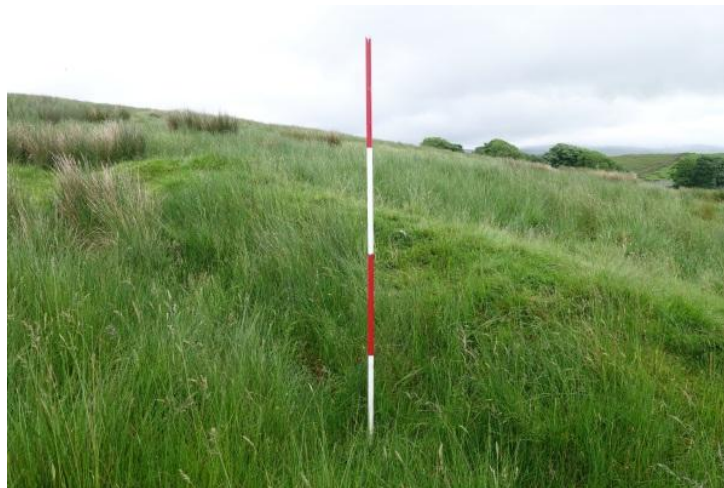
Fig. 8.3 Feature no. 1a with the bank clearly seen to the right of the ditch (John Asher)

Feature no. 1 runs upslope from Gayle Beck, starting c. 10m south of the beck at a point where the steep stream bank reduces in gradient. Along with Feature nos. 2, 3 and 4, it subdivides what current OS maps name as Thorns, an area now dominated by coarse grasses and rushes with a very recent area given over to mixed native-species tree planting. Feature 1 was surveyed as four sub-sections of one overall ditch and bank because the length running south from Gayle Beck (1d) turns through a curving ‘right-angle’ to run west-south-west (as 1c), then through a reverse angle to head northwards (1a, Fig. 8.3) with a branch to the west (1b).

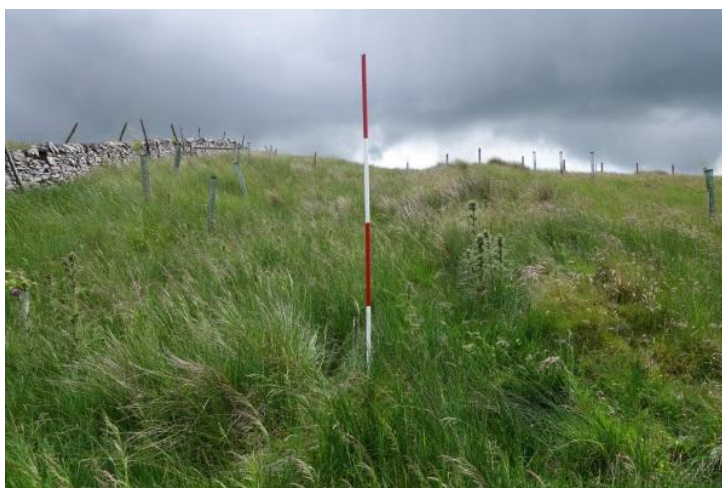
Fig. 8.4 Feature no. 1d showing the difficulties of surveying with such dense vegetation growth (John Asher)

Bank and ditch 1d were originally perceived as the eastern boundary of Thorns estate, given their prominence in the landscape, but the later discovery that Thorns Close – the very large enclosure to the east of the wall parallel to 1d – was historically part of Thorns caused that view to be rejected. Bank/ditch 1d has an average combined width of 4.9-5.8m contrasting with those for 1b, c and d which range from 3.8-4.3m, 3.6-3.9m, and 2.1m respectively. The ditches lie south of 1b and 1c but east of 1a and 1d (Fig. 8.4).¹²

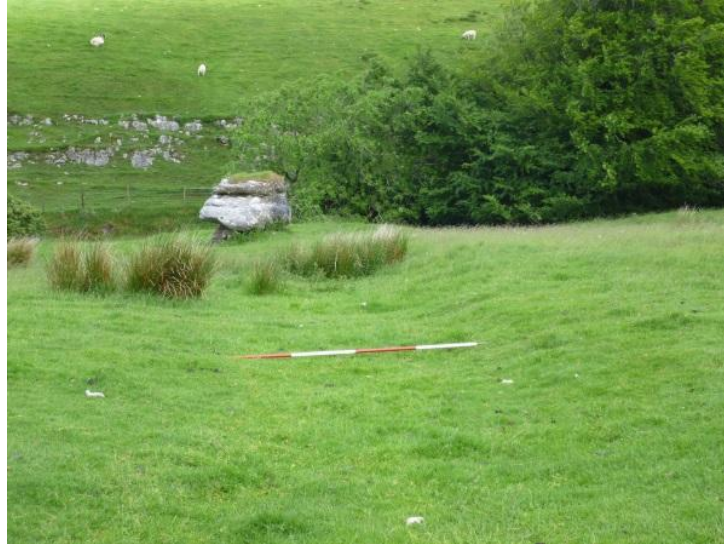
Fig. 8.5 Feature no. 5 showing the ditch approaching Gayle Beck (Ian Fleming)

Feature no. 5 marks a major boundary of a former field system in the north-western corner of the Thorns estate, bounded on the other sides by Gayle Beck and the historical external boundary of the estate. Feature no. 5 consists of a slightly curvilinear and sinuous ditch and bank that are significantly wider than the other features in this area: average ditch width is 3.1m and depth 200mm though, as with all the ditches, there has been considerable slippage of loose soil from the banks into the ditches along with silting up of the ditches from water flow along them. The ditch lies on the west side of the bank. The western end of this feature terminates c. 20m from Gayle Beck where the natural gradient of the land levels off (Fig. 8.5).

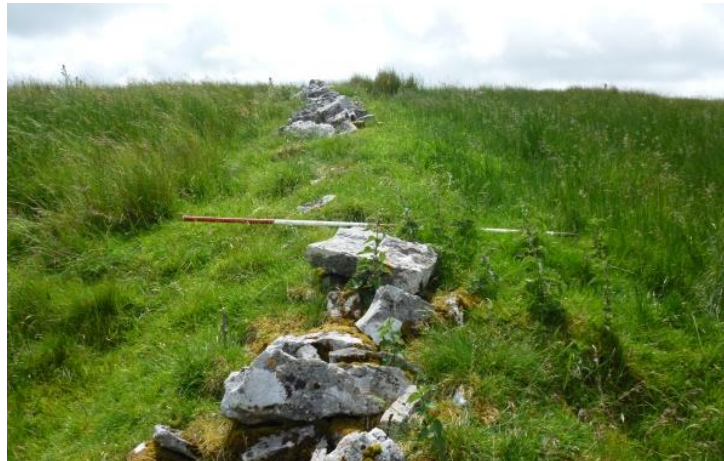
Fig. 8.6 Feature no. 10 showing a ruinous stone wall on top of the bank (Ian Fleming)

The eastern end of no. 5 runs seamlessly into **Feature no. 10**. Indeed they are one and the same feature. This is equally large in scale with ditch width averaging 3.8m and depth 400mm; the ditch similarly runs on the west side of the bank. For much of its northern length the bank has a later field wall on its top (Fig. 8.6).

Where it is possible to accurately measure bank width, no. 10 averages 4m. There is visible ground evidence that Feature no. 10 may be stone cored, though this is a tentative suggestion. It is curving in plan form and peters out at its eastern end for no apparent reason, seemingly unconnected to any other bank and ditch.

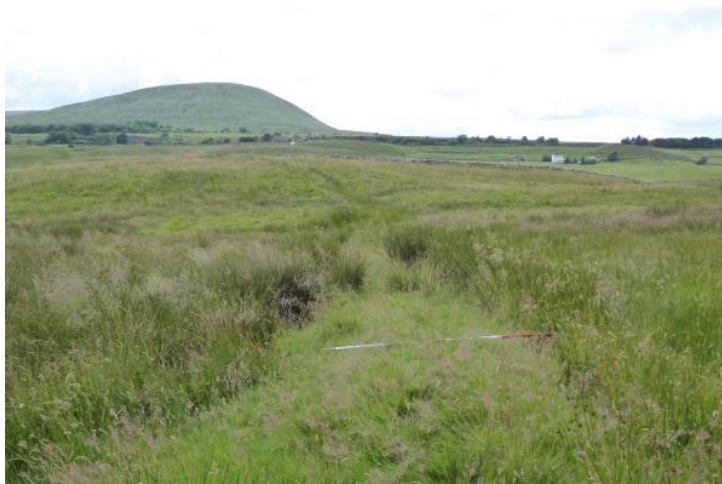
Fig. 8.7 Feature no. 13 with the bank clearly seen in the foreground and the ditch in the background running upslope (Lynda Hutchins)

Up to this point, ditch no. 13 lies on the west side of the bank with average widths 1.67m and 1.2m respectively, and average ditch depth 680mm and bank height 530mm. At the top of the natural rise the feature describes a sharp but curving change in direction to once again head downslope to a boggy area at the bottom. Though rush growth is dense for most of its length, both ditch and bank are clearly visible except where they cross the bog. Along this west-north-west to east-south-east line the ditch lies south of the bank.

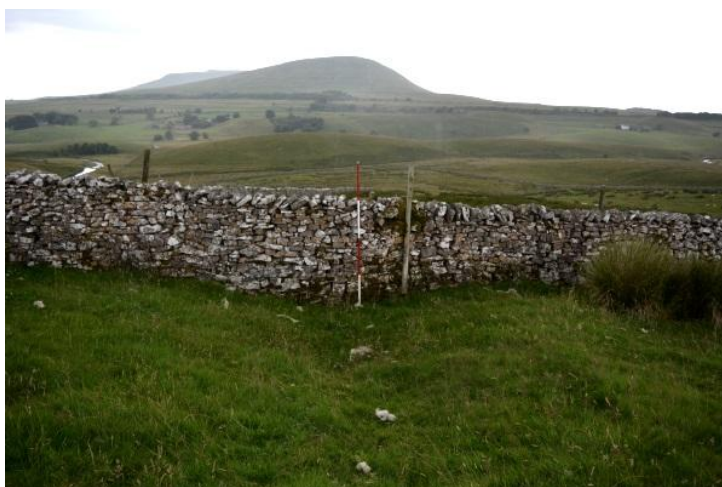
Fig. 8.8 Feature no. 15 showing the ditch and bank crossed by a later dry-stone wall (Ian Fleming)

Just before Feature no. 13 meets a long upstanding stone wall another bank and ditch joins it – **Feature no. 14**. It runs uphill from here to a point opposite the line of Feature no. 12's north-west to south-east alignment at which point the by-now almost imperceptible bank turns through a right-angle as a continuation of no. 12. Vegetation growth makes parts of Feature no. 14 difficult to see except in mid winter but much of it is visible; because of this it proved more than difficult to obtain reliable measurements. At the bottom of the hillslope Feature no. 13 becomes **Feature no. 15** which describes a 400m-long course northwards and uphill. While most of its length is straight it initially turns through a very gentle curve under two stone walls, one upstanding and one derelict (Fig. 8.8).

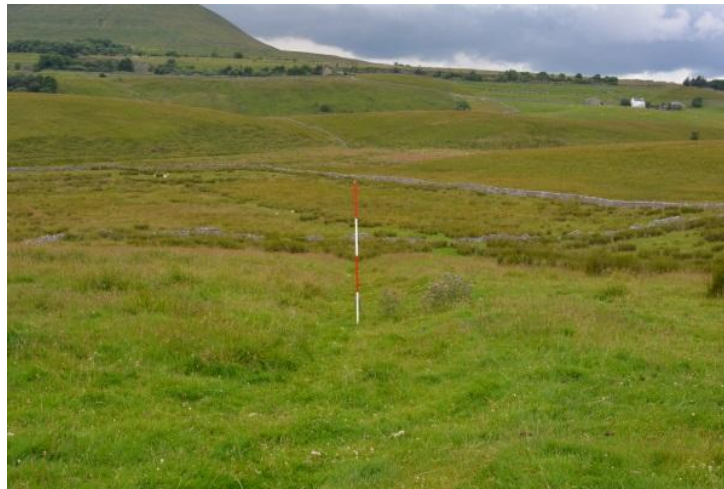
*Fig. 8.9 Feature no. 15 with a clear ditch heading downslope
(Ian Fleming)*

The ditch lies to the east of the bank. Average ditch and bank widths are 1.98m and 3.65m respectively, making this a major boundary feature. The ditch now is only 360mm deep on average (Fig. 8.9).

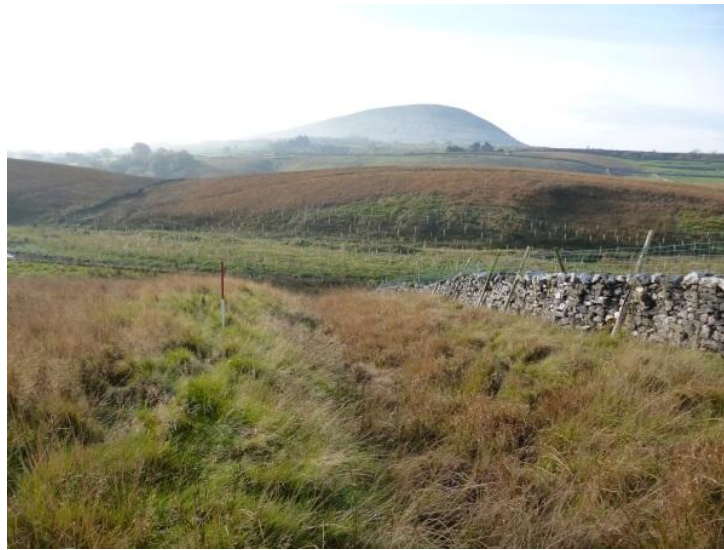
Fig. 8.10 Feature no. 28 showing the prominent bank with the ditch between it and the wall (Ian Fleming)

On the south-western side of the estate a further length of very prominent bank and ditch – **Feature no. 28** - runs from near the major change in direction of Feature no. 13 to parallel the later stone wall downslope stopping just beyond another wall just short of where the Ribble formerly flowed. The ditch lies on the north-west side of the bank, between it and the wall (Fig. 8.10). Both bank and ditch are broad: the bank averages 2.07m and the ditch

2.43m. Depth ranges from 450-900mm. It is slightly sinuous in plan form. One large sheep scrape in the bank shows that it is composed almost entirely of soil with very little stone content.

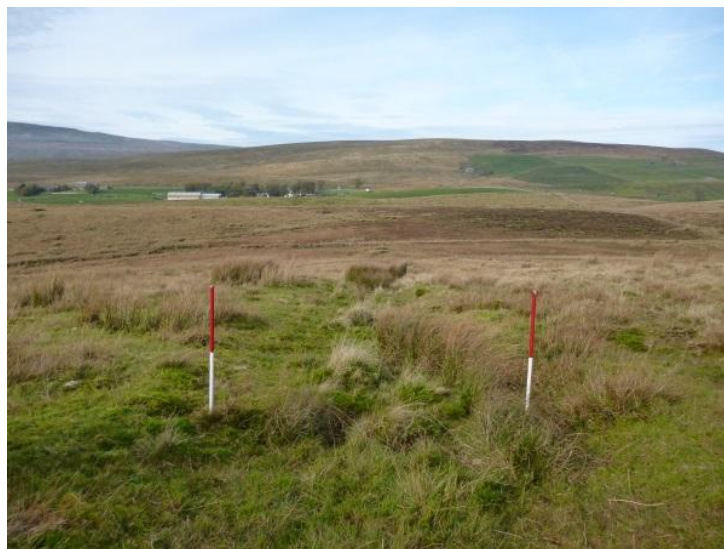
Fig. 8.11 Feature no. 29 showing the ditch with a bank on both sides (Ian Fleming)

In what is now called Thorns Close – historically part of a larger enclosure called Thorns Cow Close – to the east of the settlement, there are two major north-south ditch and bank features. **Feature no. 29** consists of a major 560m-long ditch, from 2-5.8m in width but now only 600mm deep on average, on the west side of a broad bank with an average width of 2.9m. In sections towards the southern end there appear to be banks on both sides of the ditch (Fig. 8.11) though in other sections the bank is difficult to demarcate on its outer edges.

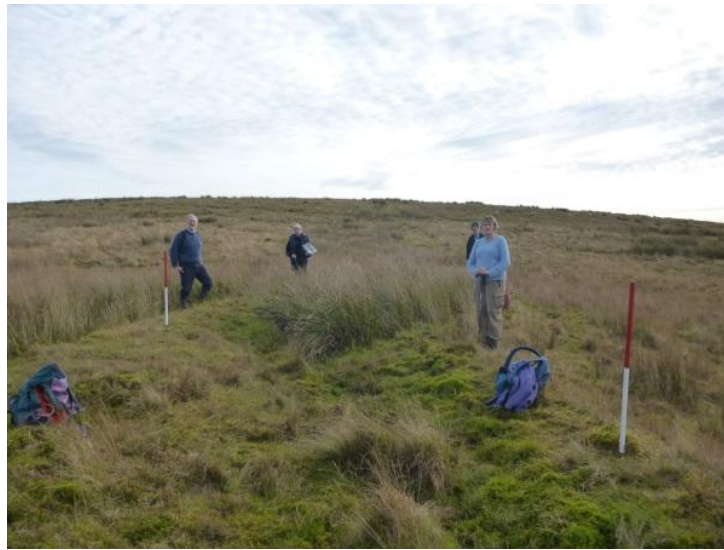
Fig. 8.12 Feature no. 29 with volunteers and rucsacs marking the enclosure bank (Ian Fleming)

bifurcates and forms a rectangular 'enclosure' c. 20m on its north-south axis by 5.4-6m on the east-west axis (Fig. 8.12). There is a gap of 1-2m between the main bank and the side banks of the enclosure and the northern end is open to the bog.

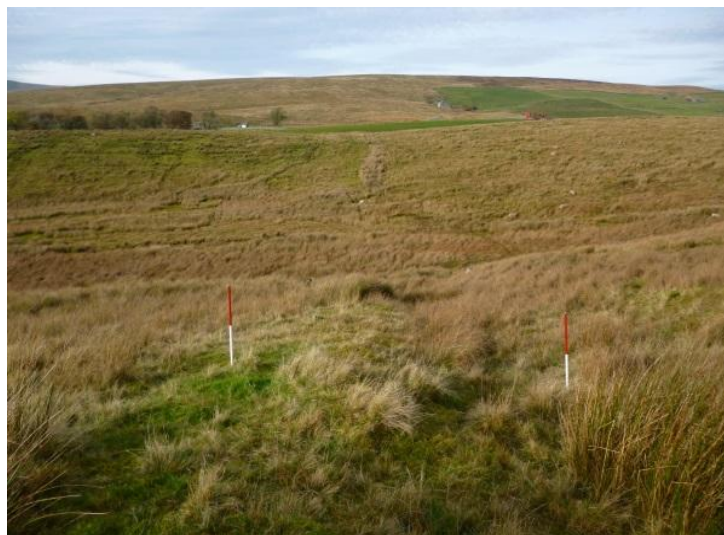
Fig. 8.13 Feature no. 29 clearly showing the bank running down to a boggy area and the ditch beyond showing as a line of light-coloured rushes (Ian Fleming)

Feature no. 29 resumes on the north side of the bog and is again broken by a further area of bog (Fig. 8.13) and it terminates c.15m south of Gayle Beck. In this northern section both bank and ditch are mostly very prominent with both having their maximum widths here. In this section the ditch lies on the east side of the bank. Northwards of the second bog the bank appears to be stone cored throughout its slightly sinuous length.

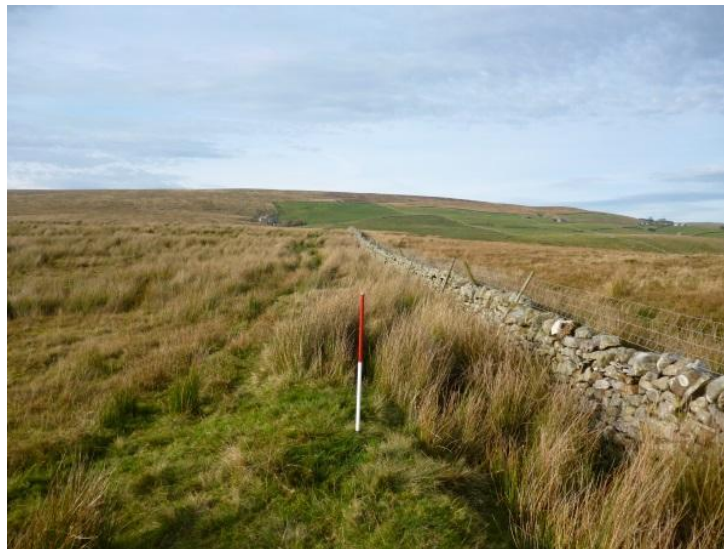
Fig. 8.14 Feature no. 30 with the bank close to the later wall which was built in the ditch (Ian Fleming)

Feature no. 30 is 670 m in length and it is paralleled along its entire length by the later field wall dividing Thorns Close from the open fell of Cam End. It is sinuous throughout and changes alignment several times, here being west of the wall and there being to the east,

with prominent S-bends in the bank. For much of its length the wall runs within the ditch (Fig. 8.14). Where the bank/ditch meets the bog around Cove Syke there is a long gap where it would have proved impossible to create such a solid structure. Throughout almost its full length the ditch is on the east side of the bank except where the feature is east of the wall. Bank width averages 2m (ranging from 1.3-2.7m); because of the wall it is not possible to accurately measure ditch width but average depth is 760mm. In places the outer edge of the bank is over 700mm high in addition to the depth of the ditch. South of the straight wall that marks the southern end of Thorns Close, the ditch and bank are not seen and dense infestation of rushes prevents close examination. At times, along the curving wall that continues southwards, there is the occasional glimpse of what may have been a boundary bank but nothing that can be logged with any degree of conviction.

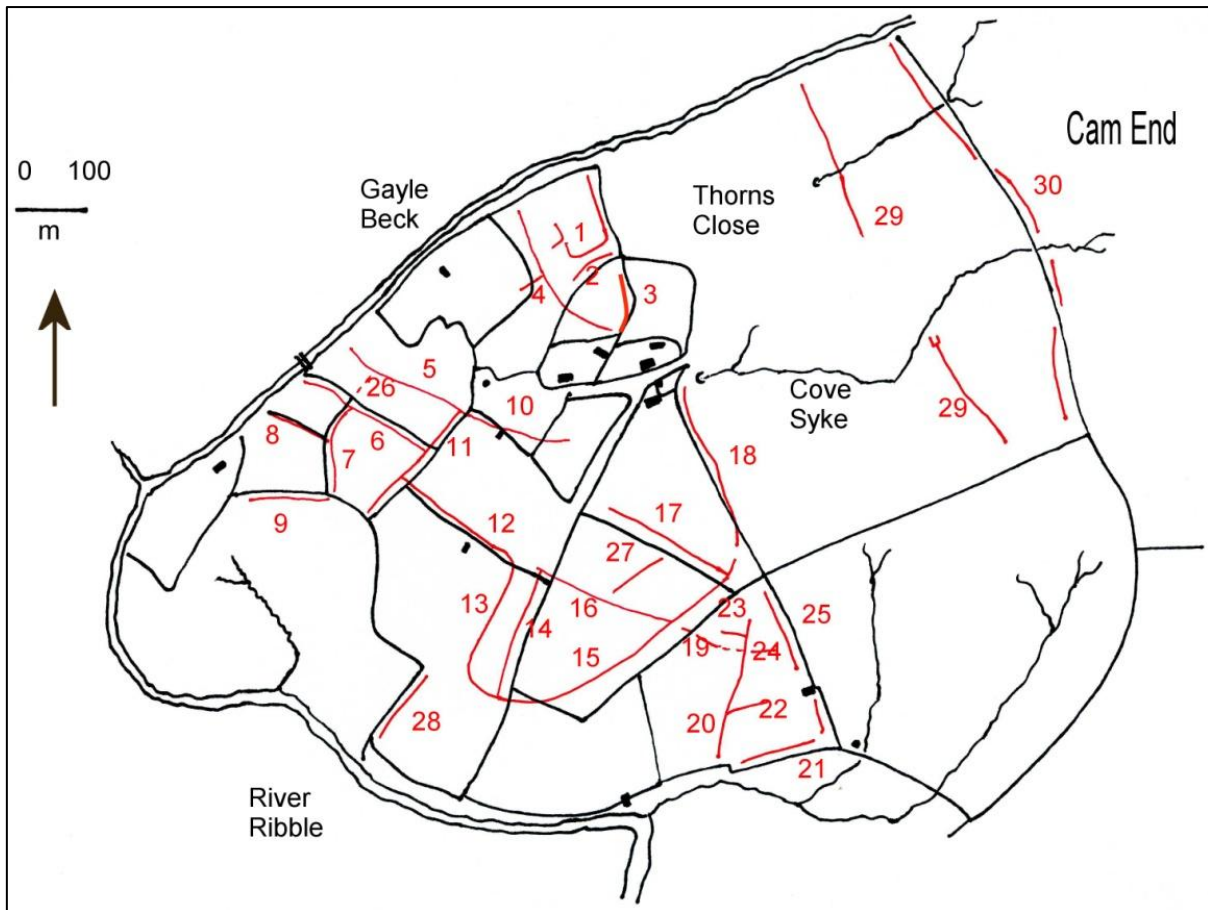
Fig. 8.15 Ditches and banks as sketched at the end of the field survey (compare with Figure 8.2)

Close analysis of the data shown in Table 8.1, together with careful examination of each ditch and bank feature on the ground, enable certain conclusions to be drawn regarding the original purpose of each feature based on the identification of patterns apparent. Thus, the features have been categorised into four broad groups: external estate boundaries; major internal boundaries defining and partly surrounding sets of enclosures; less prominent internal 'field' boundaries; and those which are relatively modern drainage features. Each category will be discussed in turn. All ditches and banks are depicted on Fig. 8.15.

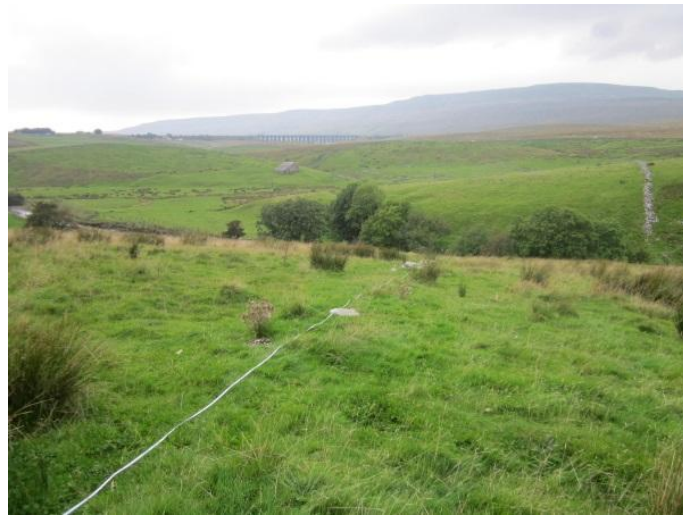
Fig. 9.2 Wall no. 14, footings only with no standing wall (Pat Carroll)

remain as footings with no sections of standing wall (Wall nos. 14 and 17, Fig. 9.2) and Wall no. 26 is mainly footings but has a few sections of ruined wall. Three walls are in a totally ruined state from end to end (Wall nos. 4, 12 and 32, Fig. 9.3).

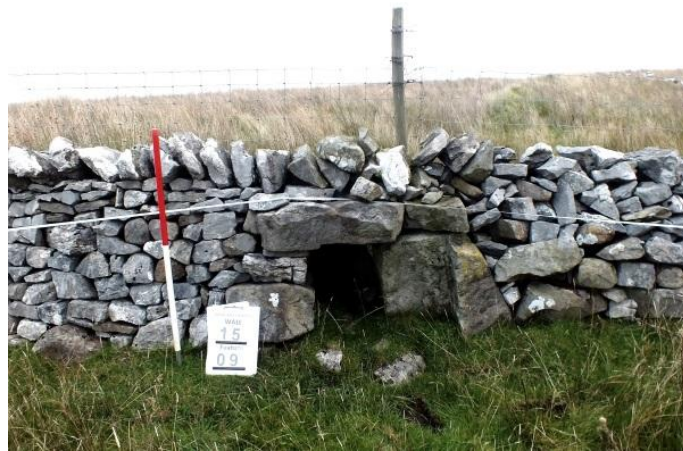
Fig. 9.4 Wall no. 15, sheep creep (Phil Carroll)

Features of wall furniture noted were seventeen sheep creeps (Fig. 9.4), one cattle creep (Fig. 9.5) and fourteen smoots (Fig. 9.6) of which nine appeared to be for water courses. In addition to these were a number of engineered gaps in walls where a stream or wet ditch crossed. There were six blocked-up gateways, half of which were narrow ones. Of the four stiles recorded there was one ladder stile and three stone step stiles. There were gate stoops of various ages mainly of stone, with one very weathered limestone stoop on Wall no. 34a (Fig. 9.7). Stoops formed from slabs of 'slate' were found on Wall nos. 19, 21, 23 and 29c (Fig. 9.8); significantly these all surround a single field.

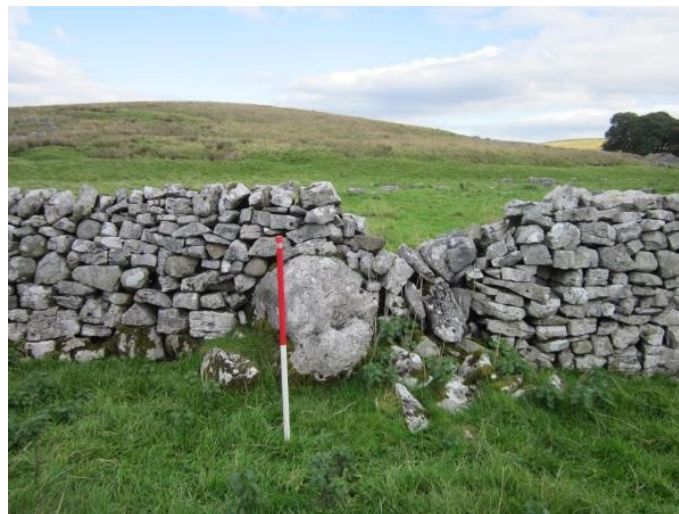
Fig. 9.9 Wall no. 10, incorporating an earthfast boulder (Pat Carroll)

Wall nos. 10, 11 and 15 incorporated earthfast boulders (Fig. 9.9); nos. 11 and 31 had sections built along rock outcrops; nos. 8, 12 and 31 used boulders within the fabric; and nos. 8, 11, 12 and 31 contained orthostats or recumbent stones, all suggestive of older walls.

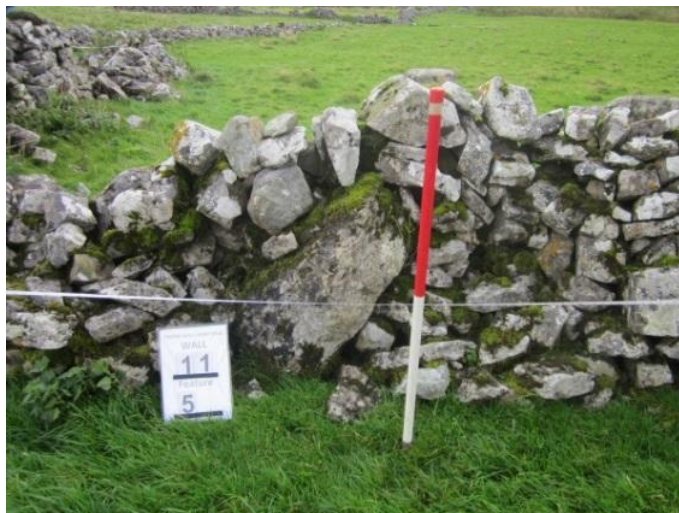
Fig. 9.10 Wall no. 11, displaying the characteristics of older walls (Pat Carroll)

Using the above criteria, all the recorded markers for Wall nos. 11, 16 and 36 came out as pre-1700 (Fig. 9.10) and all those for Wall nos. 19, 28b, 28c and 29b came out as post-1700. The remaining walls had markers for both but divided into roughly a third with predominantly pre-1700 results, a third with post-1700 results, and the remaining third having equivocal results (see Section 5). This can only be a rough guide and other factors need to be taken into consideration. It should also be borne in mind that if a whole length of wall has been rebuilt this can then appear 'modern' even though it follows the course of an old wall.

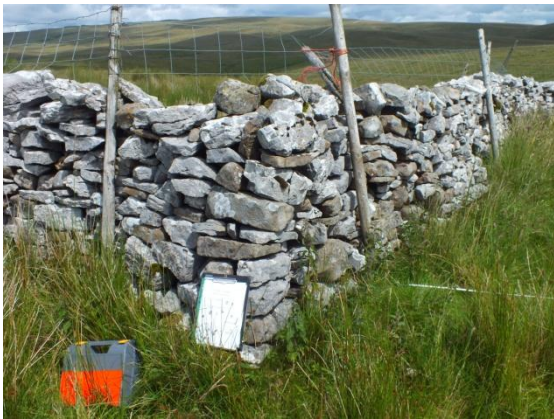
Fig. 9.23 One wall turning through a right-angled corner or two walls meeting at a field corner? (Phil Carroll)

One aspect of the survey that could only be evaluated on site was the actual identification given to a length of wall, in so much as judging where a wall really started and finished its length. In many of the eventual thirty-nine walls this was not as straightforward as originally expected, for it is not possible, when removed from site, to definitely state that Wall X starts 'here' and runs to 'there', if the wall in question comes into direct contact with another wall (or walls) either at the end(s) or even midway along the wall run (Fig. 9.23).

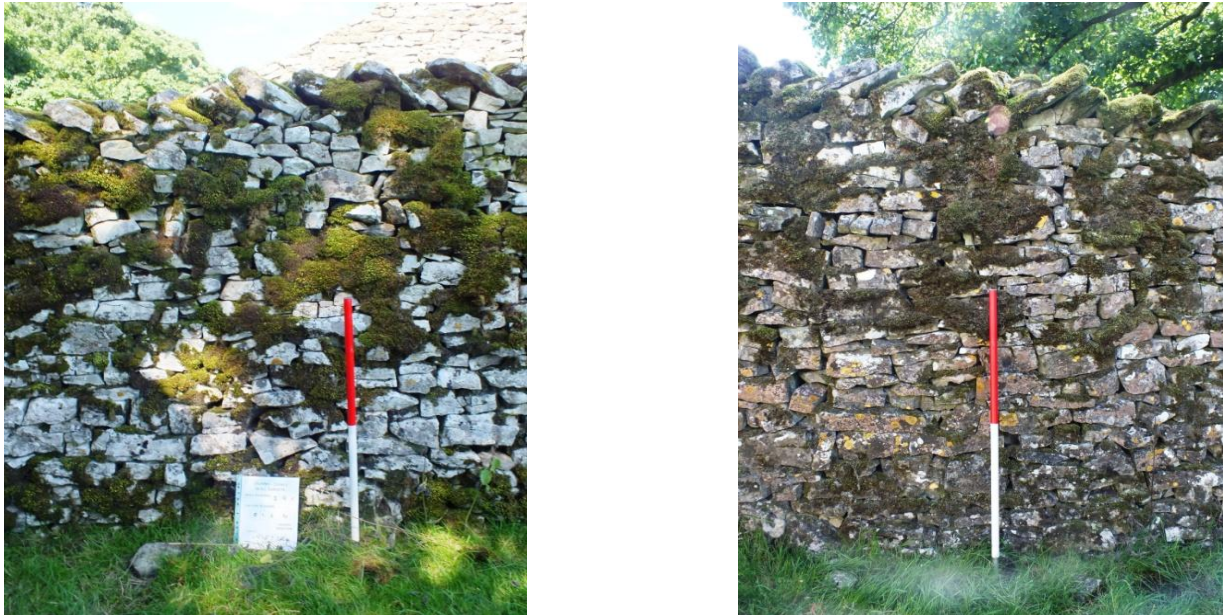
Fig. 9.27 The effects of weathering and plant growth on two sides of the same wall profile on Wall no. 29 (Phil Carroll)

mention the numerous patching of walls from previous repairs and multiple modifications over time (Fig.9.27).

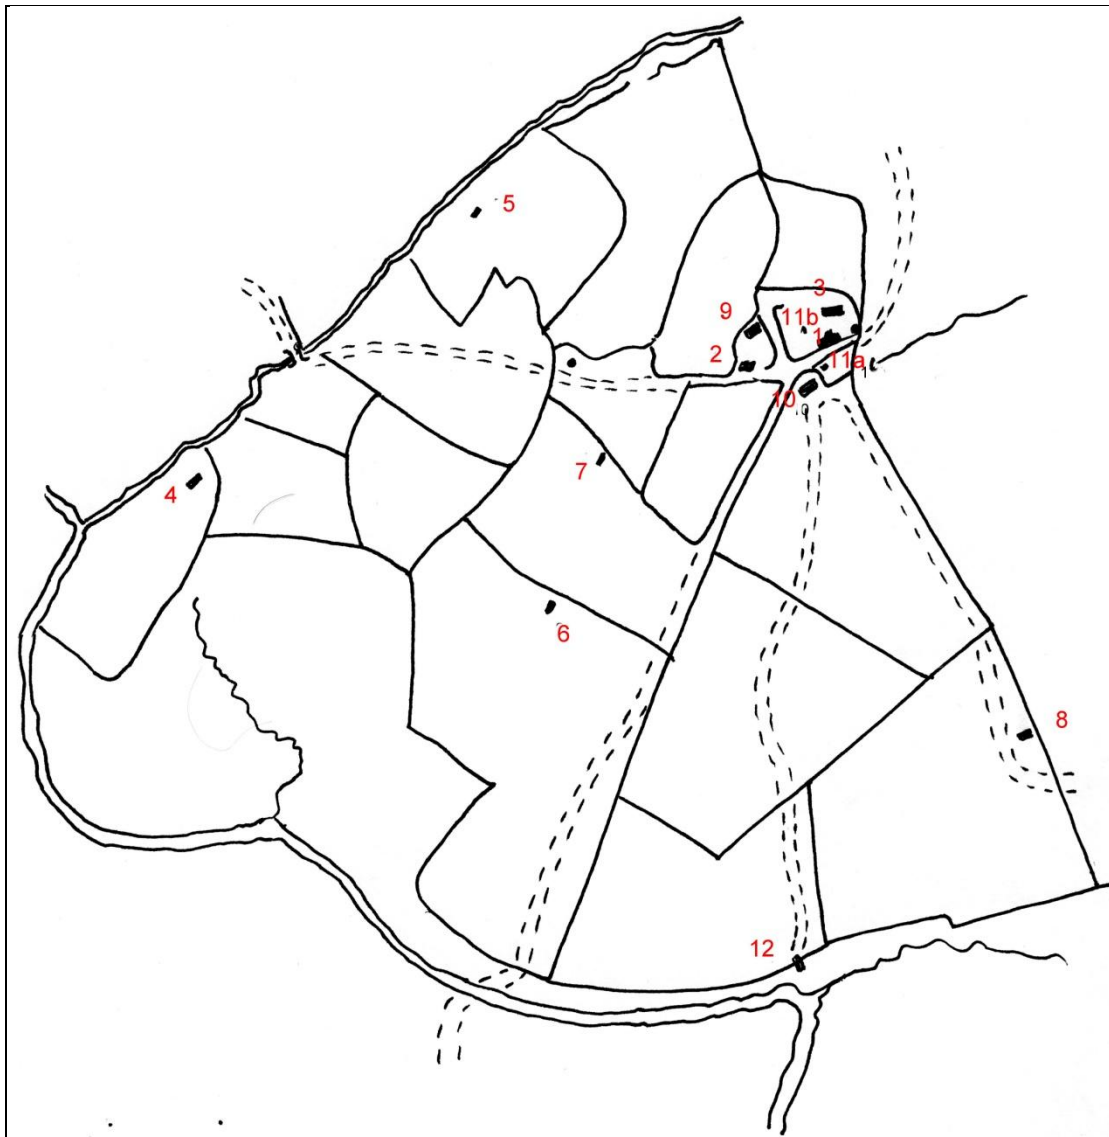
Fig. 10.2 Buildings in the Thorns landscape (for numbers see text)

Fig. 10.2 shows the location and spatial relationships of buildings across the Thorns landscape.
