Thorns through Time

The story of an abandoned settlement

Stories in Stone: Project H3

David S. Johnson

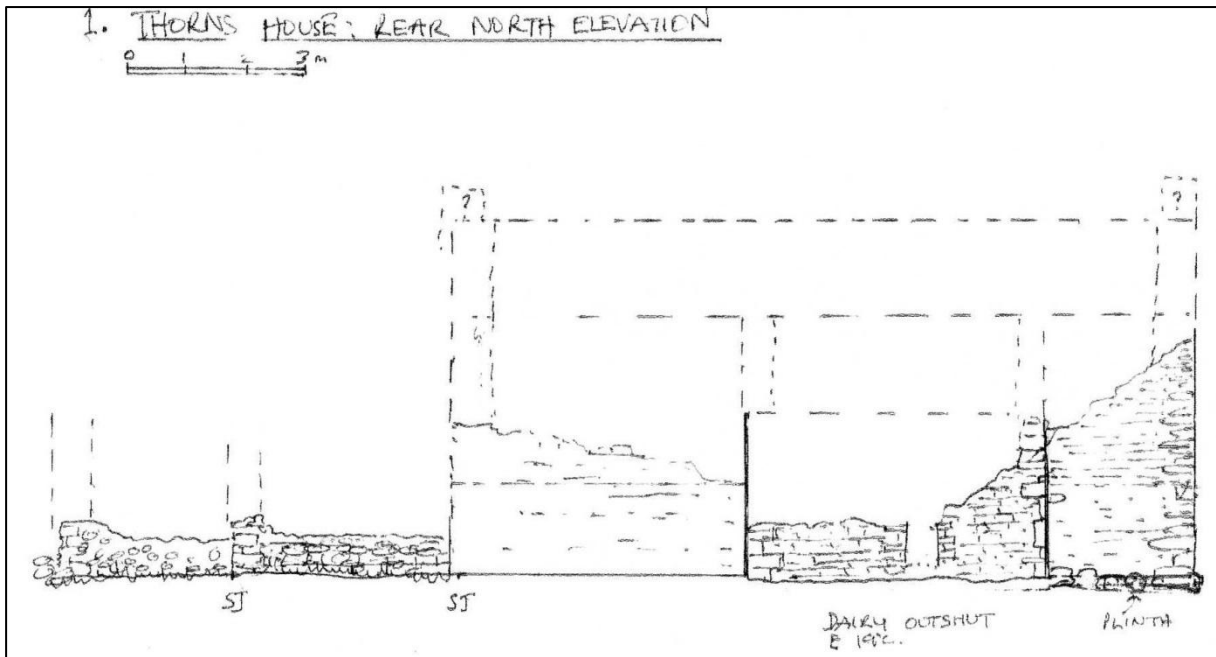
Fig. 10.6 Thorns 1, rear elevation and dairy

The north wall (Fig. 10.6) is dominated by the added dairy outshut which was perhaps a sub-cellar with a low window and which may have incorporated the stair too. Watershot stonework indicates a probable early nineteenth-century date of 1800-1840s. The walls at 560mm are much thinner than in the older house.

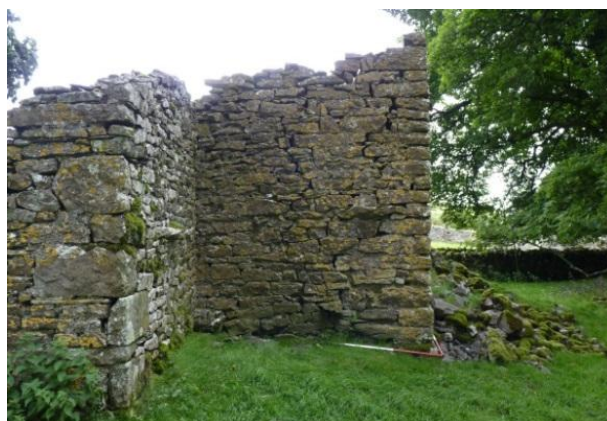
Fig. 10.8 Thorns 1, rear outshut dairy, on left (Carol Ogden)

The plinth, padstone, small quoins with neat coursing, and low eaves line suggest the earliest work perhaps c. 1600 or even earlier. The thatched building was probably cruck-built. The padstone of the first cruck bay, built into the plinth, was later replaced by a stone cross wall and heightened walls. A straight joint by the padstone often indicates where a cruck was removed prior to heightening the walls for a full two-storey building in the seventeenth century, with small two-light mullioned windows. Any stone clearance or excavation could reveal other padstones and evidence for fireplaces. The heightening of the walls at the west end does not seem to have been well-bonded with the older walling which has resulted in the west gable falling out from the centre. It is said that there was also a fireplace on that wall (pers. comm. Reg Dobson). By c. 1820 the rear outshut was added against the heightened walls. The mullioned windows were replaced by sash windows with the bodystead chamber receiving a smaller nineteenth-century window (Figs. 10.8 and 10.9).

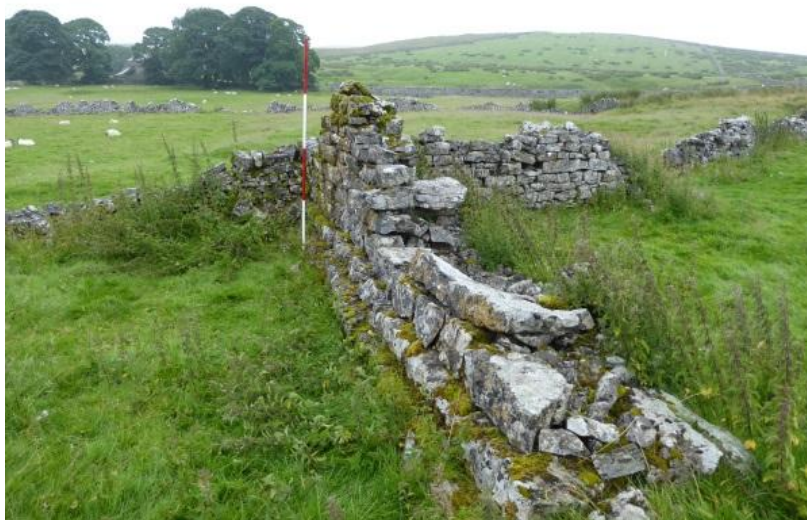
Fig. 10.22 Thorns 7, detail of double plinth (Lynda Hutchins)

This building is very well constructed and unusual in having a prominent exterior double-stepped plinth and good wall-coursing to a thick and slightly battered wall. The double plinth on the north-west exterior side changes to a lower level on the low gable end. The wall corner still standing has quoins the same size as the wall courses, which is often seen on sixteenth-century walling. There is one very large, dark, well-cut sandstone quoin incorporated and this was possibly reused. Plinths of various sorts are seen in other buildings in Thorns.

Only the north corner of walling is still standing (Figs. 10.21 and 10.22).

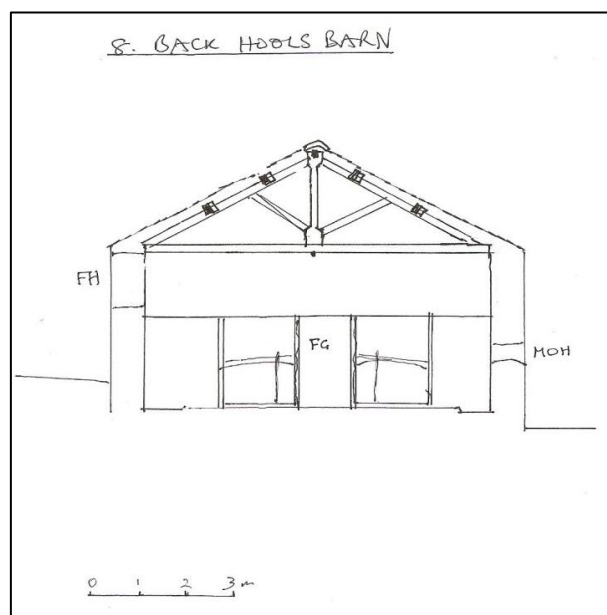
Fig. 10.28 Thorns 8, interior and roof truss

The timber lintels of all the wall openings seem to be made of reused oak, some of which are now lying on the ground. Their rotten state makes interpretation difficult but there are pegholes for tenons but no obvious cruck halvings are seen.

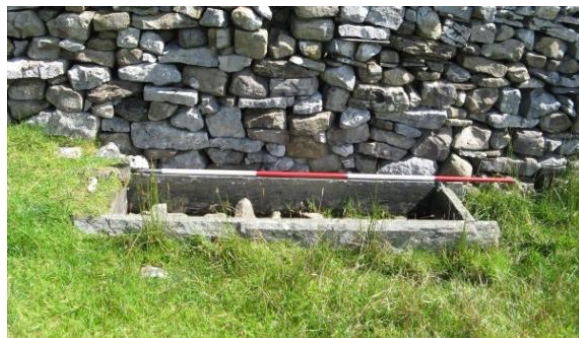
Fig. 10.29 Thorns 8, water trough (Mark Woronowski)

A water trough of Horton flag (Fig. 10.29), used for watering the cows each day in the long winter months, remains in the garth. It was fed through an extant narrow cast-iron pipe from a spring on the east side of the meadow wall. The trough is made of five sawn flags held together by fitting into grooves and with iron rods screwed to fit. The trough corners were sealed with lead. This 'flat-pack' assembly meant such troughs were easily transported. The remains of iron gutters and wall brackets on the barn with pipes apparently going into the ground on the north-west corner suggest some rain water was also collected, perhaps in cisterns made from Horton flag.

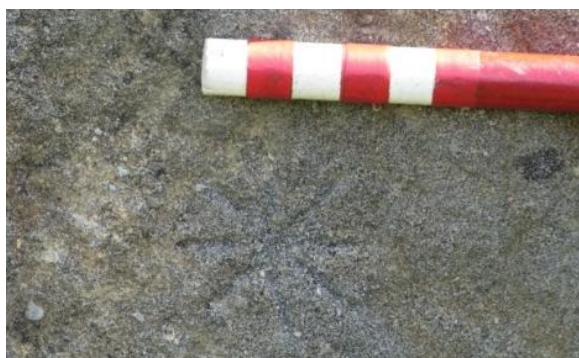
Fig. 10.30 Thorns 8, eight-sided star (Mark Woronowski)

An 'F' is carved into a door jamb by a shippon door. An eight-pointed cross or star may be an apotropaic symbol or just a doodle by a craftsman such as a mason (Fig. 10.30).

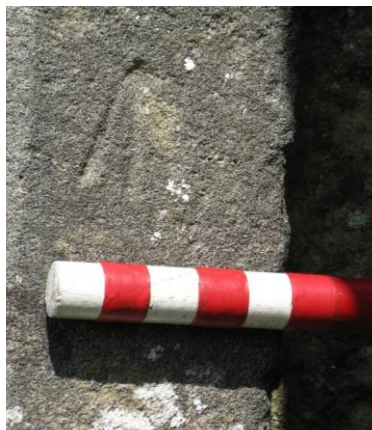
Fig. 10.31 Thorns 8, arrow-like carving (Mark Woronowski)

Two arrow-like carvings with an indented hole above that resemble an OS benchmark but might be sailing ships (Fig. 10.31). (Other carvings of ships are seen at elsewhere in Upper Ribblesdale.)

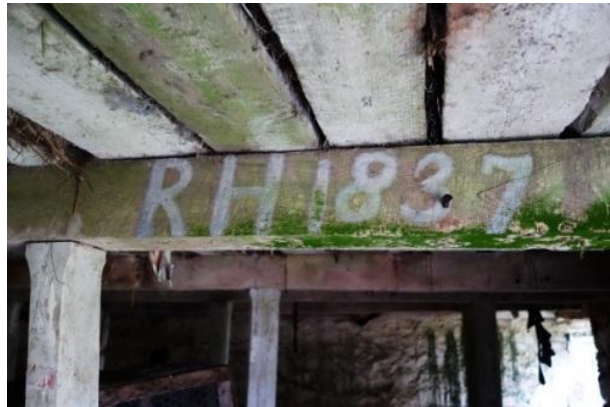
Fig. 10.41 Thorns 10, 'RH 1837' in west shippon (John Asher)

The double shippon at the low end is separated from the hay mew by a thin skellbuse wall (400mm thick). The boskins were well made of good timber (imported softwood) with slate panels which support the hayloft above. The inscription 'RH 1837' is painted on one of the

loft beams and dates the making of the shippon and probably the roof trusses too (Fig. 10.41).¹⁹ Similar trusses in upper Wharfedale have dates of c. 1840.

These data are invaluable, not least in interpreting the origin of the bank barn (Thorns no. 10) and Back Hools Barn (Thorns no. 8). Graffiti on a timber in the west shippon of the bank barn – ‘RH 1837’ (see Figure 10.41) – was assumed to relate in some way to work either in or on building the barn. Was the unidentified RH a farm worker who in an idle moment put his mark there or was he one of the carpenters who built the barn? This would have remained pure and unanswerable speculation were it not for the data in this set of accounts: the entries for 1836 and 1837 relate directly to the building of the bank barn, so RH was almost certainly involved in this work and he was probably the Howson paid on 23 November 1836. The entry ‘removing old barn’ confirms that the bank barn was built on the site of an earlier barn that was demolished at this time just as the entry ‘digging foundations’ shows that the earlier barn had a smaller footprint than the bank barn. Building the new barn took the best part of two years though the payment entered in October 1837 for slating does not mean the work had just been completed: it was common for estates to settle invoices at either the half-year or year end. Other entries in the ledgers in the 1830s, including 1837, relate to the purchase of American timber: whether this was imported through Lancaster or from Liverpool via the Leeds and Liverpool Canal was not stated. There are no entries at this time for Baltic timber, though account entries for 13 October 1855 do show the Estate buying Baltic timber (£23 0s 9d) and ‘timber at Lancaster Docks £3 14s’ though this could have been either Baltic or American timber. The accounts make mention of building a barn *and shippon* at Thorns so this probably refers to the bank barn and the now-collapsed long shippon that was added against the north wall of the barn. There is no specific mention of the stable that was a later addition to the barn’s east gable. To build the barn, as far as these accounts tell, cost a minimum of £77 2s 3½d but they do not include the cost of lime mortar, plaster and limewash and there may well have been costs hidden under different headings.

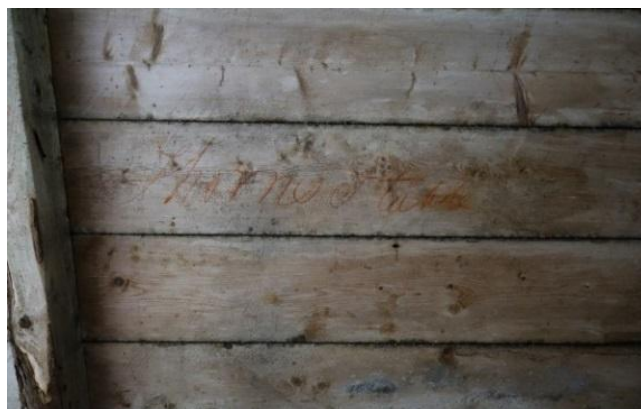
Fig. 10.42 Thorns 10, 'The new Stable' (John Asher)

The loft above has wide floor boards but no sign of a trap door, although there is a rectangular gap in the floor boards that may have been a trap door. Twice inscribed on the new floor boards of the loft in nineteenth-century flowing cursive letters and in red carpenter's chalk are the words 'The new Stable' (Fig. 10.42). This may have been a destination written on the consignment at the carpenter's yard.

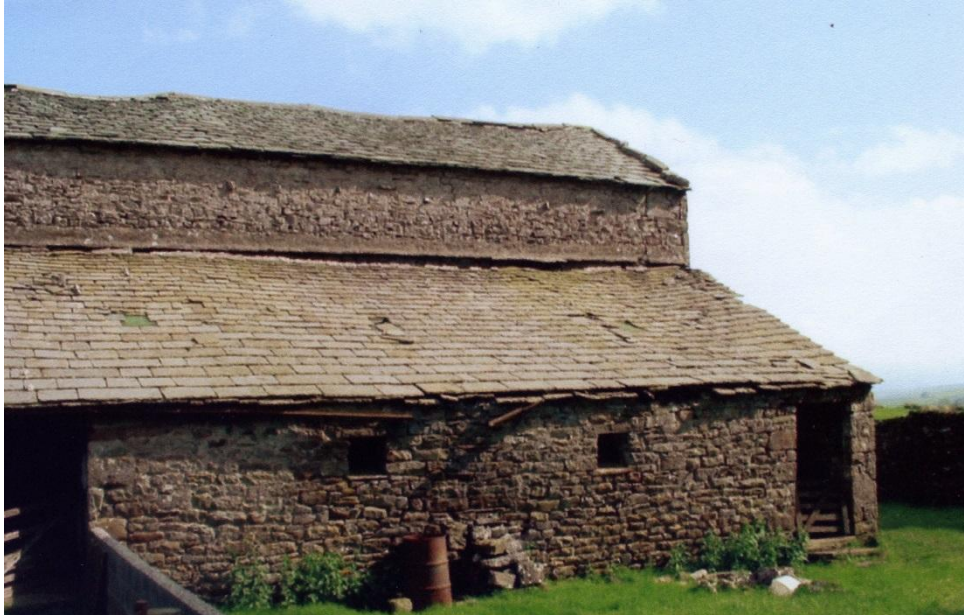
Fig. 10.43 Thorns 10, north elevation and outshut in 2004 (Frank and Muriel Laver)

The long outshut on the north wall retains standings for fourteen cows. Some of the sawn rafters are still seen but much of the structure is covered in rubble and is difficult to view. It would have been lofty and airy, fulfilling nineteenth-century legislation (Fig. 10.43).

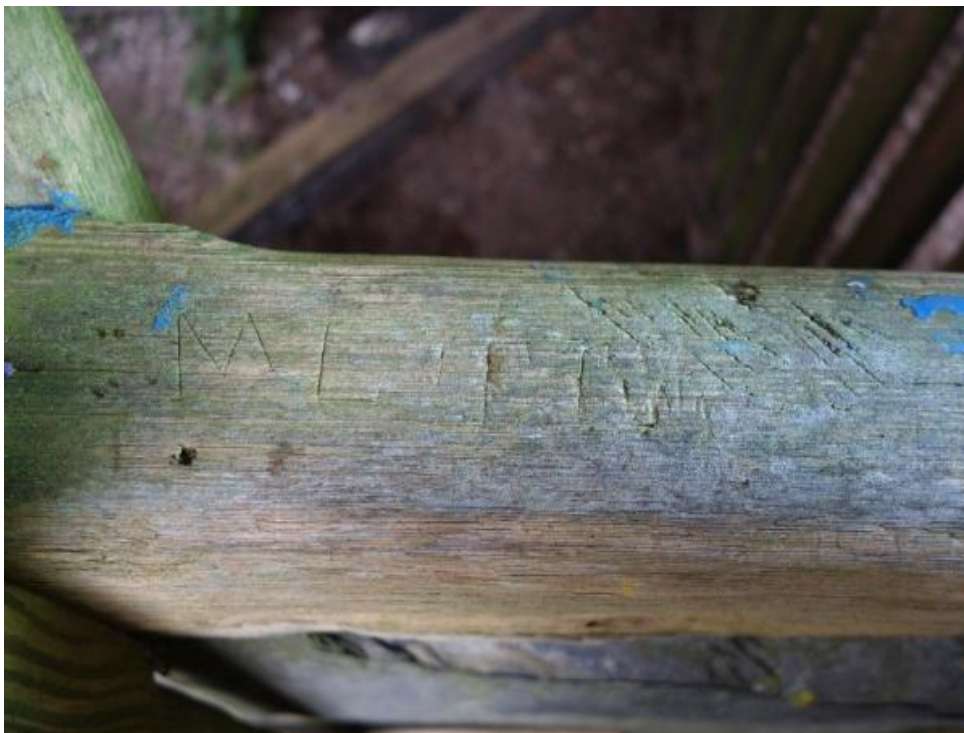
Fig. 10.44 Thorns 10, inscribed marks (ML and FL) on boskin timbers (John Asher)

Various inscribed (farm workers'?) marks, in a now defunct type of script, are visible on boskin timbers at the east end of the north outshut (Fig. 10.44). 'ML' and 'FL' may well have been inscribed by Francis Lambert for himself and his wife Mercy, who were certainly living here and farming 173 acres (70ha), according to census records for 1851.

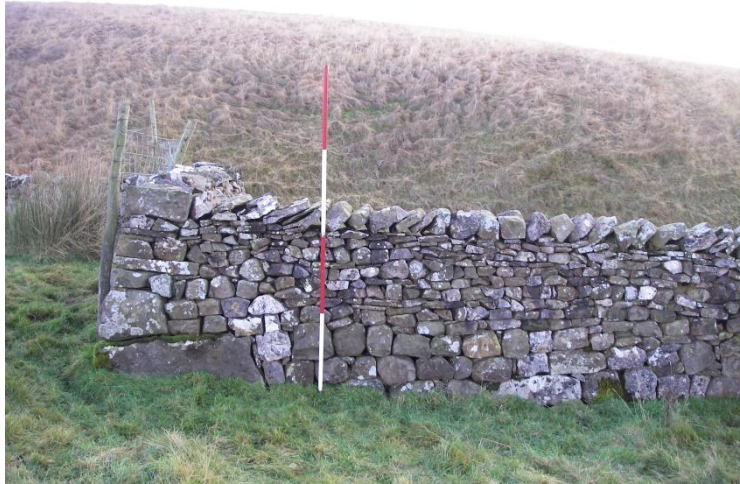
Fig. 10.48 Thorns 12, north-east corner (David Johnson)

Little remains on the ground to show this tenement ever existed other than a vague earthwork though its original L-shaped plan, shown on OS mapping of 1846-48, does not show in the earthwork. The basal courses of the building's north and east walls have survived in the current field wall, and a partial straight joint and large sandstone base slabs in the north-west and north-east corners mark the putative west end of the building (Figs. 10.48 and 10.49). Walling stone is dominantly sandstone with many of the stones being squared rather than rounded. One large block (630mm long), beyond doubt still *in situ*, lies on the south side of the boundary wall marking the line of the south wall and making the building 4.5m wide internally

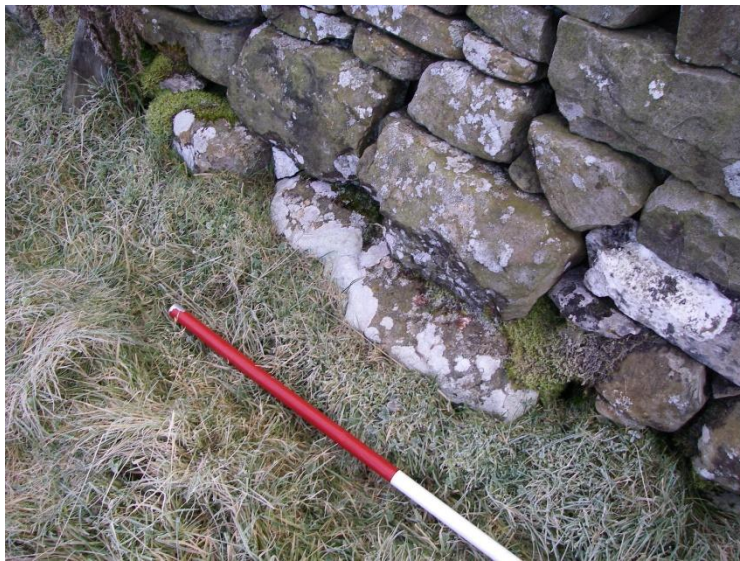
Fig. 10.49 Thorns 12, north-west corner with foundation slab or padstone (David Johnson)

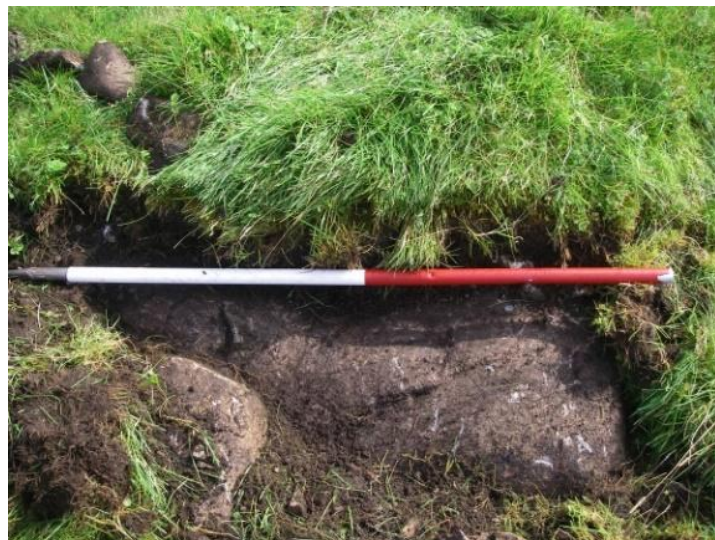
Fig. 10.50 Thorns 4, corner block (David Johnson)

Holme Barn (Thorns 4) is built almost entirely of limestone rubble, including quoins and doorheads, but the foundation plinth has some flat-topped sandstone boulders at one corner (Fig. 10.50). The ruin of the house by the trackway (Thorns 2) also has a red sandstone boulder at step-plinth level (see Figure 10.10). Possibly these are corner padstones or plinths for cruck blades. The farmhouse (Thorns 1) has a straight joint on the frontage (see Figure 10.4) besides a tall boulder embedded in the plinth wall, which might be a padstone for a cruck blade now removed. The truss has been replaced by a stone cross-wall here. Low Flat Barn has a rough plinth (see Figure 10.18) which is particularly prominent at the north end with sandstone boulders and limestone blocks projecting from the wall, and possibly late cruck padstones.

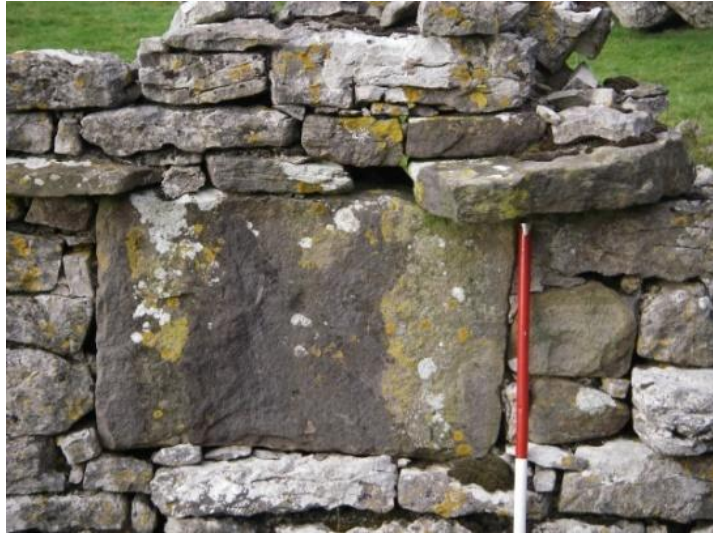
Fig. 10.51 Thorns 2, sandstone slab (Lynda Hutchins)

High Flat Barn (Thorns 7) and the house by Trackway no. 1 (Thorns 2) are both of limestone walling with minimal sandstone, as at Holme Barn, but both are of very well-coursed rubble blocks and two unusual step plinths that change from a lower level in the wall to a higher level. Both have a large sandstone dressed slab vertically embedded in the wall where the plinth changes level (Fig. 10.51). The reason for the sandstone slab is unknown, but possibly where a cruck was removed. It is perhaps no coincidence that a barn at Low Birkwith also has a high, two-step plinth and good coursing which might be pre 1600 or even medieval (Barn C, Low Birkwith, YVBSG 1996, 9). At Thorns, the four buildings with walls only of limestone also have 700-800mm wall thicknesses and are perhaps the oldest building remains (Appendix 10.5).

Just part of a front wall survives to about 2m high (see Figure 10.11) and this has a low plinth and then a straight joint with a higher plinth and, unusually, a large squared and dressed sandstone slab inserted vertically into the wall. The double-step plinth which changes in height beside a large dressed sandstone is also seen in the remains of High Flat Barn. The double-step plinth is seen in Low Birkwith, too, around a former cruck building. It is possible that the sandstone is filling a gap in the wall caused by removing the cruck foot. The plan (see Figure 11.10) is again of three cells of uneven width and of similar size to House 3. Stone structures on the rear wall suggest a rear dairy like that at House 1. The 1846-48 OS map shows no porch at the front as the house is on the trackway but two outshuts are shown at the rear, perhaps a dairy and a porch. The field wall opposite the house front has been moved outward to widen the road past the house. An attached low end may have been an agricultural building or cart shed. Measurements of the rubble spread that mark the building are 6m in width x 16m in length (or 20m including the attached east cell.)

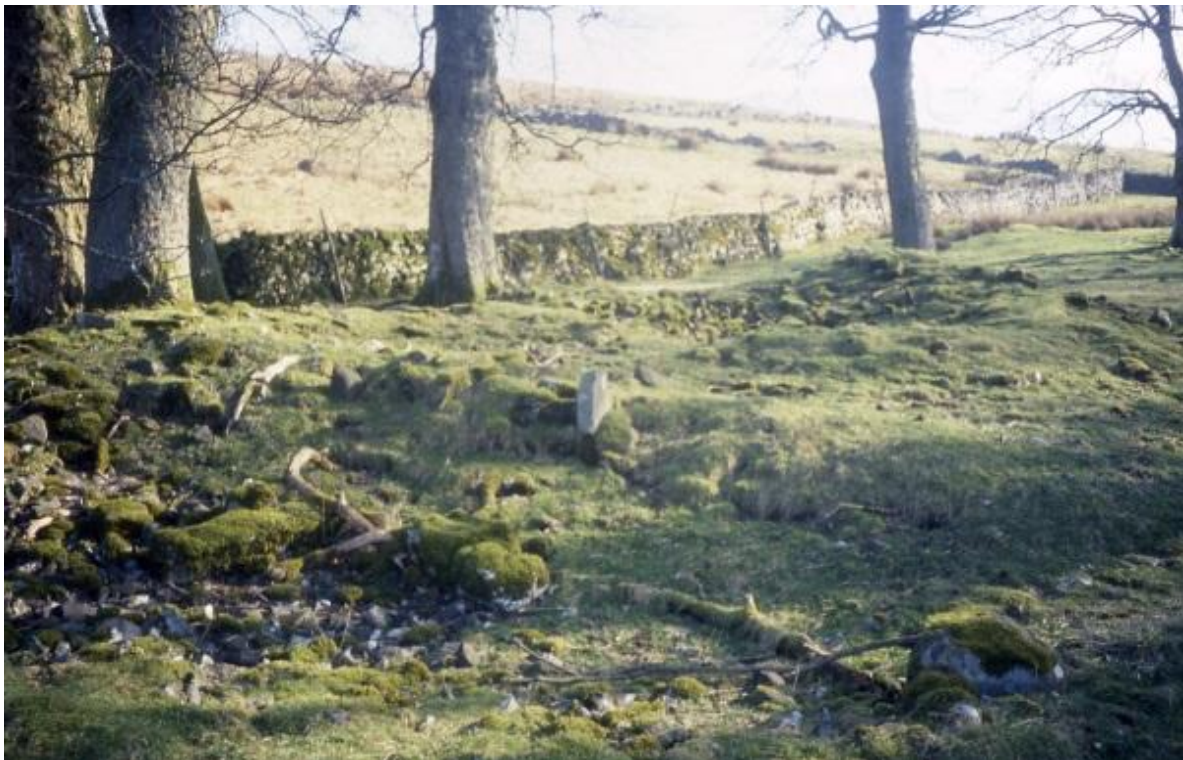
Fig. 10.52 Thorns 3, surviving remains, prior to excavation (David Johnson)

The front entry may have been moved into the left bay where there is a ground dip and a mapped extension, perhaps a porch. There is a possible internal doorway connecting with the next bay. The third bay, on the right, is the biggest cell and has two sites where stones may mark doorways. Whether this was an agricultural end is uncertain. Without an excavation to find the housebody fireplace and its relationship with the entry, the plan type cannot be discerned. Uneven bays are very characteristic of cruck buildings which may indicate a three-bay cruck house here until the 1880s.

All that remains now of this house are rubble-covered foundations (Fig. 10.52).

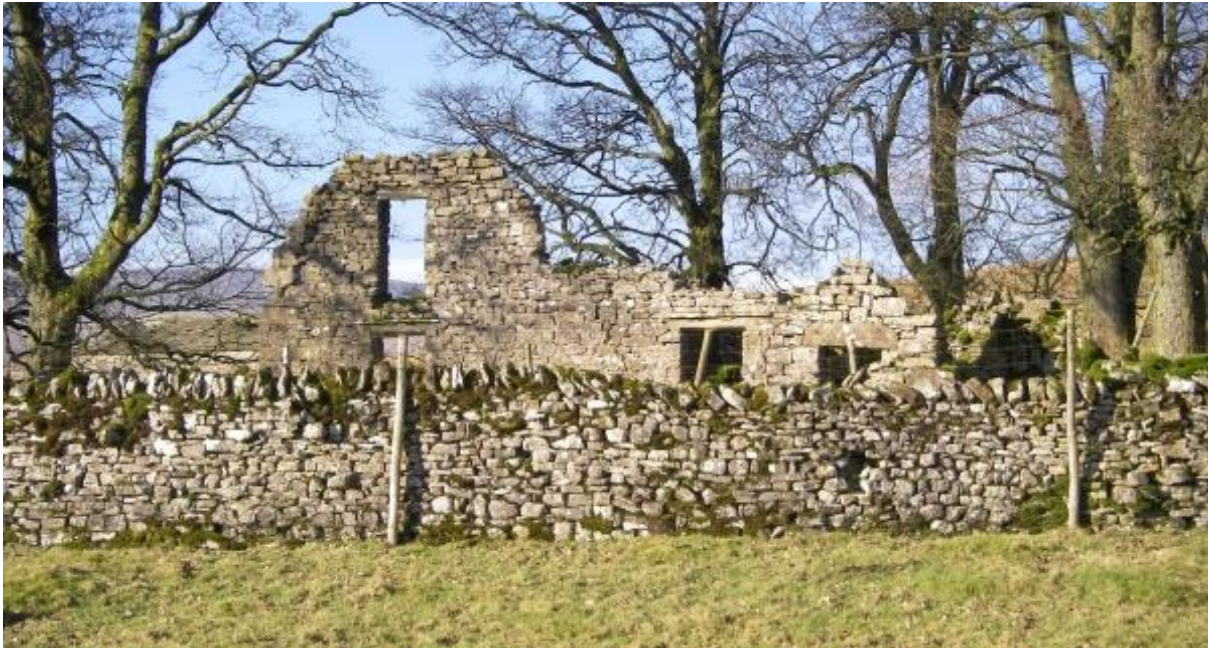
Fig. 10.53 Thorns 1 in January 2017 (David Johnson)

The farmhouse (Thorns 1) (Fig. 10.53) is the only house with any walls standing to two storeys. It is of two cells but is now ruinous, and was abandoned before 1891. The entry doorway has a large lintel with rounded upper corners (often sixteenth century) and probably forms a lobby into the two-bay bodystead room, beside a gable firehood, which might remain under the rubble to the east of the entry door on the south side of the building. To the west was a parlour and probably the site of the first dairy behind it. This has sixteenth-century-style walling with low eaves which suggest a cruck building. A larger rear dairy outshut and sub-cellar were added in watershot stonework about 1820. Beyond the eastern end of the house are the stony foundations of two single bays. These may be an added kitchen/service room or farm buildings but their thick walls suggest they might be older than the present house and the remains of a once larger house. Arnold Pacey gave the name 'shadow houses' to Ribblesdale dwellings where an earlier house and adjoining barn had become detached during rebuilding and where the house reused components of the older dwelling

House 1 measures 6 x 12m (or 19m including the possible two cells of agricultural additions). The elevation drawings (see Figures 10.4-10.7) show evidence of a substantial pre-1600 plinth to a linear building, a possible padstone built into the plinth at the position of the cross wall (now of stone), a small joint in the stonework where a cruck blade has been removed, evidence of a lower roofline, and heightening to two storeys, supported over the parlour by close-set floor joists at former eaves level. The upper part of the two-storey house may only have covered the parlour chamber with its large nineteenth-century front window (or possibly a taking-in door). The bodystead retained, until recently, a chamber window over it but much lower in the wall than the parlour chamber window so it perhaps remained a loft. What is missing at Thorns is any reused cruck timber. A large beam which appears to be oak was buried in grass outside the house and might help interpret the house. The remains of two-light mullioned windows were reused for the large nineteenth-century windows but could have been part of the low-eaved house into the seventeenth century. Excavation may help understand the plan.

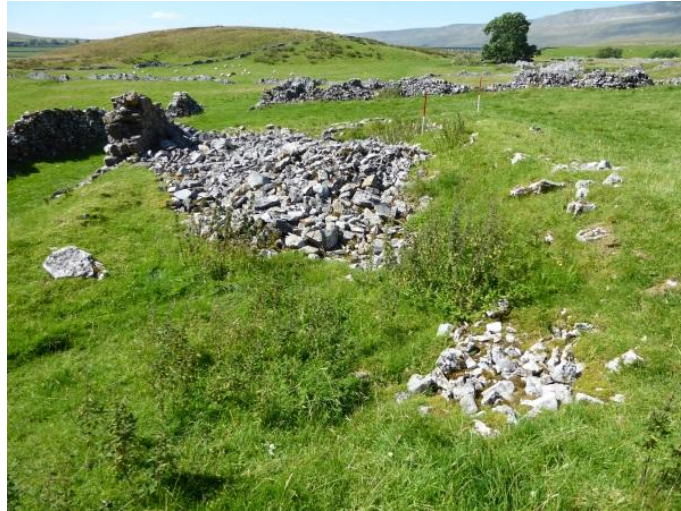
Fig. 10.54 Thorns 2, ruin by Trackway no. 1 (Mark Woronowski)

Thorns 2, another ruin (Fig. 10.54), lies to the west beside Trackway no. 1, separated from House 1 by a stone-walled garth or yard.

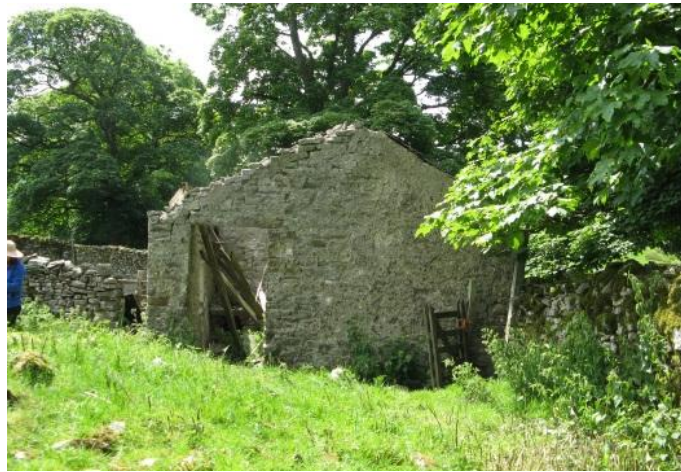
Fig. 10.55 Thorns 11a, wash-house, in 2016 (Mark Woronowski)

The wash-house and privy (Thorns 11) are part of nineteenth-century domestic improvements (Figs. 10.55 and 10.56). The well near the garth north wall would also have been an essential resource (see Chapter 12, Test pit 5).

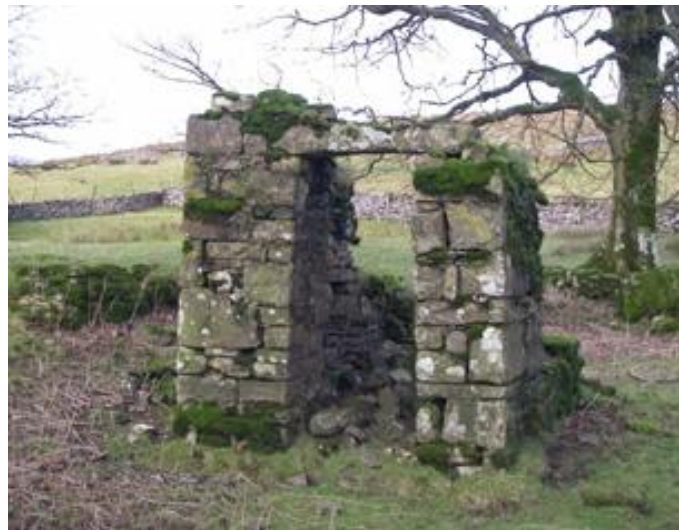
Fig. 10.56 Thorns 11b, privy, in 2016 (Dianne Wall)

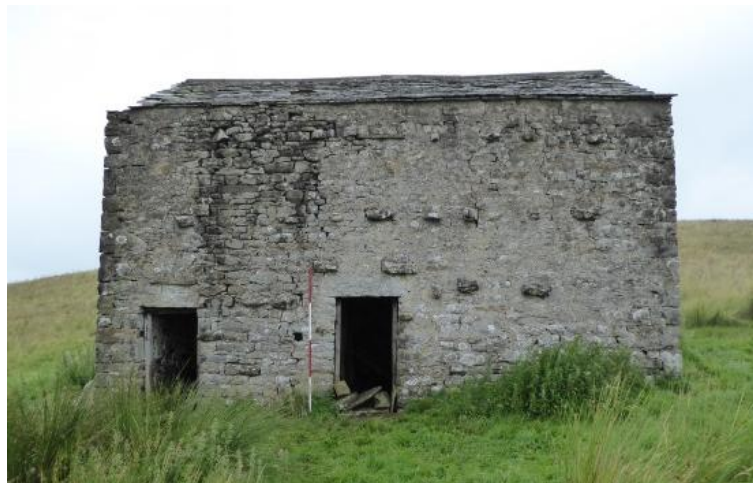
This is a typical rectangular, two-door plan, Dales field barn and the only field barn in Thorns which is still roofed (Fig. 10.57).

Fig. 10.57 Thorns 6, Low Flat Barn, in 2016 (Lynda Hutchins)

At two bays and 6 x 8m, it is the smallest barn and the shippon retains standings for only four or perhaps five cows. From the two forking holes, meadow hay could easily have been loaded from the higher ground on the west into the mew and baulks over the shippon. Sleds may have been used since the ground is rough and steep for a wheeled cart or wagon. The roof truss is a bolted early nineteenth-century kingpost, one of four such roofs surviving in Thorns but this seems a replacement of an older building with a slightly heightened roof. A plinth of some large boulders and limestone blocks on the gable and a small plinth along the front suggest perhaps an eighteenth-century date, as do the rows of through-stones. The walling, however, has been much repaired or rebuilt so that the quoins of the middle part of the wall with a boulder base could be older. There is also a possible gable padstone and wall disturbance. Of interest inside are the railway sleepers, used as boskin posts, which retain the shadow of the iron railway blocks for holding the rails. It is suggested that in the 1870s the temporary tramways for the completed Ribblesdale railway work were sold off.

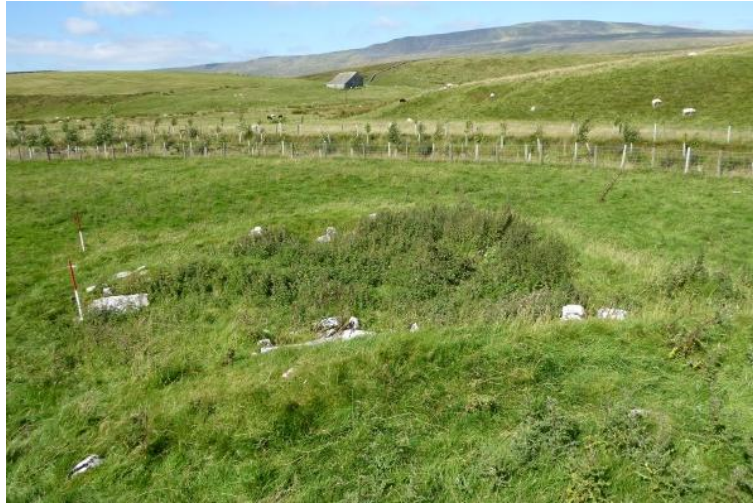
This has an L-shape and a plan type common in the Dales (Fig. 10.58). It may have begun as 6 x 9.5m but the low end shippon was widened from 6 to 8m. It was demolished before 1907 but probably retained the two-door field barn plan but with a wider shippon for seven cows across, rather than just five. An excavation would confirm the plan and if it was originally cruck built at 6 x 9.5m.

Fig. 10.58 Thorns 4, Holme Barn remains in 2016 (Carol Ogden)

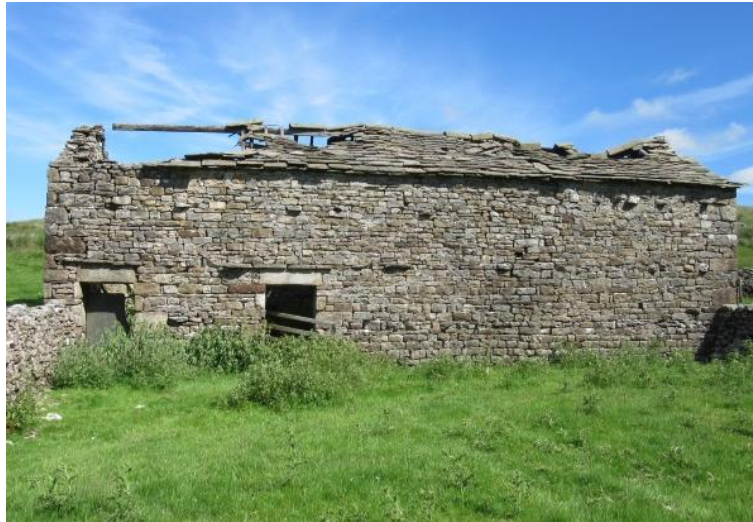
This barn (Fig. 10.59) lies just north of the hamlet. This is another two-door field barn like Low Flat Barn, but longer, at 6 x 10m, and is three bays long with two pegged roof trusses. These are the oldest trusses surviving at Thorns (possibly late eighteenth century) and the tie beams are of re-used oak with Baltic timber principal rafters. Some Baltic shipping marks, in Cyrillic script, like those in Back Hools Barn, are seen on a rafter. In size this barn matches High Flat Barn. There is a low plinth which is seen inside the added 4m-long cart shed. The barn walls are 650mm thick. There are standings for six cows so the barn is longer than Low Flat Barn to accommodate the extra hay required. Horton Flag slabs pave the foddergang and infill the boskin panels in local style. Brown sandstone boulders, as well as limestone blocks, are increasingly evident for dressed walling stone and lintels, rather than just in the foundation plinth. The cart house was added in watershot masonry of mixed stone types c. 1820. Like Low Flat Barn, the hay forking hole is placed on the uphill ground allowing a sled or cartload of hay to have easy access for filling the mew. The cart house was partly floored with cobbles perhaps for a stable. Floor joist holes gave an attic space for equipment or perhaps pony fodder.

Fig. 10.59 Thorns 9 in 2016 (Mark Woronowski)

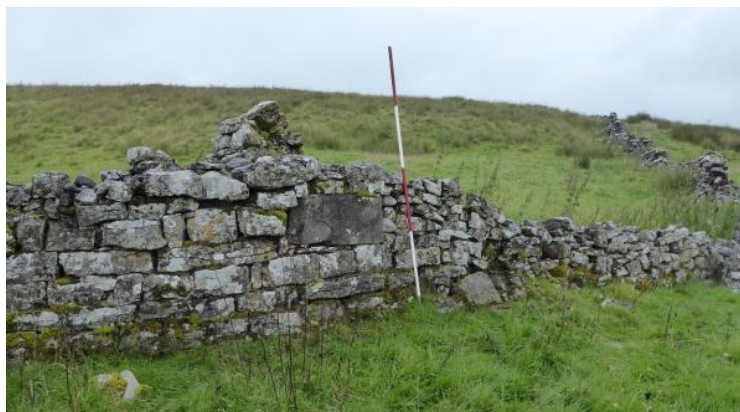
This is another rectangular plan barn and at 6 x 11m similar to the cart barn. It has an eighteenth-century field wall linked to it but an older bank and ditch (probably a medieval boundary bank) is just a few metres away. The barn plan is unclear but the mound of stone on the south corner may indicate a cruck padstone site. Notable is the very well built wall of coursed limestone rubble blocks which includes an unusual stepped double plinth around the two remaining sections of thick walling 750mm and 850mm thick (Fig. 10.60). A field barn in Low Birkwith, another Furness Abbey site, has the same building dimensions and more importantly a similar unusual double-stepped plinth nearly a metre high around the base of the building, as well as a low eaves line and a heightened roof preserving curving cruck blade sites. This is likely to be pre 1600 and possibly medieval.

Fig. 10.60 Thorns 7, High Flat Barn, in 2016 (Lynda Hutchins)

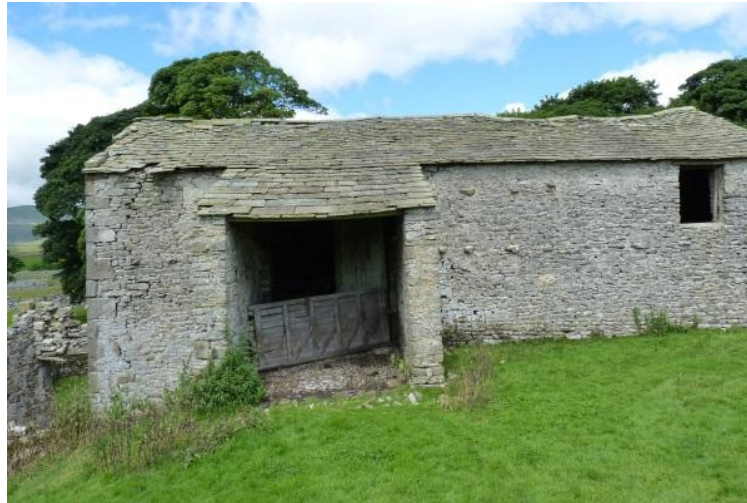
With six bays and at first measuring 7m wide x 16m long, this was the largest barn in Thorns and is early nineteenth-century in date (Fig. 10.61). It has five kingpost roof trusses that look like Baltic softwood timber and are suspension bolted. The shippon is dated 'RH 1837' in

Fig. 10.61 Thorns 10, bank barn, in 2016 (Dianne Wall)

A stable for two horses was added to the east gable of the barn, in later times to be used for housing two cows. Joiners' red-chalk writing on the sawn ceiling floor boards records 'The new Stable' and perhaps indicates a destination from the carpenters' workshops.

The hay storage capacity in the bank barn of 386m³ translates into 13.8m³ required per cow over winter. Back Hools Barn by comparison has 168m³ of hay storage for twelve cows = 14m³ per cow, so a very similar amount. Some Dales farmers reckon that one cow required hay from about one acre of meadow so possibly 28 acres of meadow hay would have filled the bank barn. As grassland was increasingly improved from the seventeenth century, by liming and manuring, more hay was produced and more cows could be over-wintered.

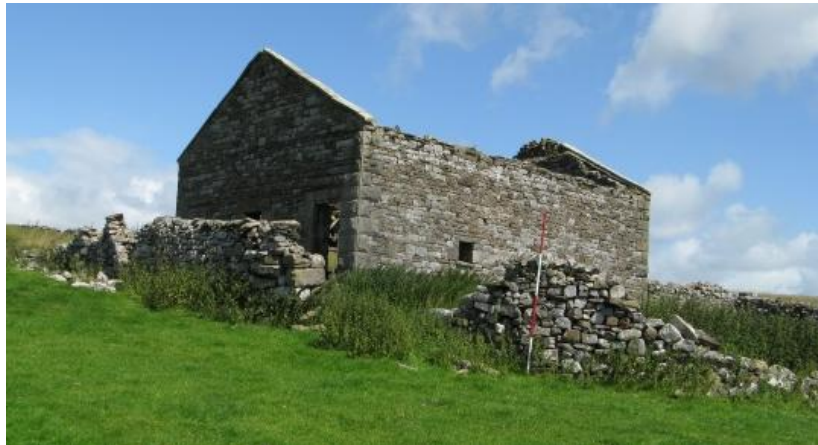
This is the second largest barn at Thorns, with similarities to the bank barn, built at a time of farming prosperity around the mid nineteenth century.²³ Its function resembles a traditional field barn with a hay mew and baulks which were filled from forking holes on the north, uphill side. It is only three bays long but is very wide at 8.5m and of later date than the bank barn.²⁴ Its double-shippon arrangement with central foddergang, gable shippon doors and standings for fourteen cows is very like that at the bank barn and such gable entries are not unusual in the Dales in the nineteenth century (Fig. 10.62).

Fig. 10.62 Thorns 8, Back Hools Barn, in 2016 (Mark Woronowski)

The estimated hay storage, however, is 168m³ which is less than half that of the six-bay bank barn where twenty-eight cows could have been overwintered. The roof trusses have fallen but were nineteenth-century bolted kingpost types as at the bank barn. Cyrillic script cargo marks can be seen as in the field barn with the cart arch. Apart from the barn width, differences include the quantity of re-used timbers for the interior lintels – the timbers are rotten and not understood but need investigation. Clay pipes were used for ventilation holes, rather than traditional stone-built vents. The architectural nature of the stonework is remarkable and suggests gentry builders rather than tenant farmers. Cut gritstone quoins exhibit good margin dressing with 'rock-faced' sides which is in a gentry tradition and a style later used by the railways for mass-produced dressed stonework such as bridges and embankments. The best-masoned quoins are on the gable front, whereas the east side has the same style but of poorer quality, so perhaps apprentices made these.

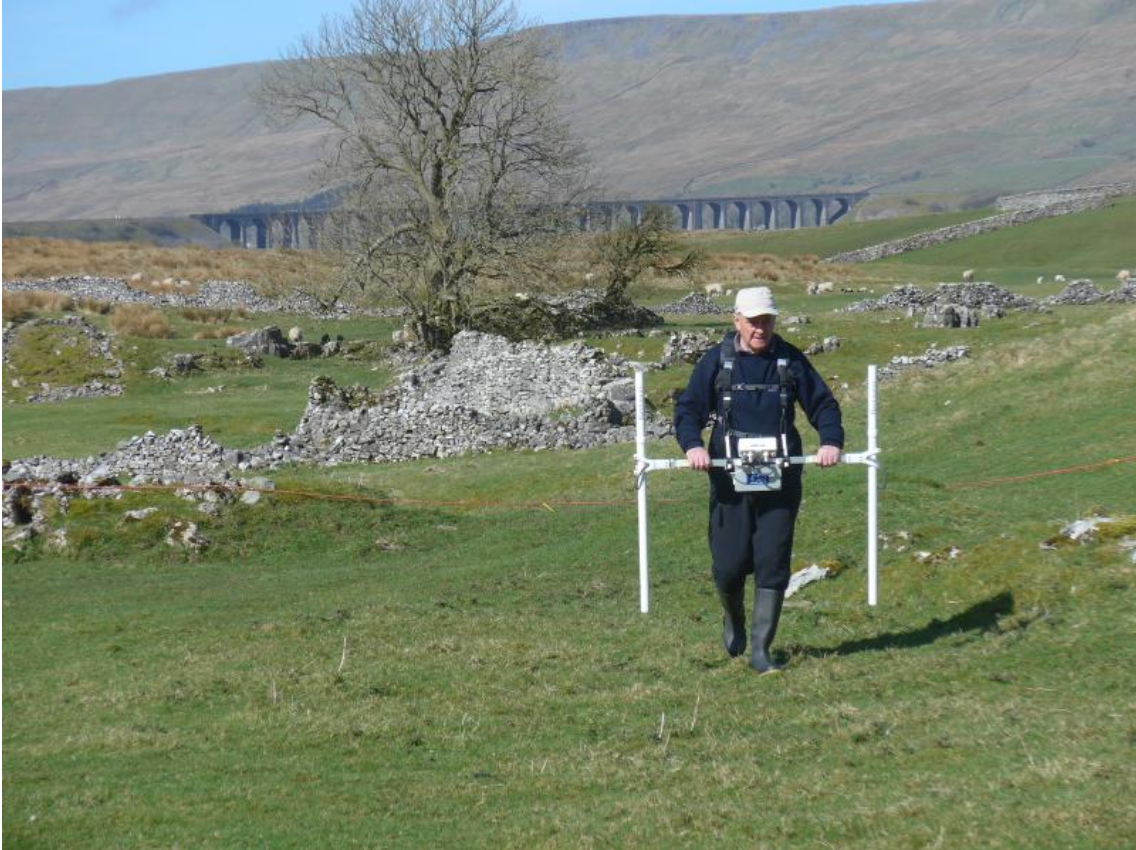
Fig. 11.1 Bartington gradiometer operated by SWAAG volunteer Mike Keenan (SWAAG)

SWAAG acknowledges the support of the Heritage Lottery Fund which, as part of the SWAAG Big Dig project (2013 through 2015), funded the purchase of the Bartington Grad601-2 Gradiometer used at Thorns.

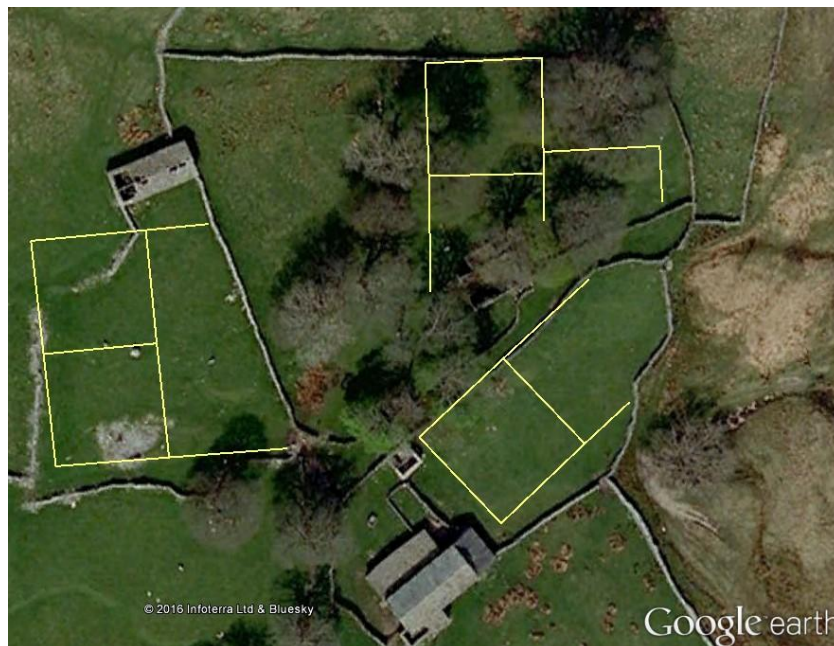
Fig. 11.3 Google Earth image with survey grids in yellow

Thorns is located to the south of the Ingleton to Hawes B6255 road, close to Ribblehead and is on the Ribble Way footpath. The map (Fig. 11.2) shows the location of survey grids in red, and the Google Earth image (Fig. 11.3) is an aerial view of the survey area.

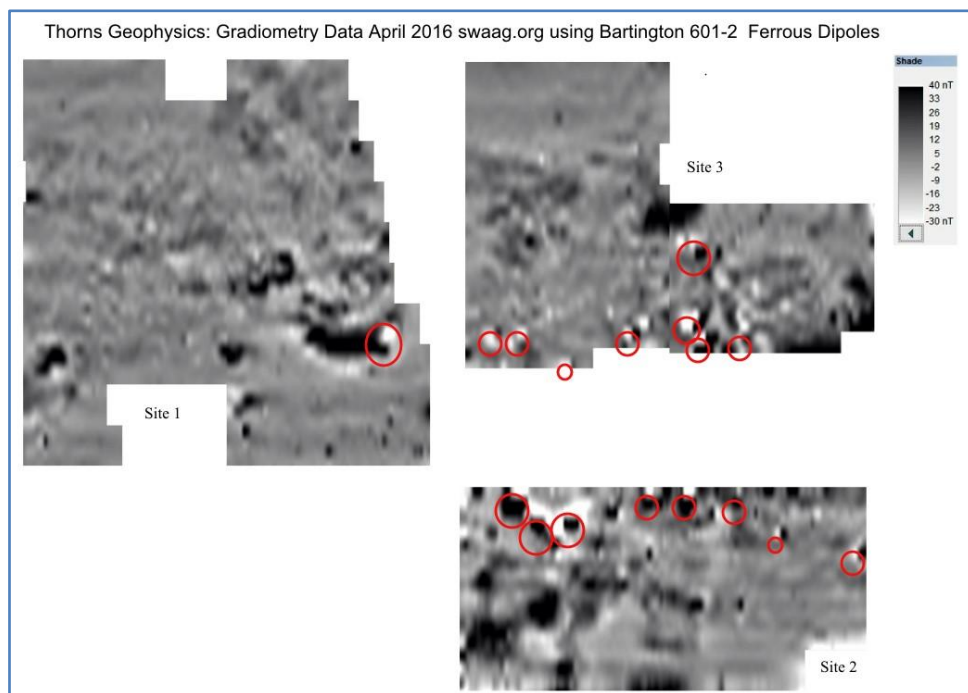
Fig. 11.8 Greyscale image showing ferrous bipolar signals

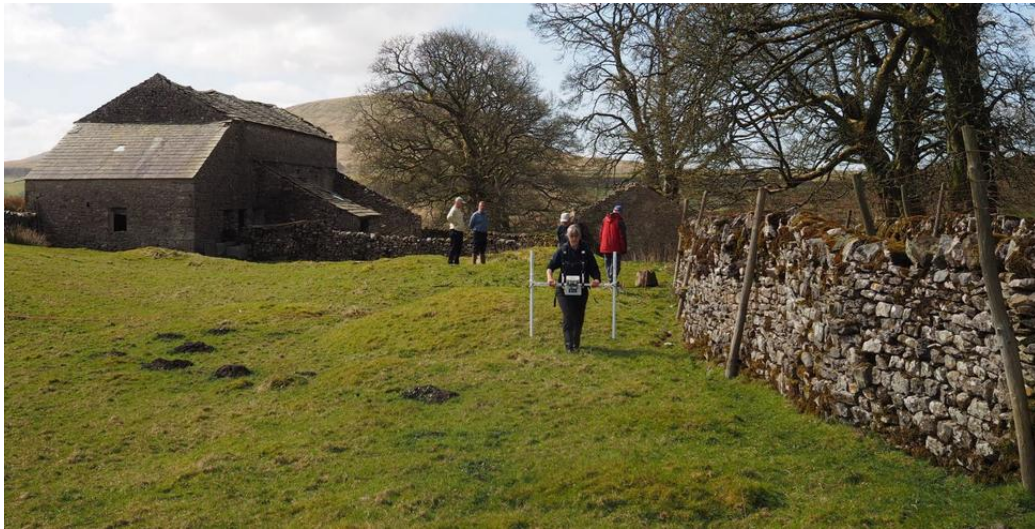
Most of the bipolar signals are close to dry-stone walls and may be due to wall-top wire placed to stop sheep jumping over them (Fig. 11.9).

Fig. 11.9 Wall-top wiring adjacent to survey site 2

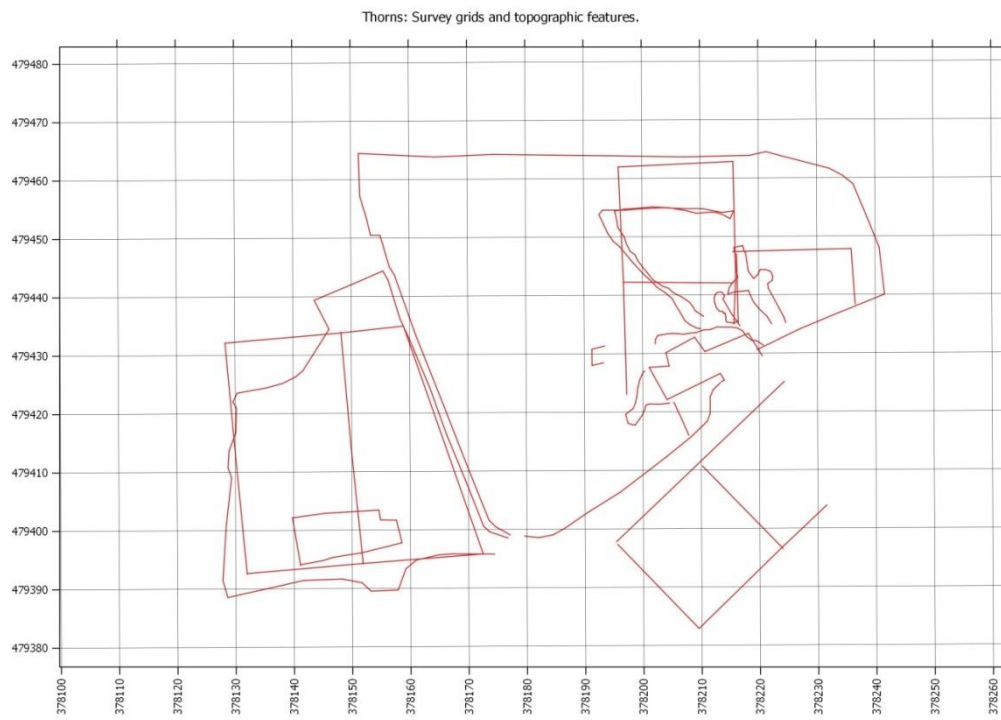
Fig. 11.14 GNSS data with survey grids and superimposed OS grid

The results of the GNSS survey are shown below: Fig. 11.11 shows the outline of the boundary walls for Areas 1 and 3 plus selected topographic features. Fig. 11.12 shows the same data as Figure 11.11 plus the outlines of the geophysical survey grids to allow a comparison between the geophysical data and the topographical features. Figs. 11.13 and 11.14 show the data with a superimposed OS grid to help in the location of features. Fig. 11.15 shows the GNSS data plotted over the LiDAR image of the area.

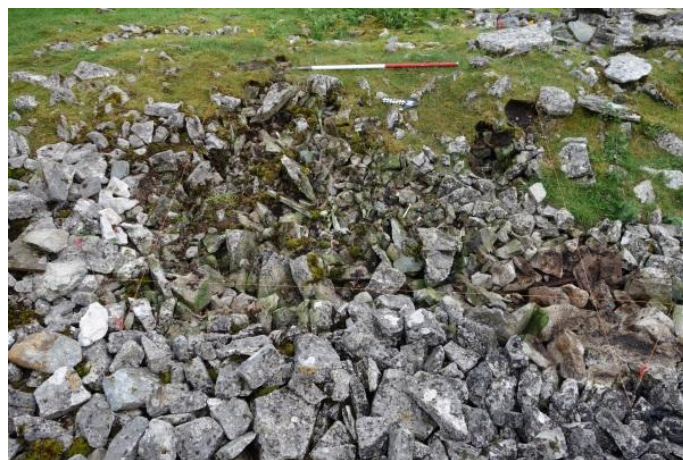
Context 101 was a deep layer of demolition and/or collapse rubble that filled the entire area within the trench apart from on the wall tops (Fig. 12.2). It extended 2.2m by 1.3m and had a maximum depth of 850mm. It mostly consisted of angular limestone pieces of very variable shape and size, most of which would have been wall fillings rather than facing stones. There were also broken fragments of blue-grey roofing slate and thin flagstone pieces that may also have been used as roofing. It was an unsorted mass of rubble with no stratification whatsoever, resulting either from deliberate demolition of the building, pushing inwards unwanted stone, or from slow decay and collapse of the abandoned building. Two hand-forged nails were logged within the rubble (small find/sf 106 and 115) as was a representative piece of fire-blackened sandstone (sf 116).

Fig. 12.2 Trench 1, rubble spread (101) (John Asher)

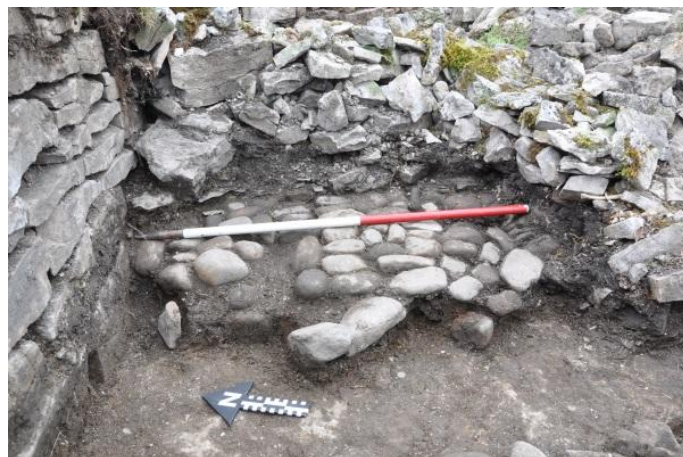
Context 104 was that part of the internal floor surface surviving in the eastern part of the trench, extending 1.16m by 690mm. It was composed of rounded, brown sandstone cobbles sourced from outside the vicinity of Thorns (Fig. 12.3). The cobbles had been set in a matrix dominated by lime mortar (Context 107) making the matrix and the cobbles together 120mm thick; the cobbles had been laid down in a somewhat haphazard manner, not all aligned on the same north-south axis, and individual long axis lengths ranged from 100-150mm. The cobbling had been laid to butt against the north wall of the outshut. One large fragment of charcoal (sf 102) was logged within the lime matrix (107) along with one sherd of brown-glazed redware pottery (sf 101).

Fig. 12.3 Trench 1, cobbled floor (104) on the east side of the trench (Chris Bonsall)

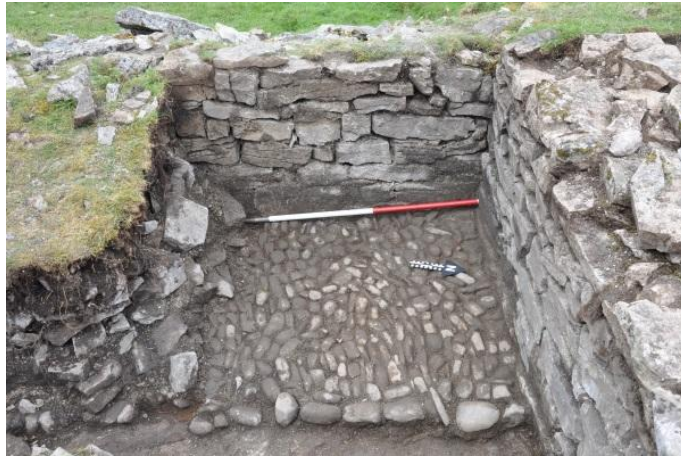
Context 106 was the west wall of the building which was made with well-coursed limestone blocks, surviving as eight courses to an even height of 750mm; it had minimal lime mortar visible within it. Within the trench it was 2m in length; only its internal face was exposed in the trench (Fig. 12.4).

Fig. 12.4 Trench 1, west wall (106) (Chris Bonsall)

Four small trenches in the western section did produce meaningful results and excavation proved that it had been a shippon – housing for cattle – running from the front (south) wall to the rear (north) wall of the small outshut. The floor had entirely been made up of cobbles (see Figure 12.4) and the walls were well constructed with lime mortar (see Figure 12.7). It was entered through a wide doorway in the south-west corner of the building (see Figure 12.10).
