Thorns through Time

The story of an abandoned settlement

Stories in Stone: Project H3

David S. Johnson

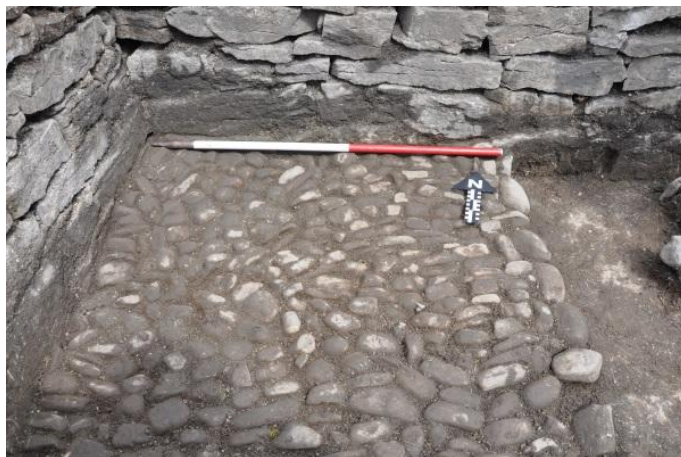
Context 108 was the western part of the floor surface which was similar to (104) in that it was composed of brown sandstone cobbles set in a lime-mortar matrix, but it differed in that these had been set on their long edge and had been laid in clear parallel rows to give a very neat effect, aligned west-east. On their eastern edge the cobbles were confined and bounded by a row of larger cobbles set at right-angles to the rest (Fig. 12.5).

Fig. 12.5 Trench 1, cobbled floor (108) on the west side of the trench (Chris Bonsall)

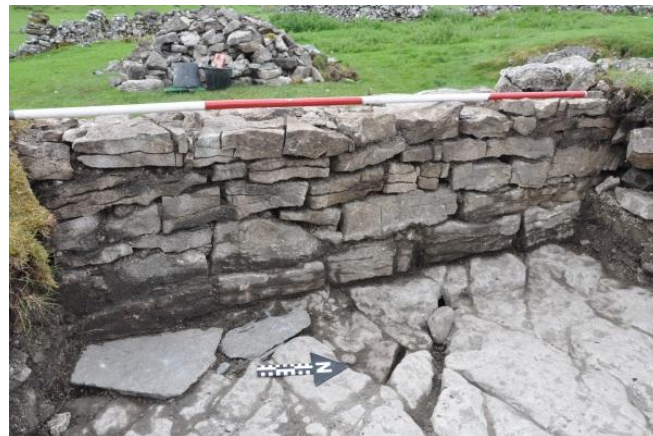
Context 202 was the west wall of the building, seen in a section 2.1m long and with a uniform width of 600mm. It survives to a height of 600mm in five courses in this trench, thus rather lower than seen in Trench 1 (Fig. 12.7). It is entirely composed of limestone with minimal lime mortar visible.

Fig. 12.7 Trench 2, west wall (202) (Chris Bonsall)

Four small trenches in the western section did produce meaningful results and excavation proved that it had been a shippon – housing for cattle – running from the front (south) wall to the rear (north) wall of the small outshut. The floor had entirely been made up of cobbles (see Figure 12.4) and the walls were well constructed with lime mortar (see Figure 12.7). It was entered through a wide doorway in the south-west corner of the building (see Figure 12.10).

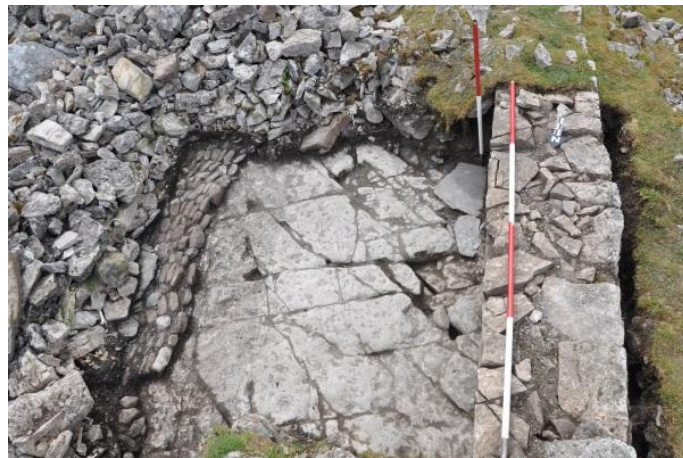
Context 205 was a narrow (400mm wide) strip of brown sandstone cobbles seen along the east edge of the trench (Fig. 12.8): the bulk of cobbles in this part of the building had long since been stripped and taken out, probably at demolition.

Fig. 12.8 Trench 2, cobbled floor (205) and bedrock (206) (Chris Bonsall)

Similarly, Context 206 was the same limestone bedrock sub-base as (109), levelled off in the same manner with the lime-mortar matrix (107) laid across it. In this trench the bedrock was exposed over the majority of the internal area, extending 2.1m by 1.8m (see Figure 12.8).

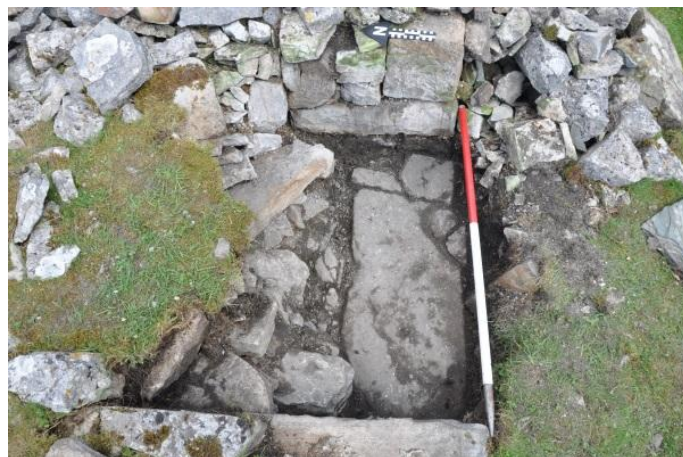
Fig. 12.10 shows Trench 3 on completion of excavation.

Fig. 12.10 Trench 3 on completion of excavation (Chris Bonsall)

Between (302) and (304) the threshold was excavated down to the threshold base, namely a large slab of Helwith Bridge 'blue flag', 900mm long by 400mm wide; the remaining space on the east side of the threshold within the doorway was filled with small slabs of the same rock.

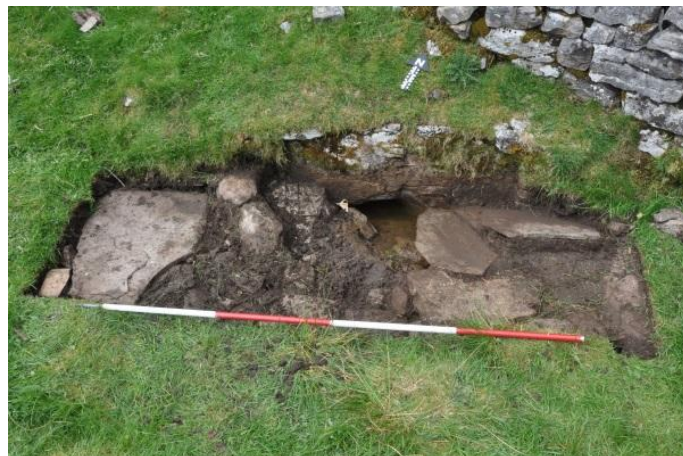
This small test pit (1.8 north-south by 900mm east-west) was designed to locate what was marked on OS First Edition six-inch mapping as a 'Well' but which had no apparent remains visible on the surface. As soon as the turf was stripped back a set of three large roofing flags was seen lying prone, set against an enhanced natural limestone face 600mm high. At the foot of this face, protected by the largest flag (800 x 560mm), was the issue of a natural spring (Fig. 12.11) which had clearly been enhanced to serve as a water source for the settlement. At some later point, probably in the nineteenth century, the spring was tapped and a buried, stone-capped culvert was dug, 9m in length, to take the water to a buried storage tank, showing now as a grassy mound. From there, a buried cast-iron pipe carried water to feed a large flagstone trough in the fold yard at the bank barn though it is no longer functional.

Fig. 12.11 The enhanced spring, or well, in Test pit 5 (Chris Bonsall)

Well (see Figure 12.11), as shown on the OS First Edition at the rear of the enclosure containing Features 1 and 3. No evidence was to be seen on the surface of the well so the specific aim here was to test if it is still there under the modern ground surface and if it was a built well or an enhanced natural spring.

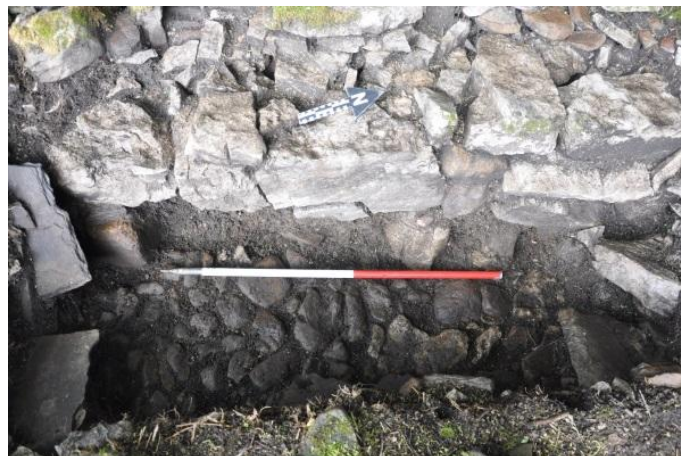
Beneath the rubble layer in the eastern bay, the same lime matrix (603) had a cobbled surface (605) impressed into it (Fig. 12.12), exposed in the trench over an area 1.7m by 505mm. The cobbles were all of sandstone and had been carefully selected for their size and roundness, though they had been laid in a random rather than a systematically-aligned pattern. This floor surface was determined as 300mm lower than (604) in the central bay.

Fig. 12.12 Trench 6, cobbled floor (605) (Chris Bonsall)

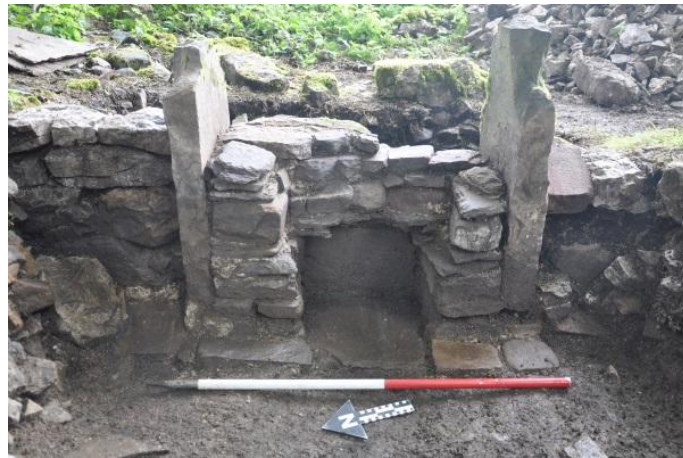
These two slabs framed a fireplace (Context 608) (Fig. 12.13) that was recessed into dividing wall (602). It is 400mm wide by 300mm deep by 550mm high, with coursed sandstone on each side of the actual grate and firebox recess, an intact flagstone base, and the cast-iron backplate still *in situ* complete with iron fixing brackets set through the wall. The

bulk of the cast-iron fireplace had been removed, presumably at demolition. Charcoal and coal were seen within the fireplace but not logged as small finds.

Fig. 12.13 Trench 6, fireplace (608) and fire surrounds (606 and 607) (Chris Bonsall)

At the rear of the bodystead a door gave access to the outshut dairy and in the north-east corner a second door gave access to the parlour. This, too, had remains of a flagged floor and a fireplace (F) set into the east gable wall complete with part of the small cast-iron range (see Figure 12.13).

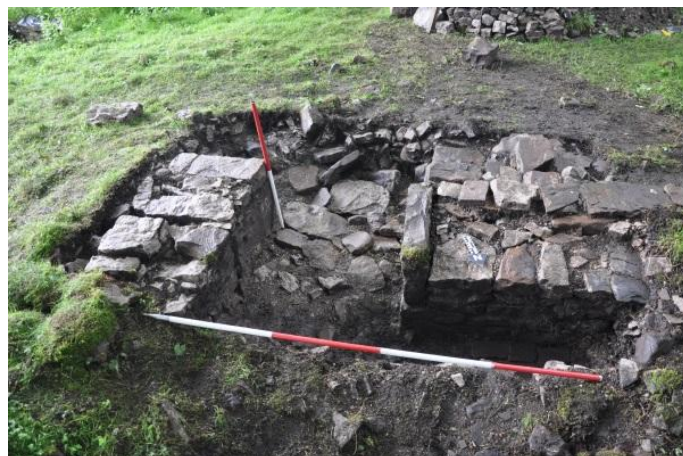
Between (702) and (703) the threshold was just seen as a rubble spread and no floor level was located though the presence of thirteen disturbed sandstone slabs may suggest they had formed the floor here. Outside the doorway were the remains of a small porch (Context 704). It was not tied in to the building walls so was a later addition. Like the doorway, it is 850mm wide and 900mm deep. On the west (left) side part of the sandstone coursing survives to a maximum height of 600mm though the opposite wall has largely been robbed out (Fig. 12.15). The slabs utilised averaged 400 x 400mm in size.

Fig. 12.15 Trench 7, porch (704) with the vertical pole, and walls (702 and 703)
(Chris Bonsall)

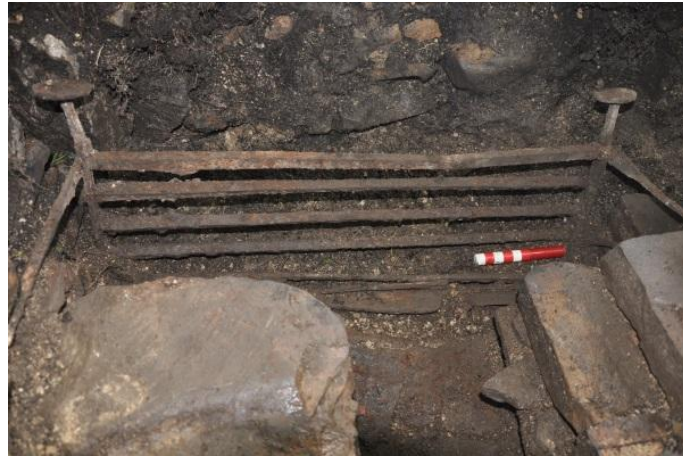
At some point in its life the building was remodelled and this process included closing off the bread oven and abandoning the original large open fireplace, replacing it with a smaller hearth with curving rear and sides (Context 803). The actual hearth and ash pit are broadly intact, the latter measuring 250mm wide by 280mm deep, the former 850mm wide by

750mm deep and 320mm high. The hearth still has its 980mm-long and 200mm-wide wrought-iron fire basket and tie-brackets in place (Fig. 12.17).

*Fig. 12.17 Trench 8, hearth (803) and fire basket
200mm scale (Chris Bonsall)*

At some point the oven was blocked off and the fireplace was reduced in size and given a curvilinear rather than rectilinear shape. The wrought-iron fire basket was found *in situ* and in sound condition during excavation (see Figure 12.17).

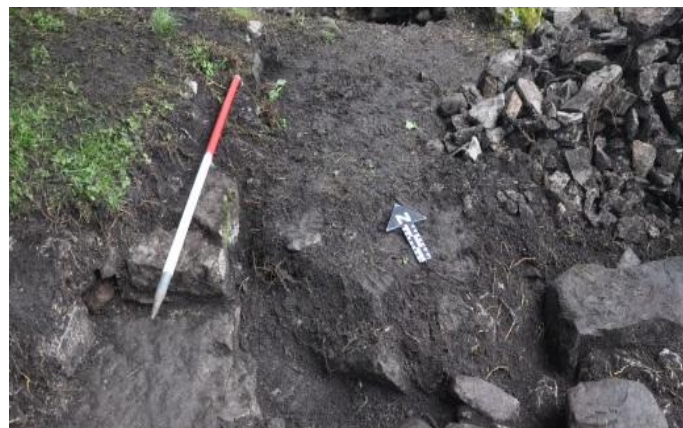
This test pit (1.5m east-west by 500mm) was set out to determine if the eastern bay, with its lower floor level, was coeval with the central and western bays of the building and if a doorway could be found. No contexts were recognised as all that was entailed was the removal of nettle growth and surface rubble. A doorway was found, 950mm wide and 700mm deep, bounded on the west side by a single squared sandstone slab (470 x 650mm) which also acted as the corner stone for the south wall of the central bay and the dividing wall between the central and eastern bays (Fig. 12.18). On the east side of the doorway two blocky sandstones formed the surviving lowest course of the wallhead. Excavation evidence strongly points to all three bays being coeval.

Fig. 12.18 Test pit 9, doorway, looking into the building (Chris Bonsall)

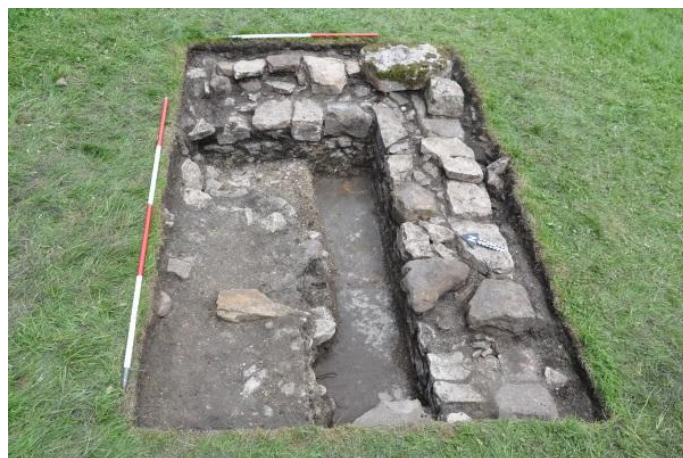
*Fig. 12.19 Trench 10, floor (1006) and walls (1002 and 1003)
(Chris Bonsall)*

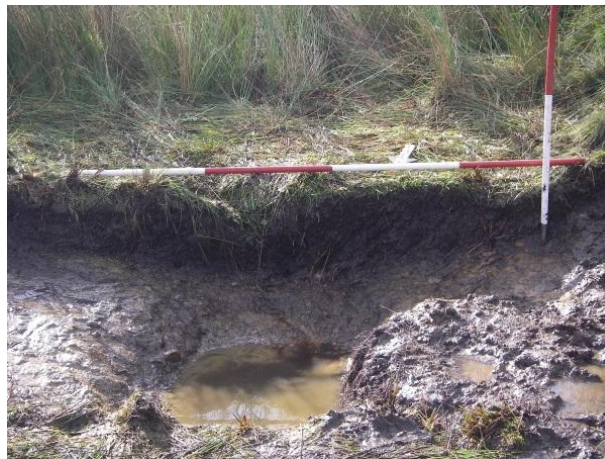
In the base of the ditch was seen a very glutinous and sticky, bleached grey clay (1107). Because of the seriously-waterlogged conditions in the ditch it was not possible to determine the thickness of this layer (Fig. 12.21): as fast as water was bailed out, it seeped back in again from upslope. It had clearly been puddled by human agency and was exceedingly anaerobic.

Fig. 12.21 The glutinous mess (1107) within the ditch (David Johnson)

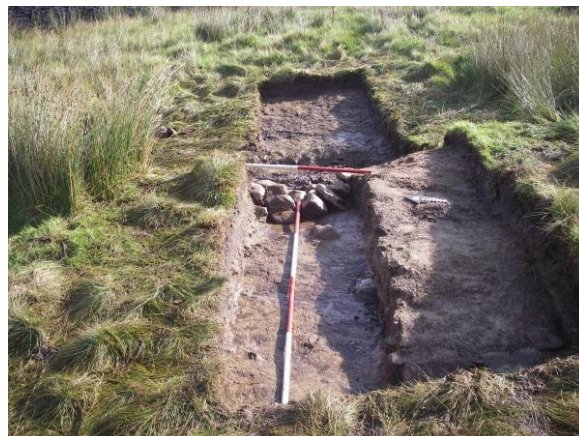
On the rim of the west bank, set into (1105) in the sondage, was a stone revetment (1108) 500mm wide, composed of large, rounded sandstone cobbles, presumably placed there to protect the bank top and to prevent surface material being washed or trampled into the ditch (Fig. 12.22).

Fig. 12.22 Trench 11, looking east through the ditch with stone revetment (1108) in the middle ground (David Johnson)

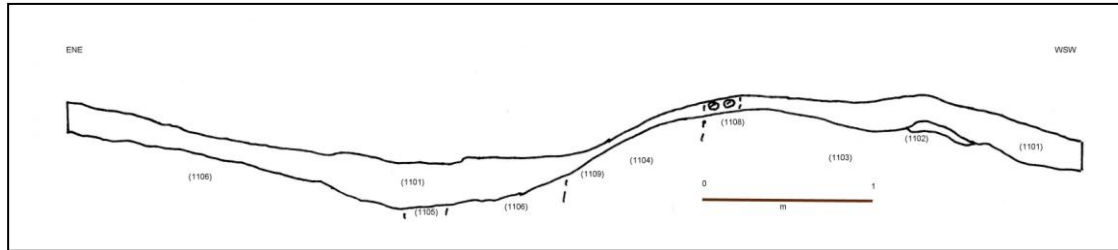
Fig. 12.23 Long-profile through Ditch and Bank feature 1d, with the steep bank centre right

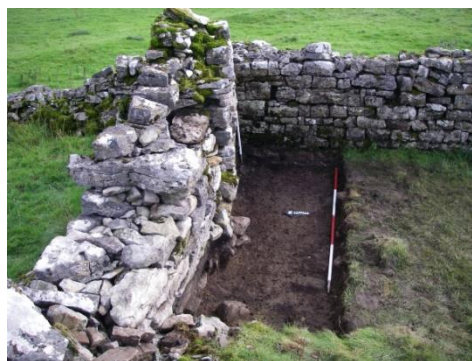
High Flat Barn (SD7801 7932), Thorns 7 in the Thorns Vernacular Building Survey, had the appearance prior to excavation of being possibly the oldest building on the Thorns estate, given the apparent thickness of the walls and the double plinth (see Chapter 10). Two trenches were demarcated to investigate the building's secrets (Fig. 12.25).

Fig. 12.25 High Flat Barn showing the location of Trench 12 (John Asher)

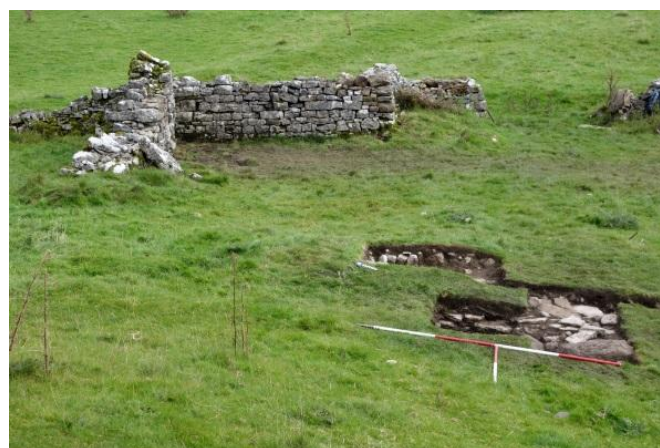
This was laid out over what earthworks suggested might be the south-west corner of the building (Fig. 12.26). Initially a 2m-square test pit to locate any surviving corner stone, it was extended in two directions to pick up the west gable and south elevation wall lines, ending up overall as a trench 3.5m east-west by 3.1m north-south. Six contexts were identified.

Fig. 12.26 Trench 13, (bottom right) showing the south-west corner of the building (John Asher)

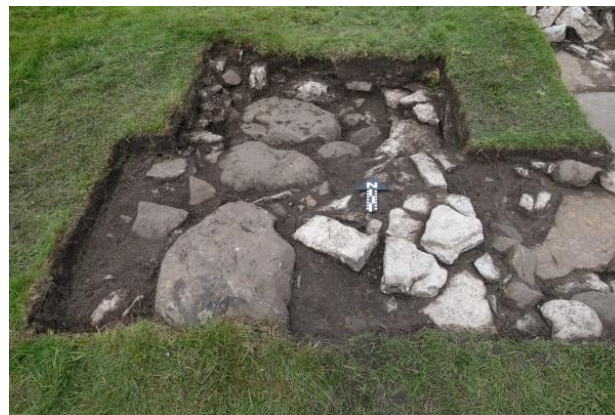
Context 1305 was the west gable and south elevation wall lines of the building, seen to survive only as wall footings composed of large squared sandstone blocks with a particularly large slab at the corner and an even larger one set across the gable wall. The rest of the walls had clearly been demolished and removed rather than having been left to slowly collapse: there simply was not sufficient stone tumble to permit the latter scenario. The gable wall was 1.9m long within the trench and the south wall 2.1m; the former was 1.05m in width and the latter 850mm.

Fig. 12.27 Trench 13, with the west gable wall on the left, the south wall next to the North arrow, the threshold slabs lower right and the floor slabs upper right (John Asher)

Finally, set within the south wall was Context 1306, seen as large squared slabs: a large Helwith Bridge 'slate' (500 by 700mm in size) set into the inner side of the wall, butted against a smaller limestone slab and a large flagstone slab (340 by 440mm) set in the outer part of the wall. The inner one was seen to butt against the floor slab (1302). Together, these slabs were interpreted as part of the building's threshold (Figs. 12.27 and 12.28).

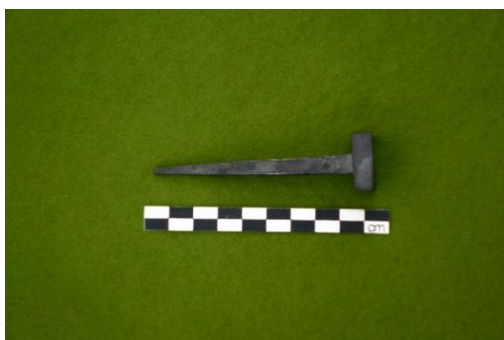
Not unexpectedly, there were many (n = 23) iron items that defied identification, such as long thin pins and a fragment of a flat iron sheet. There were twenty-one hand-forged nails of a type that is very common on early-modern to late nineteenth-century sites. They are typified by a squared profile and a large flat head and they were turned out by local blacksmiths by the hundred with boys and apprentices set to the repetitive task of heating a long iron rod in the furnace and hammering it to shape before snipping it to the required length and hammering the thicker end flat to form the head ... and then starting all over again. Fig. 12.29 shows a hand-forged nail specially made for this writer by blacksmith Ian at Bradford Industrial Museum on 28 June 2017.

Fig. 12.29 A modern hand-forged nail (John Asher)

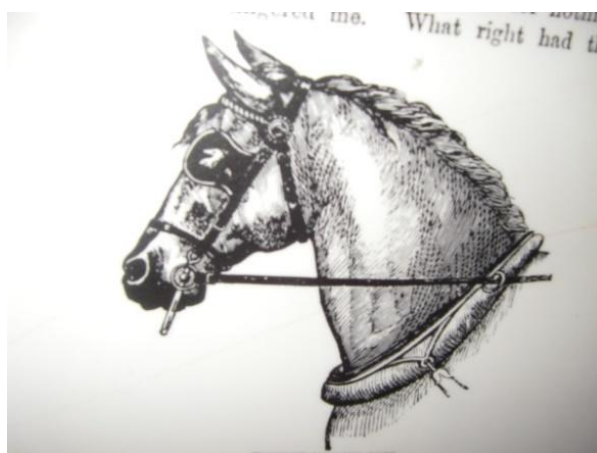
A range of items were logged from the floor of Trench 10, all of them pony and cart furniture. Sf 176 is one side of a set of hames which were placed in grooves on the upper side of the padded collar round the animal's neck and held in place by leather straps or short chains (Fig. 12.30). The eye at the lower end of the hames was the attachment for the traces and its purpose was to distribute the pull of the traces equally on the animal's shoulders.²⁷ The small size of this set of hames is evidence that the animal in question at Thorns was a pony rather than a horse.

Fig. 12.30 Diagram of a hames in position on the collar
© Bradford Industrial Museum

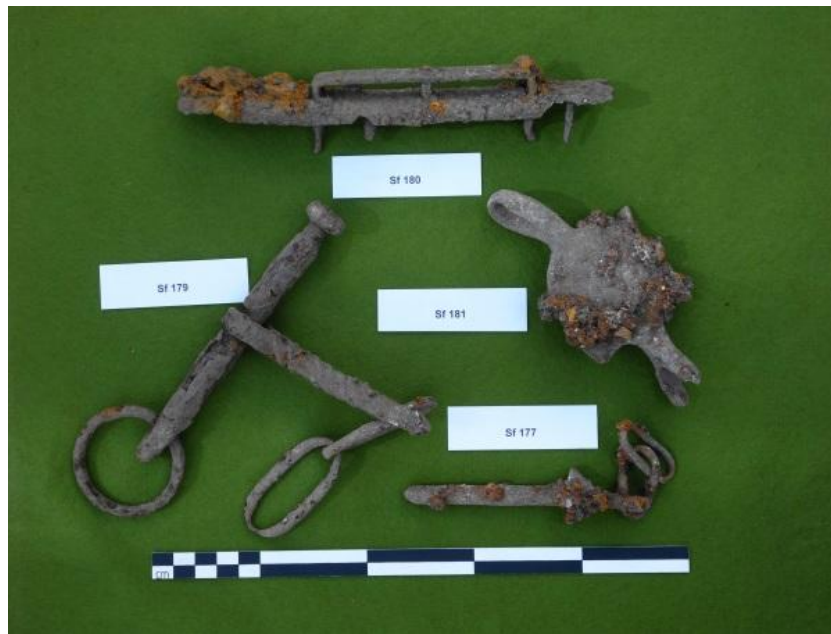
Other connected items included sf 180, a fixing plate from the side of a small cart to which the straps were attached, and similar fixings forming part of pony and cart furniture (sf 177, 178, 179 and 181) (Fig. 12.31).

Fig. 12.31 Items of pony and cart furniture from Trench 10 (John Asher)

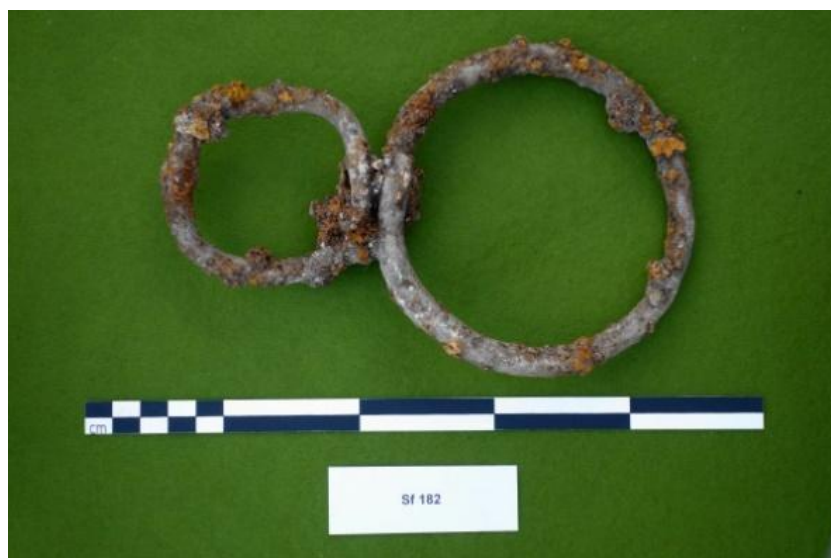
Sf 183 is a heavy-duty bracket of the type attached to the side of a cart for holding one of its shafts in place; while sf 182 is two swingles, part of a swingletree pivoted in the centre of the cross bar of a plough that held the traces in position but gave the horse freedom of movement at its shoulders (Fig. 12.32).

Fig. 12.32 Sf 182, part of a horse-drawn plough swingle (John Asher)

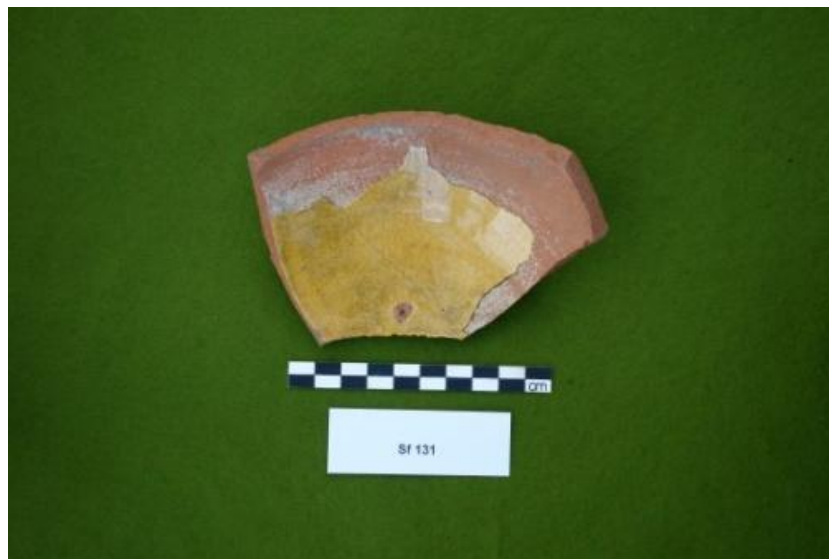
Fig. 12.33 Large redware sherd from the base and side of a pancheon or baking bowl. Unknown origin (John Asher)

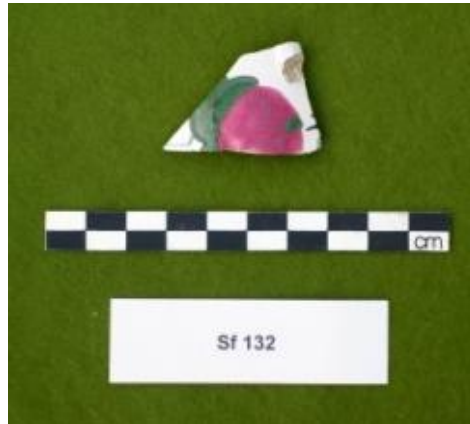
Fig. 12.34 Part of a fine, white earthenware cup in the style of Wemyss Ware, post-1882 (John Asher)

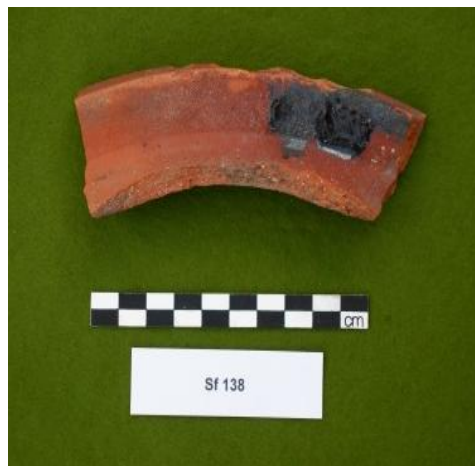
Fig. 12.35 Part of a large black-glazed redware storage vessel, probably a fleshpot for storing meat pickled in brine (John Asher)

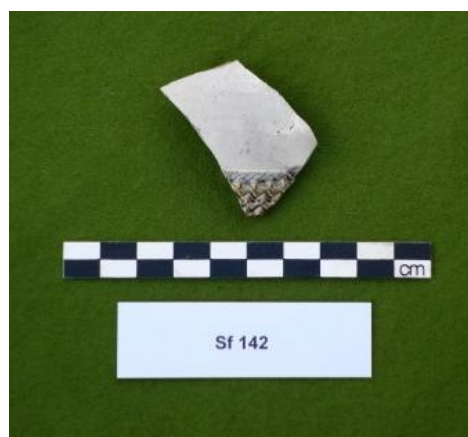
Fig. 12.36 Part of a white salt-glazed vessel with rouletted decoration, probably made in Staffordshire c. 1720 (John Asher)

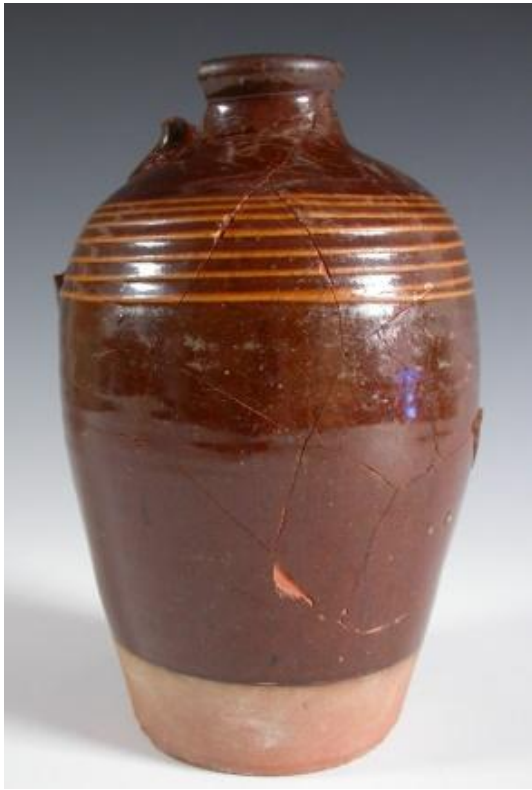
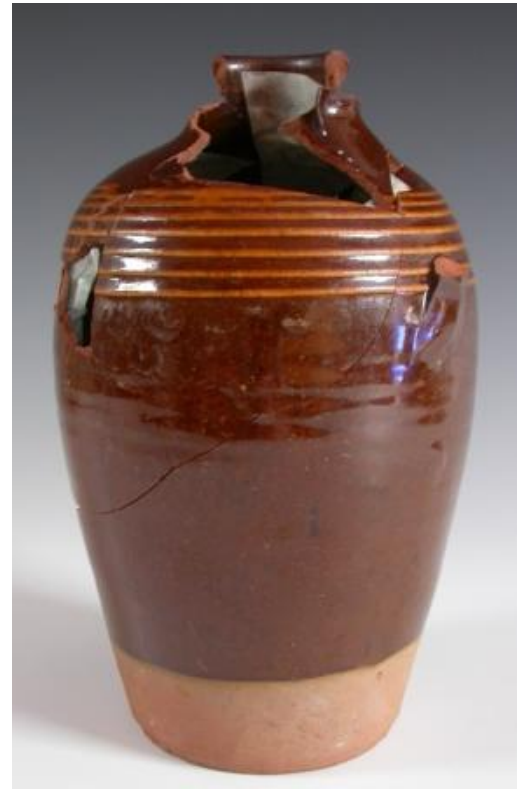
Fig. 12.37 A finely-made lead-glazed earthenware flagon with sliptrailing, a 'forenoon' bottle used for holding an outdoor worker's small beer. Made in Burton-in-Lonsdale c. 1780-1820. Reconstructed by Karen Barker, Antiquities Conservation Service (Barbara Blenkinship)

Fig. 12.38 Another view of the forenoon bottle (Barbara Blenkinship). This item was generously donated by Mr J. C. White to The Folly Museum and Heritage Centre, Settle

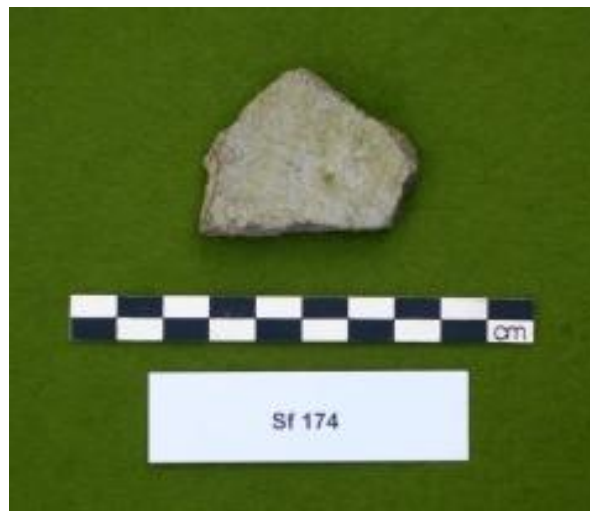
Fig. 12.39 Part of a large stoneware flagon with a green glaze, made in Burton-in-Lonsdale from 1830 (John Asher)

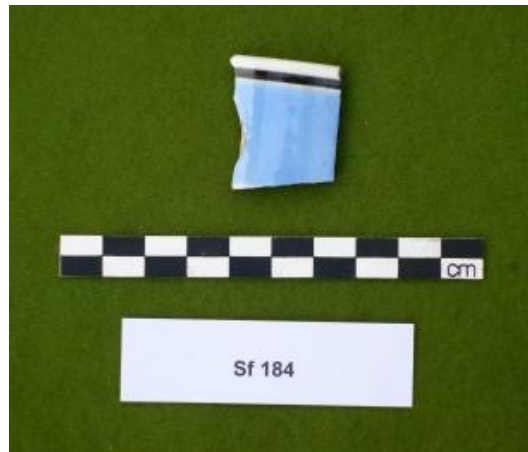
Fig. 12.40 Part of white earthenware, slip-decorated tankard, mass produced in Staffordshire from c. 1875 – 1900 (John Asher)

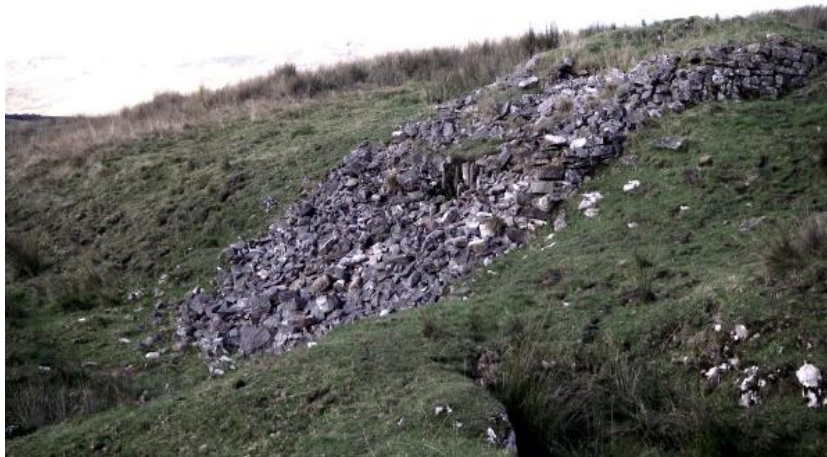
Fig. 13.3 Ruinous lime kiln at the southern end of Lister's allotment (David Johnson)

To what extent either Elam or Lister carried out any improvements to their allocations is debateable. The now-ruined lime kiln at the southern end of Lister's allotment may have been brought back into use to reduce acidity levels in the soil thereby improving the quality of the pasture, and until relatively recently the pasture here was in a much better state than it is now (Fig. 13.3). Much of Elam's allotment was and still is very wet, even boggy, and there is little evidence on the ground of any systematic improvement after 1803.

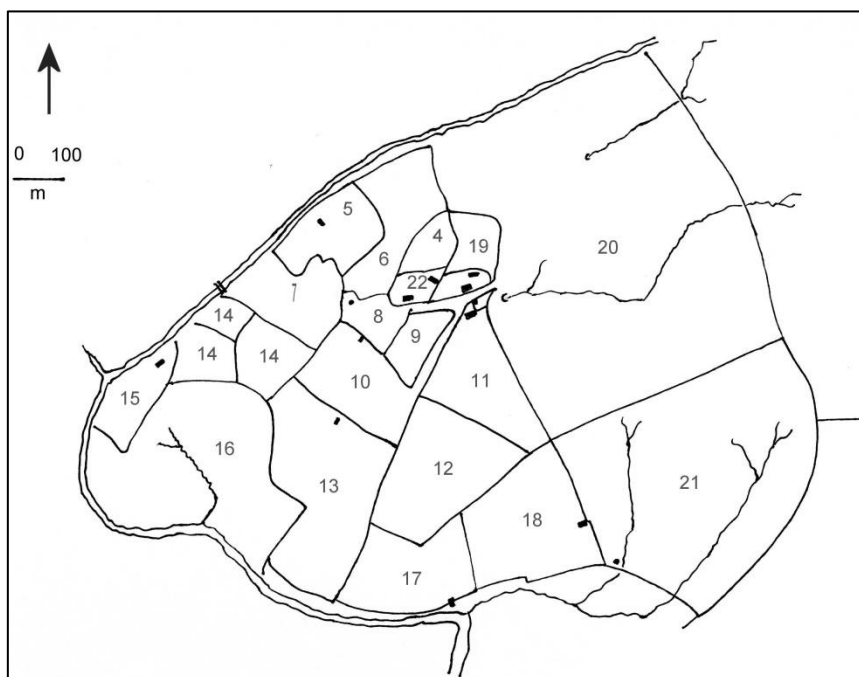
Fig. 13.4 Current field code numbers superimposed on historical field boundaries

As stated, Fields 15 and 16 (Holme and Nell Holme) did not form part of the Thorns estate but numbers 20 and 21 (Thorns Cow Close) did so the data in Table 13.8 reflect this. At its maximum extent the estate totalled only 104 acres (42.09ha) of inbye land with Thorns Cow

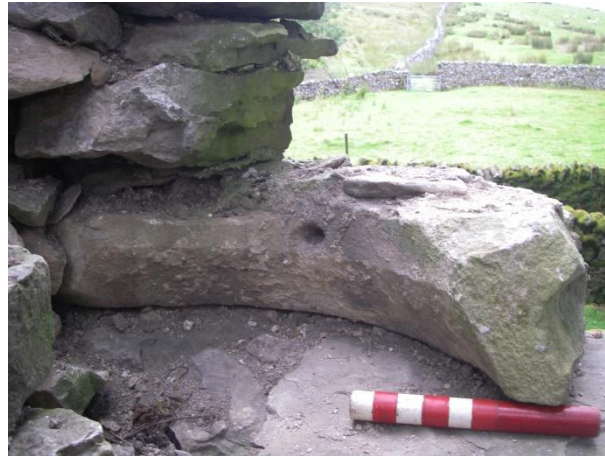
Fig. 15.3 The fire window lintel as found reused in the front face of the house. The view here is on the inside of the wall where it had been hidden from view prior to building consolidation works (200mm scale) (David Johnson)

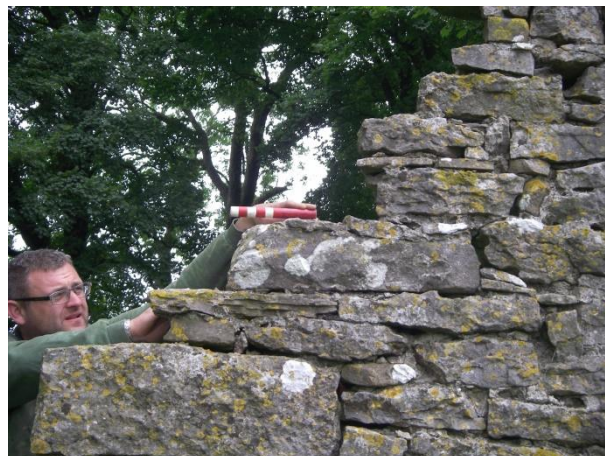
Fig. 15.4 The outer face of the reused fire window lintel, with Simon, one of the building team, holding the 200mm scale (David Johnson)

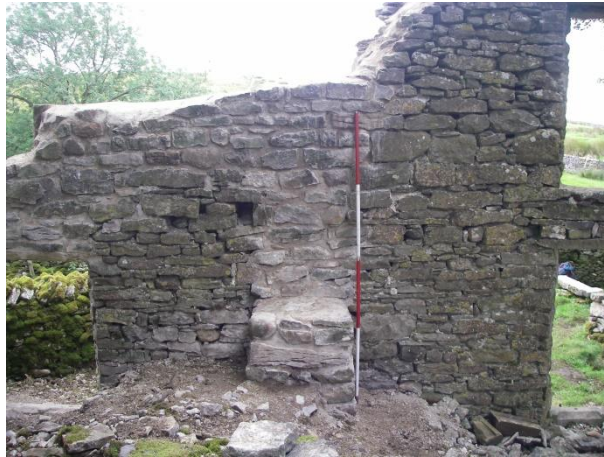
Fig. 15.5 The restored stub from the second-phase dividing wall between bodystead (to the left) and parlour (to the right) (David Johnson)

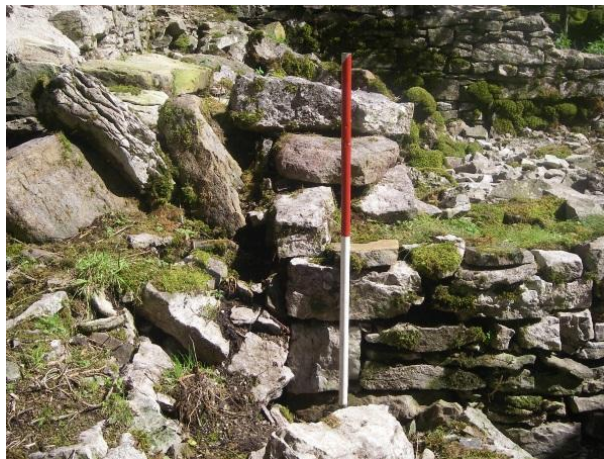
Fig. 15.6 The straight joint indicating the doorway from bodystead to parlour (David Johnson)

There was almost certainly a firehood over the fireplace in the parlour – the ‘best’ or private room of the house – with a ceiling of timber joists spanning across to a central beam. The fireplace in the bodystead must also have been moved during this phase from the gable wall to the central dividing wall when the original cruck frame was taken out and a stone cross-wall inserted in its place (Fig. 15.5), with a doorway connecting the two rooms at the north end of the cross-wall, indicated by a straight joint in the masonry (Fig. 15.6).

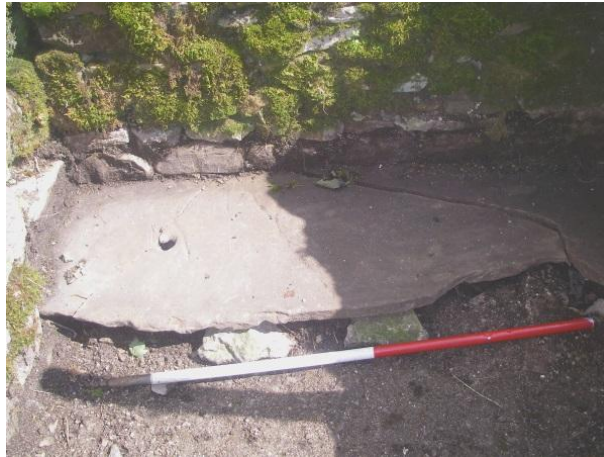
Fig. 15.7 The seat or shelf in the porch. The floor level lies below the later accumulation of soil (David Johnson)

It is likely that in 1836-37 the rear dairy (8.5m² or 91 square feet) was added as an outshut, probably replacing an earlier and smaller dairy at the rear (north) side of the bodystead where there is partial survival of a window. A doorway was cut through the rear wall of the parlour to give access to the added dairy with two steps down to the lower level of the outshut. The dairy was lit by a splayed window in its rear wall (which at first sight from outside may now be mistaken for a door). During this phase the former mullioned front windows were enlarged by heightening and lowering, and with small-glazed sash windows added. The old lintels and sills were reused. The porch was rebuilt on the front doorway, complete with a flagstone seat or shelf and a niche, during this rebuild (Fig. 15.7).

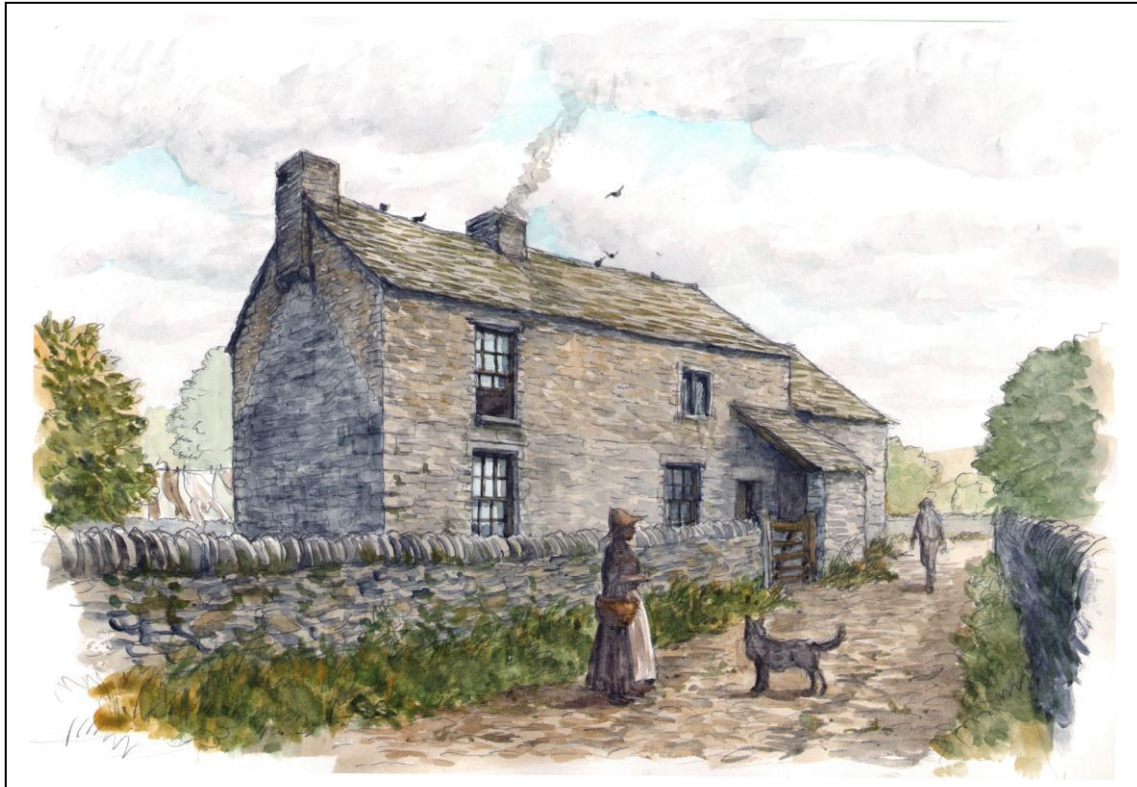
Fig. 15.9 An impression of Thorns 1 in its final phase of occupation in the mid-nineteenth century (artwork © Dominic Andrews based on a sketch by Alison Armstrong)

Fig. 15.8 is a reconstruction of how the house may have looked in the sixteenth-century, and Fig. 15.9 how it might have looked in its final, post-1837 phase.

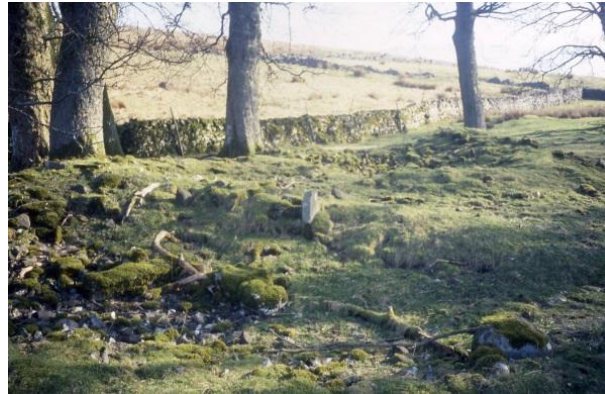
Fig. 15.11 Thorns 3 photographed in early spring 1995, looking north-east (David Johnson)

Prior to ground surveying and excavation, this structure was visible in winter months as an elongated earthwork, though more of an uneven rubble spread than an actual earthwork (Fig. 15.11). During summer months it is effectively masked by nettle infestation (Fig. 15.12).

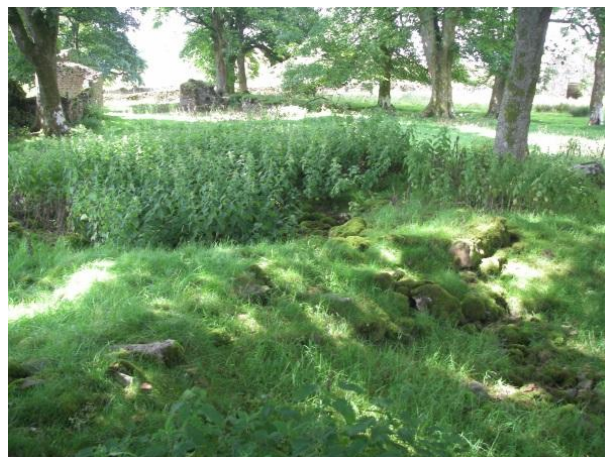
Fig. 15.12 Thorns 3 photographed in summer 2014, looking towards the privy (David Johnson)

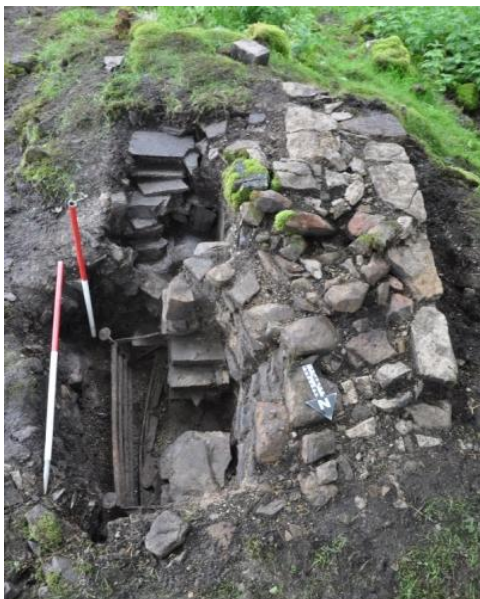
Fig. 15.14 The early-phase fireplace with the inserted eighteenth-century bread oven at the far end. The later curving fireplace is also seen (Chris Bonsall)

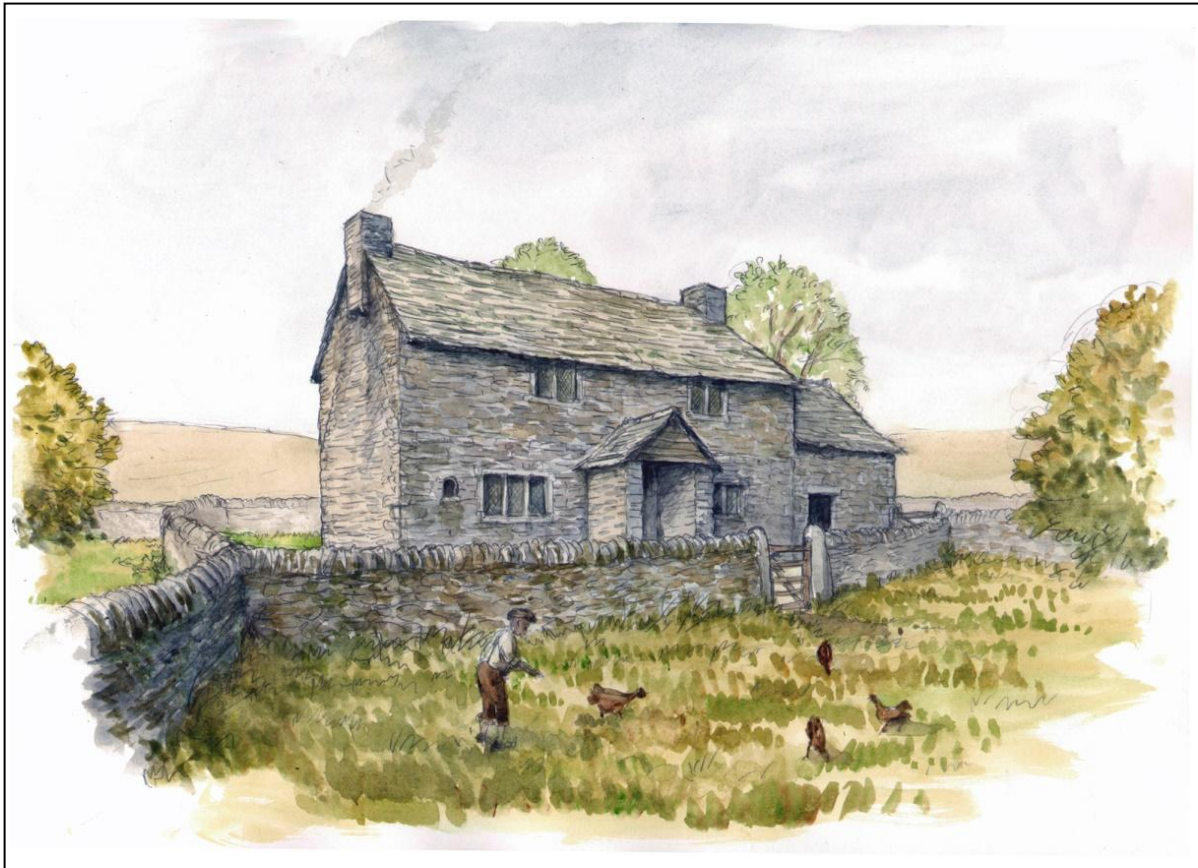
Fig. 15.15 An impression of Thorns 3 in its final phase of occupation in the mid nineteenth century (artwork © Dominic Andrews based on a sketch by Alison Armstrong)

Fig. 15.15 is an artist's impression of how Thorns 3 would have looked in its final phase of occupation.

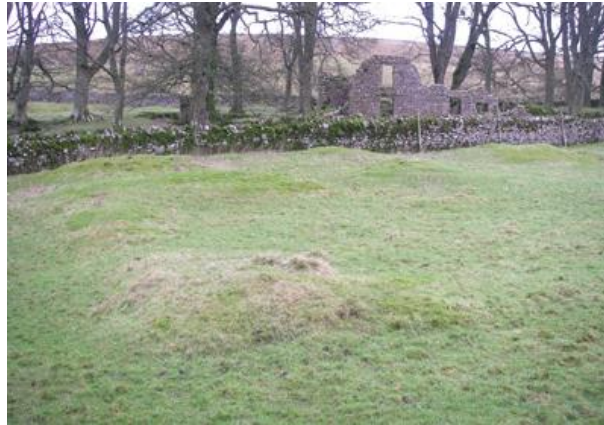
Fig. 15.16 The vague earthwork of Thorns 13, against the wall in the background, with the garden before it within a banked enclosure (David Johnson)

Feature 13 (see Figure 15.16) consists of two contiguous earthwork platforms close to the wash-house, with 'lumps and bumps' nearby, hypothesised as a building with adjacent garden. There were very slight traces of wall footings visible through the turf and a small trench was laid out to answer questions about the feature's form and function.

Though the trench opened over this earthwork was only 5m² in size, an impressive amount of detail was gleaned from it. It was not included in the Vernacular Buildings survey (see Chapter 10) because the earthwork was so vague (Fig. 15.16) and only one stone block protruded above the turf prior to excavation so there was nothing visible to support the contention that it had been a building. Having said that, the way in which the specific spot was depicted on First Edition OS mapping, surveyed in 1846-48, allowed a hypothesis to be put forward that it had indeed not only been a building but had been a domestic house: it was shown as a roofed L-shaped building with the long limb of the L facing south and the short limb sitting roughly where the wash-house was later erected. Furthermore, First Edition mapping used a specific form of notation for gardens and this was applied to the squared banked enclosure adjacent to the south (long) axis of the building as mapped. Gardens in the past, especially in farm situations, were not like today's lawns and flower beds, but were geared at producing vegetables and small fruit. Thus, the hypothesis formulated for excavation was that the visible stone lay at the south-east corner of the front face of the building, and that the south-facing part of the building was a house opening to a low-walled garden.

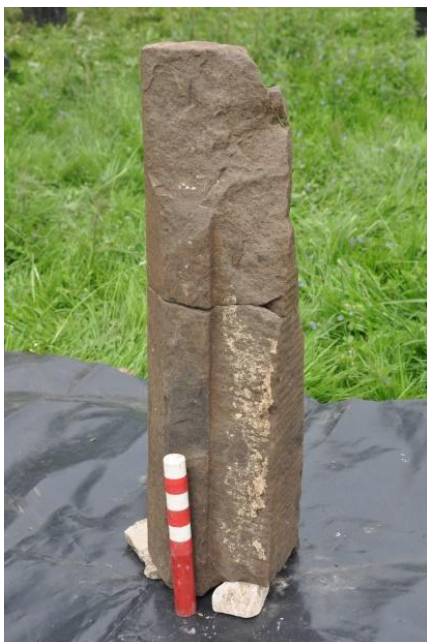
Fig. 15.17 Part of an eighteenth-century window jamb, 200mm scale (Chris Bonsall)

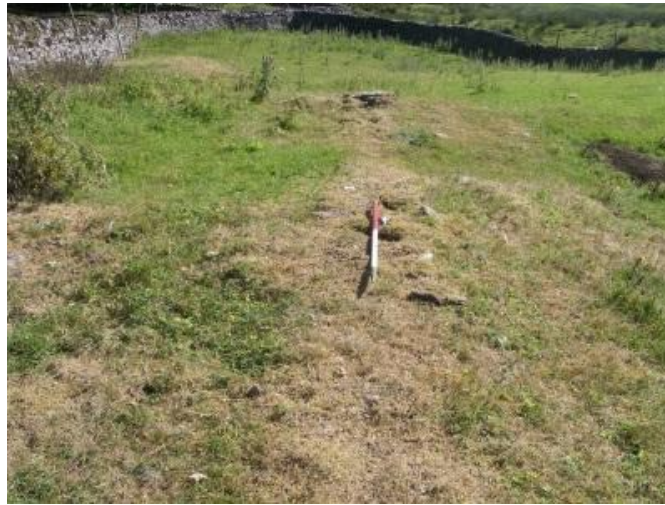
Fig. 15.18 The south (front) wall of the house showing as a parchmark in the drought of summer 2018 (David Johnson)

From the excavation evidence (see Chapter 12, Section 3), it can be confirmed beyond doubt that the trench contained the south-east corner of a house with well-built and strongly-mortared walls with surviving evidence of lime plaster and orange-coloured limewash; it had a slate floor; the south wall within the trench contained a window with an eighteenth-century stone mullion (Fig. 15.17); and it had been roofed with flagstone rather than grey slate. On the basis of all this, and from earthwork evidence, it can be asserted with a high degree of confidence that there was a door to the west of the proven window and a second window beyond that, enabling a picture of a symmetrical house to be imagined, built in the eighteenth century (Fig. 15.18). The relative narrowness of the east gable and front (south) wall – 550-600mm – adds weight to the idea that it was of this period. It can be taken as a given that the banked enclosure was a garden surrounded by stone walls as probing along the banks located buried stone that was not apparent to either side, and there is a considerable depth of fine silt within the enclosure. It can be assumed, with some confidence, that the western end of the long limb, and the north-south short limb were agricultural bays attached to form one long building. If the entire structure had been agricultural, the floor would have been cobbled rather than slated; while the quantity of pottery and window glass from the trench strongly points to domestic use.

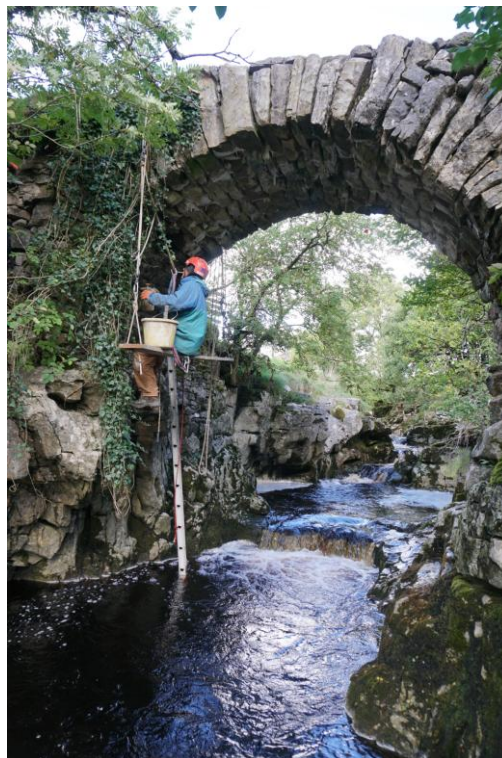
Fig. 16.2 Thorns Gill footbridge in 2018 undergoing structural repairs undertaken by Pete Roe, heritage builder (YDNPA HER)

⁴ In 2018 a grant under the *Stories in Stone* Heritage Grants scheme (D9) funded minor repairs to the structure of the bridge thereby ensuring its long-term future (see Chapter 16.1 and 16.7).

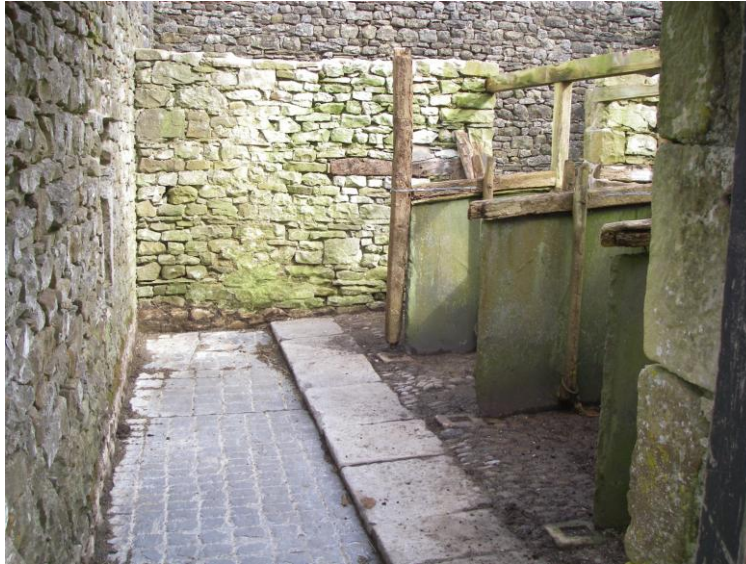
Fig. 16.3 Back Hools Barn cleaned out and conserved for the future (David Johnson)

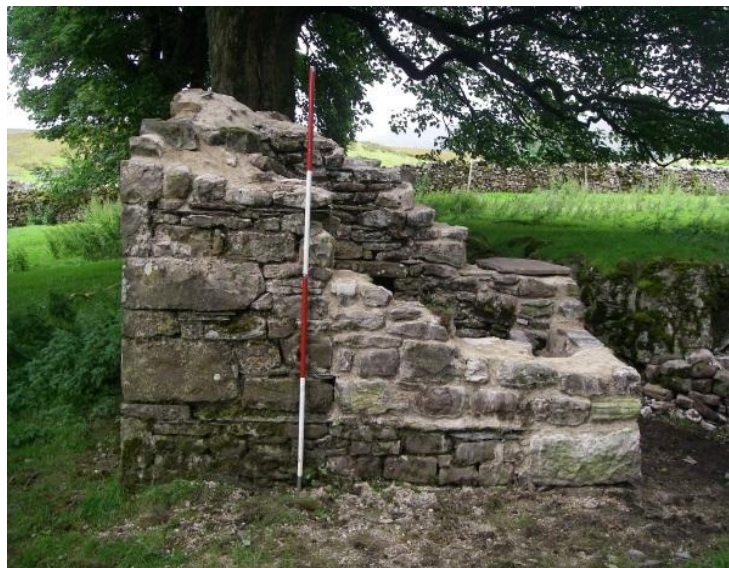
Fig. 16.4 The privy – the 'out-office' in contemporary parlance – on completion of consolidation works (David Johnson)

adjacent to it was put back and no stone was imported as that would have compromised the structure's historical integrity (Fig. 16.4).
