Thorns through Time

The story of an abandoned settlement

Stories in Stone: Project H3

David S. Johnson

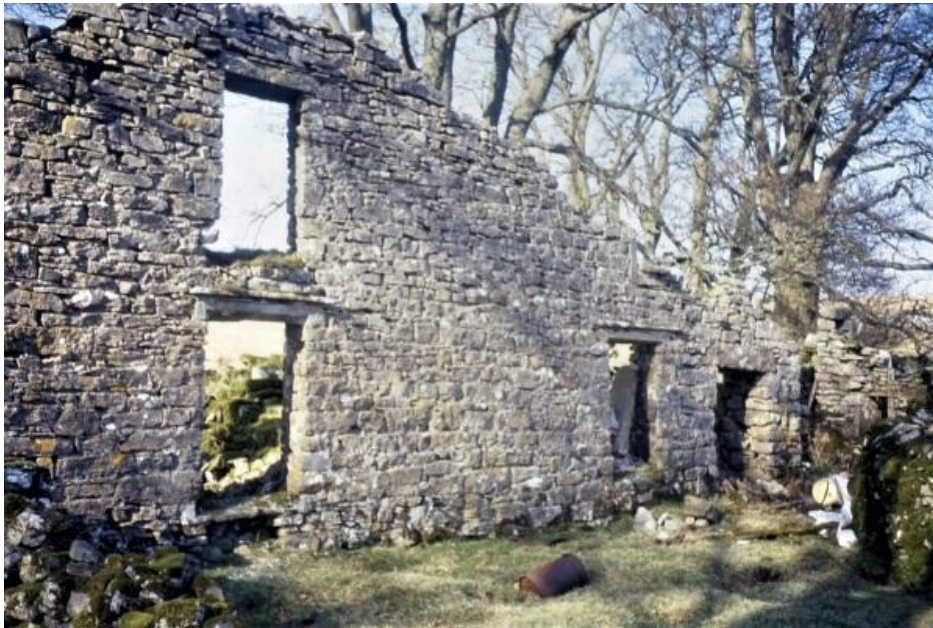
Fig.16.5 The house frontage in 2003 (David Johnson)

For the house (Thorns 1), masonry that had fallen – or been deliberately pushed off by unknown persons – in recent years was put back in position to make the frontage closer in appearance to what it had been when photographed in 2005 (Figs 16.5 and .6). Within the building the internal dividing walls between the housebody and the parlour and the parlour and the added rear dairy were cleared of fallen rubble, exposed to view and consolidated using dry-stone walling methods; both windows and the front doorway were similarly exposed to view, the positions of the fireplaces in both rooms were identified, three niches were cleared of rubble and exposed within the added dairy, and another niche as well as a flagstone bench or shelf were 'exhumed' within the front porch. The short length of low garden wall at the front of the house was also fully rebuilt.

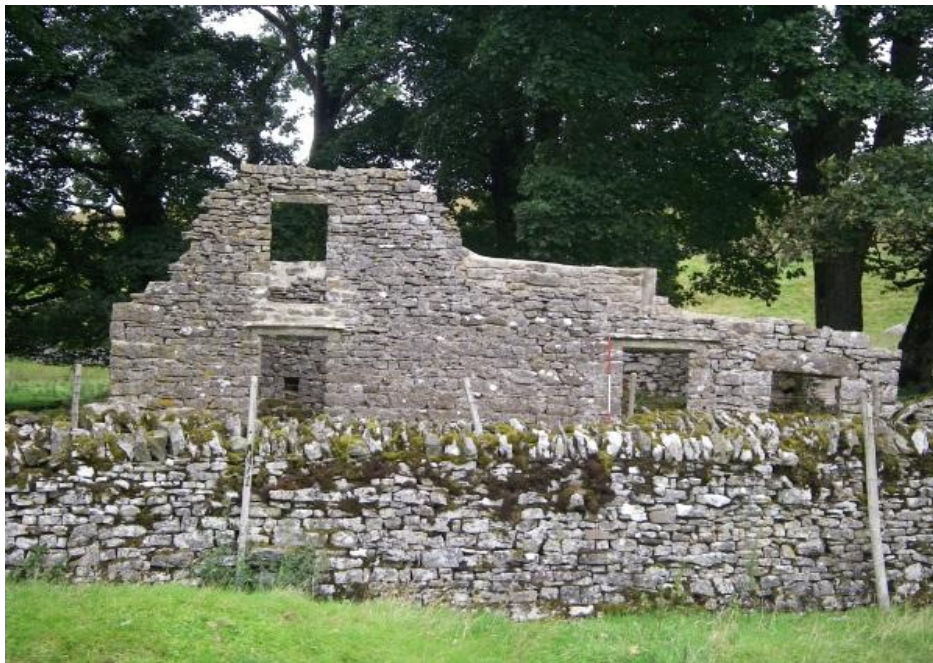
Fig. 16.6 The house frontage after consolidation in August 2017 (David Johnson)

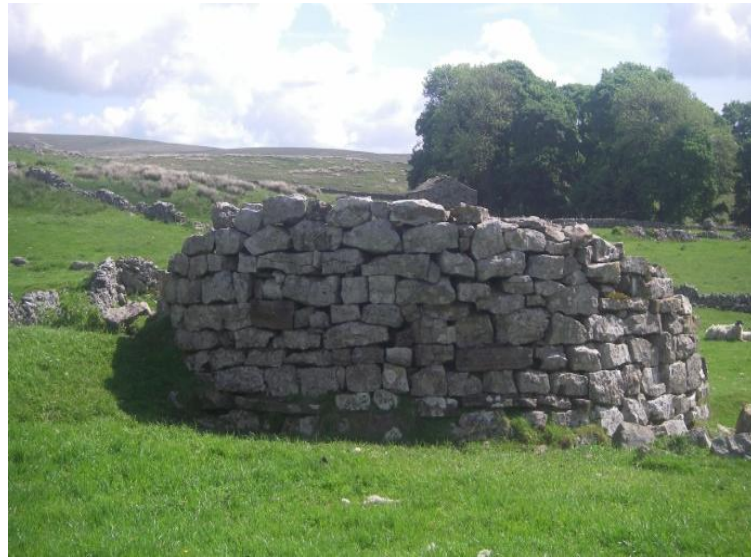
*Fig. 16.7 The lime kiln after stabilisation works
(David Johnson)*

4. The lime kiln just west of the settlement was also stabilised and tidied up, at no cost, again only making use of stone that had fallen off the kiln in recent years (Fig. 16.7).

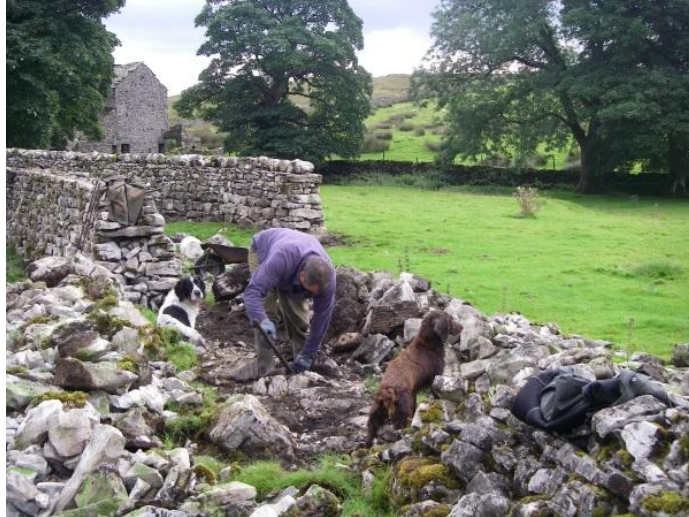
Fig. 16.8 Chris Rushton, helped by Alfie and Reg, rebuilding Wall no. 3, with completed Wall no. 8 in the background (David Johnson)

5. As an indirect result of the *Thorns through Time* project 110m of ruinous dry-stone wall were restored in traditional style under the H2 *Dry Stone Walls* programme between the settlement and the lime kiln: project H2.13 incorporated 57m of Wall no. 8 and 53m of Wall no. 3 (Fig. 16.8); furthermore, H2.28 funded the rebuilding of two lengths of wall of 10m and 20m within the heart of the settlement.

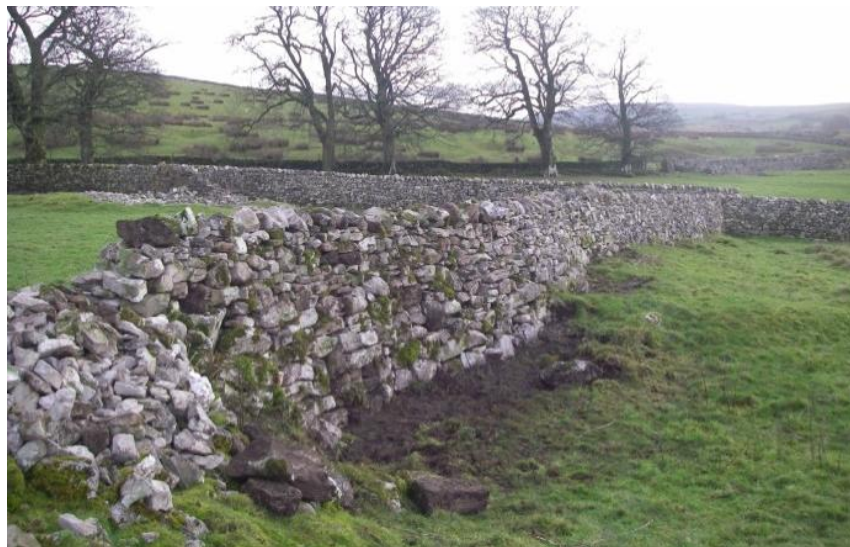
Fig. 16.9 Wall rebuilt by voluntary labour (David Johnson)

In addition, a further length of 28m of Wall no. 6 was repaired or rebuilt as a gesture of goodwill towards the landowners, at no cost and on a voluntary basis (Fig. 16.9). Similarly, as High Flat Barn was being excavated the interior of the surviving north wall was stabilised and a section of the east gable and the adjoining short length of field wall were also repaired, at no cost.

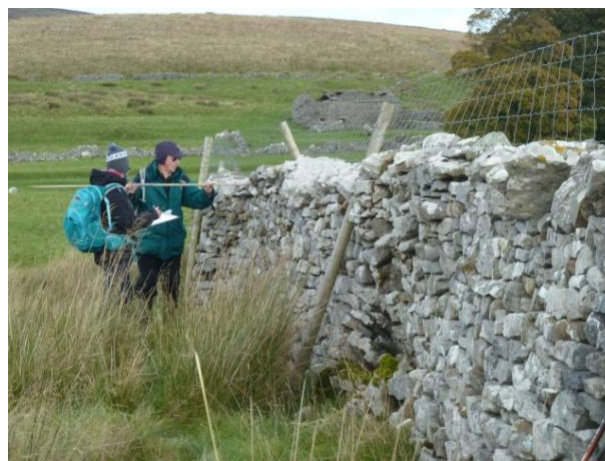
Fig. 17.1 Wall no. 19

Nine sections of 25m each were measured with the following results. The last section was measured three times by three observers.
